Visual Site Inspection Report

Project Name	H-600 Pipeline Spread G	AFE	124300137	Spread	H-600 Pipeline Spread G
Contractor	Precision			Report #	1159
Inspector	Trey Ingram			Date/Time	4/23/2018 4:12 PM
Permit #	TBD	Inspection Type	Weekly	Station Begin	+0
State	VA	Inspection Area	Full	Station End	+0
County	Giles	Ground	Damp	Temperature (°F)	55.00
Municipality	N/A	Weather	Light Rain	Rain Gauge (in)	0.00
GPS Location	37.3171298252766, -80.658827405498			Rain Accumulation Time (days)	1.00

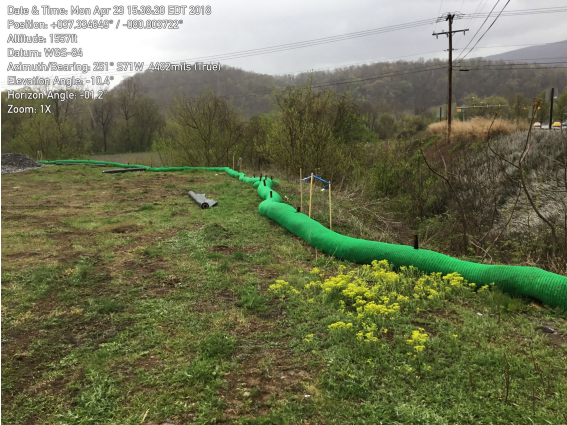
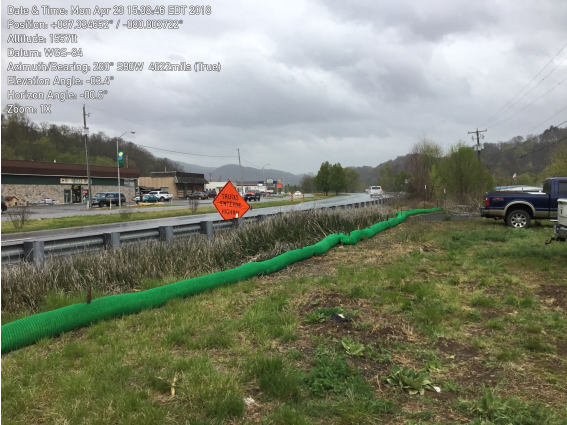
GPS Location	37.31709923133, -80.6589202769852		GPS Location	37.317265612108, -80.6588084623968	
Description	ECDs in good condition but lacking mulch. Yard 28		Description	ECDs in good condition but lacking mulch. Yard 28	
<p>Date & Time: Mon Apr 23 16:11:45 EDT 2018 Position: +037.317911° / -080.658307° Altitude: 1772ft Datum: WGS-84 Azimuth/Bearing: 219° S39W 3893mils (True) Elevation Angle: -14.5° Horizon Angle: +01.9° Zoom: 1X</p>

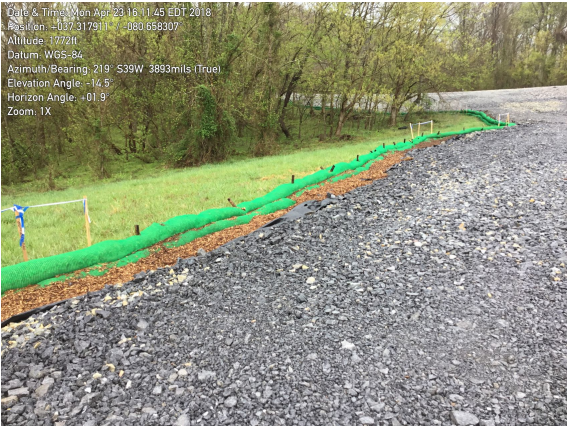
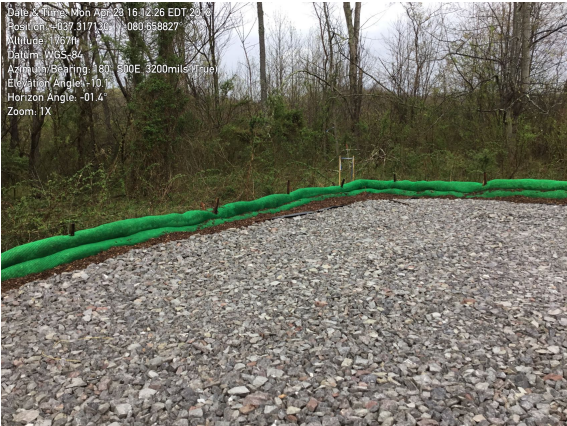
GPS Location	37.317265612108, -80.6588084623969		GPS Location	37.3176030871241, -80.6594285553639	
Description	ECDs in good condition yard 26		Description	ECDs in good condition. Yard 26	
Insert image here			Insert image here		
GPS Location			GPS Location		
Description			Description
