Visual Site Inspection Report

Project Name	H-600 Pipeline Spread G	AFE	124300137	Spread	H-600 Pipeline Spread G
Contractor	Precision			Report #	2276
Inspector	Brian Shields			Date/Time	5/26/2018 7:59 AM
Permit #	TBD	Inspection Type	Weekly	Station Begin	+37
State	WV	Inspection Area	Partial	Station End	+37
County	Monroe	Ground	Damp	Temperature (°F)	72.00
Municipality	N/A	Weather	Cloudy	Rain Gauge (in)	0.00
GPS Location	37.4170056197959, -80.7420978102684			Rain Accumulation Time (days)	1.00

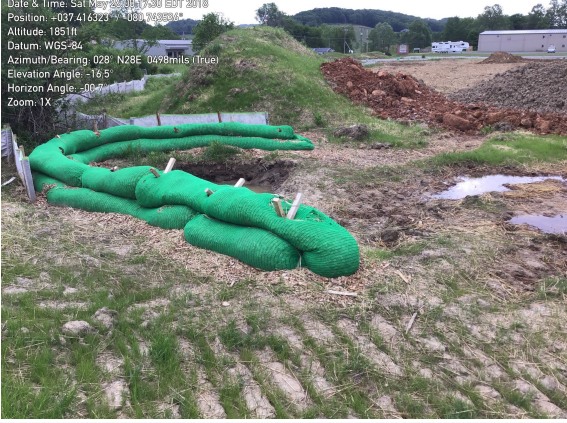
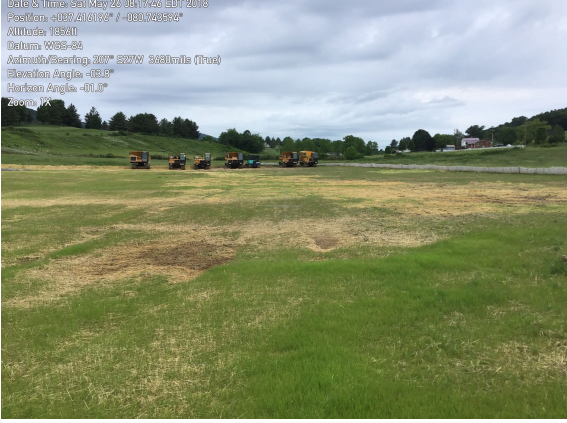
<p>Date & Time: Sat May 26 08:17:44 EDT 2018 Position: +037.416924 / -80.741396 Altitude: 1851ft Datum: WGS-84 Azimuth/Bearing: 326° N27W 333mils (True) Elevation Angle: -02.5° Horizon Angle: -00.0° Zoom: 1X</p>		GPS Location 37.4169154605245, -80.7413960248984	
Description		Description		Compost trap and dump at yard 37. GPS coordinates in photo above.	
  <p>Date & Time: Sat May 26 08:18:49 EDT 2018 Position: +037.416924 / -80.741396 Altitude: 1874ft Datum: WGS-84 Azimuth/Bearing: 255° S25W 4119mils (True) Elevation Angle: -10.0° Horizon Angle: -00.0° Zoom: 1X</p>

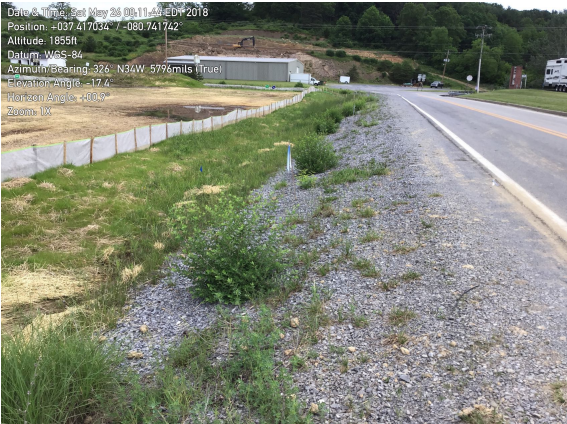
Description		Description		Silt fence installed at yard 37. GPS coordinates in photo above	
Description		Description		Roadside swale at yard 37. GPS coordinates in photo above.	
Insert image here		Insert image here			
GPS Location		GPS Location			
Description		Description
