Visual Site Inspection Report

Project Name	H-600 Pipeline Spread G		AFE	124300137	Spread	H-600 Pipeline Spread G	
Contractor	Precision				Report #	3076	
Inspector	Brian Shields				Date/Time	6/14/2018 4:10 PM	
Permit #	TBD	Inspection Type	VA SWPP		Station Begin	11788+43	
State	VA	Inspection Area	Partial		Station End	11352+97	
County	Montgomery	Ground	Dry		Temperature (°F)	85.00	
Municipality	N/A	Weather	Sunny		Rain Gauge (in)	0.01	
GPS Location	37.2970287222763, -80.3862293065343				Rain Accumulation Time (days)	1.00

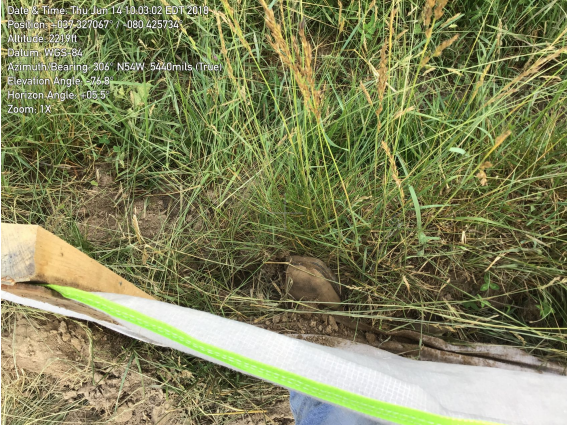
GPS Location	37.2971922112976, -80.386172980145	GPS Location	37.2971922112976, -80.386172980145		
Description	Silt fence not properly installed and in need of maintenance. GPS coordinates in photo above.	Description	Installed compost filter sock no maintenance needed. GPS coordinates in photo above.

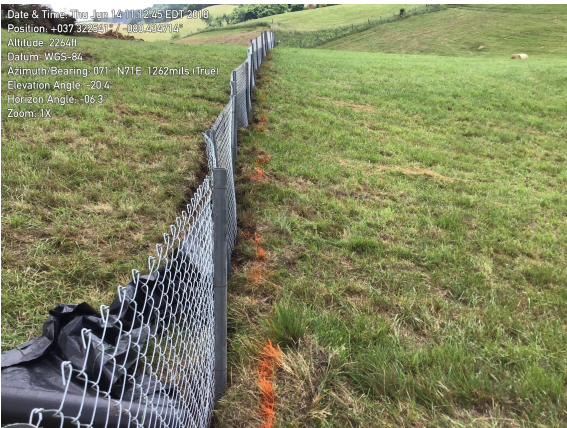
GPS Location	37.2971922112976, -80.386172980145	GPS Location	37.297202562948, -80.3864992876354		
Description	Super silt fence being installed near st#11480+00. GPS coordinates in photo above.	Description	Waterbars installed near st#11704+10. GPS coordinates in photo above.		
Insert image here		Insert image here			
GPS Location		GPS Location			
Description		Description
