## Visual Site Inspection Report

<b>Project Name</b>	H-600 Pipeline Spread G	<b>AFE</b>	124300137	<b>Spread</b>	H-600 Pipeline Spread G
<b>Contractor</b>	Precision			<b>Report #</b>	3608
<b>Inspector</b>	Brian Shields			<b>Date/Time</b>	6/25/2018 3:46 PM
<b>Permit #</b>	TBD	<b>Inspection Type</b>	VA SWPP	<b>Station Begin</b>	11596+94
<b>State</b>	VA	<b>Inspection Area</b>	Partial	<b>Station End</b>	11553+66
<b>County</b>	Montgomery	<b>Ground</b>	Wet	<b>Temperature (°F)</b>	77.00
<b>Municipality</b>	N/A	<b>Weather</b>	Light Rain	<b>Rain Gauge (in)</b>	0.20
<b>GPS Location</b>	37.3895678669562, -80.6846482773132			<b>Rain Accumulation Time (days)</b>	1.00

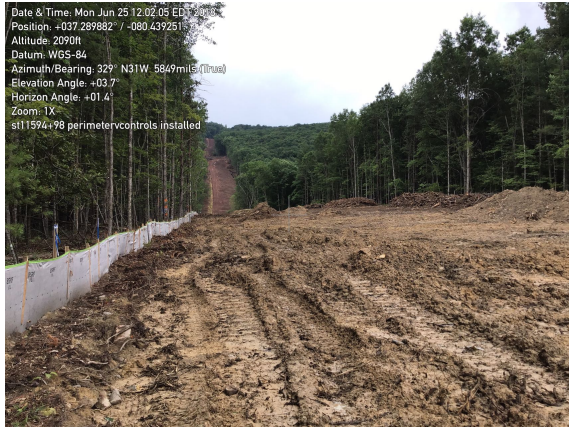
A/E	124300137	Date/Time	6/25/2018 3:46 PM	Report #	3608
Pictures					
<p>Date &amp; Time: Mon Jun 25 12:02:05 EDT 2018 Position: +037.289882° / -080.439251° Altitude: 2090ft Datum: WGS-84 Azimuth/Bearing: 322° N31W 58.49mils (True) Elevation Angle: +03.7° Horizon Angle: +01.4° Zoom: 1X st11594+98 perimeter controls installed</p>

GPS Location	37.3897182382991, -80.6846338604397	GPS Location	37.3897182382991, -80.6846338604397		
Description	Perimeter controls in good working condition near st11594+98. GPS coordinates in photo above.	Description	Undercut sf at sr#11593+05. GPS coordinates in photo above.		
<p>Date &amp; Time: Mon Jun 25 12:02:11 EDT 2018 Position: +037.318537° / -080.410173° Altitude: 2230ft Datum: WGS-84 Azimuth/Bearing: 112° S61E 2.08mils (True) Elevation Angle: +07.2° Horizon Angle: +03.9° Zoom: 1X Undercut silt fence st11579+20 to st11589+01</p>

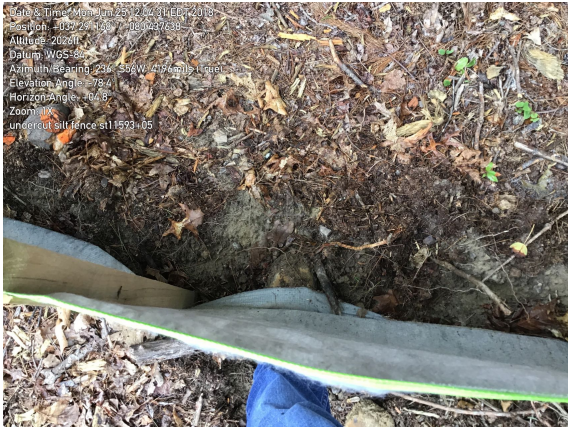
<p>Date &amp; Time: Mon Jun 25 12:02:11 EDT 2018 Position: +037.289882° / -080.439251° Altitude: 2090ft Datum: WGS-84 Azimuth/Bearing: 322° N31W 58.49mils (True) Elevation Angle: +03.7° Horizon Angle: +01.4° Zoom: 1X Undercut silt fence st11593+05</p>

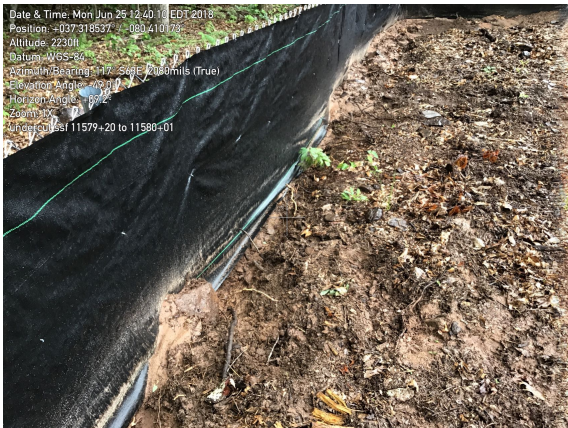
<p>Date &amp; Time: Mon Jun 25 12:40:10 EDT 2018 Position: +037.318537° / -080.410173° Altitude: 2230ft Datum: WGS-84 Azimuth/Bearing: 112° S61E 2.08mils (True) Elevation Angle: +07.2° Horizon Angle: +03.9° Zoom: 1X Undercut silt fence st11579+20 to st11589+01</p>

GPS Location	37.3899021791642, -80.684663783834	GPS Location	37.3899021791642, -80.684663783834		
Description	Sf not trenched in at s-pp20 Crossing, st#11588+05. GPS coordinates in photo above.	Description	Super silt fence undercut and untrenched st#11579+20 to st11589+01. Sock checks needed. GPS coordinates in photo above.		
<p>Date &amp; Time: Mon Jun 25 12:45:24 EDT 2018 Position: +037.317351° / -080.409446° Altitude: 2164ft Datum: WGS-84 Azimuth/Bearing: 072° N99E 14.94mils (True) Elevation Angle: +07.3° Horizon Angle: +07.3° Zoom: 1X undercut sf st11584+02 sediment off row</p>

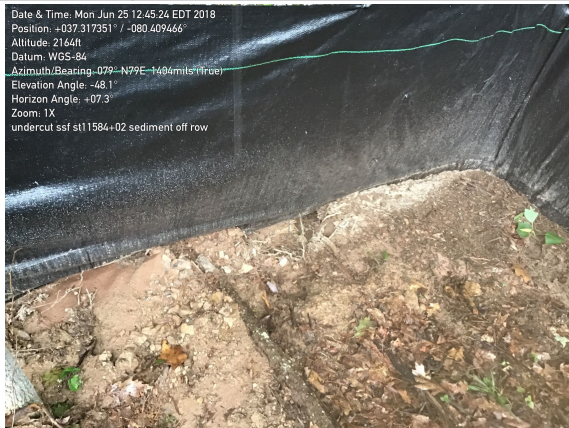
Description	Undercut super silt fence at st#11584+02 leading to sediment off ROW. GPS coordinates in photo above.	Description	Sediment off ROW at st#11584+02 above stream s-pp21. GPS coordinates in photo above.

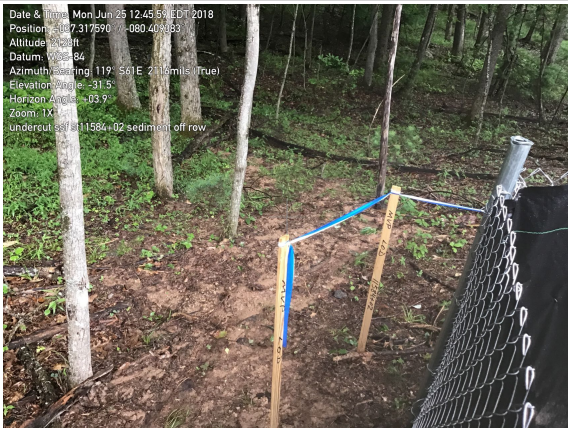
<p>Date &amp; Time: Mon Jun 25 12:45:51 EDT 2018 Position: +037.317351° / -080.409446° Altitude: 2164ft Datum: WGS-84 Azimuth/Bearing: 119° S61E 2.10mils (True) Elevation Angle: +31.5° Horizon Angle: +03.9° Zoom: 1X Undercut silt fence st11584+02 sediment off row</p>
