# Visual Site Inspection Report

<b>Project Name</b>	H-600 Pipeline Spread G	<b>AFE</b>	124300137	<b>Spread</b>	H-600 Pipeline Spread G
<b>Contractor</b>	Precision			<b>Report #</b>	4134
<b>Inspector</b>	Brian Shields			<b>Date/Time</b>	7/6/2018 12:31 PM
<b>Permit #</b>	TBD	<b>Inspection Type</b>	VA SWPP	<b>Station Begin</b>	11788+43
<b>State</b>	VA	<b>Inspection Area</b>	Partial	<b>Station End</b>	11602+42
<b>County</b>	Montgomery	<b>Ground</b>	Dry	<b>Temperature (°F)</b>	87.00
<b>Municipality</b>	N/A	<b>Weather</b>	Cloudy	<b>Rain Gauge (in)</b>	0.00
<b>GPS Location</b>	37.2966805013892, -80.3610188274056			<b>Rain Accumulation Time (days)</b>	1.00

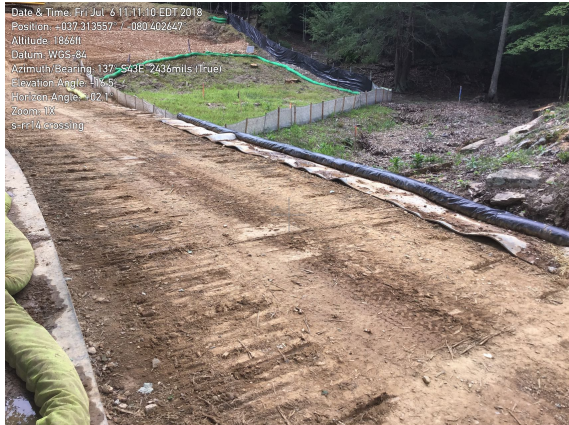
GPS Location	37.2967379959647, -80.3610888776186	GPS Location	37.296667252702, -80.361066078842		
Description	S-rr14 Stream Crossing. GPS coordinates in photo above.	Description	Installed plunge pool at st#11611+00. GPS coordinates in photo above.

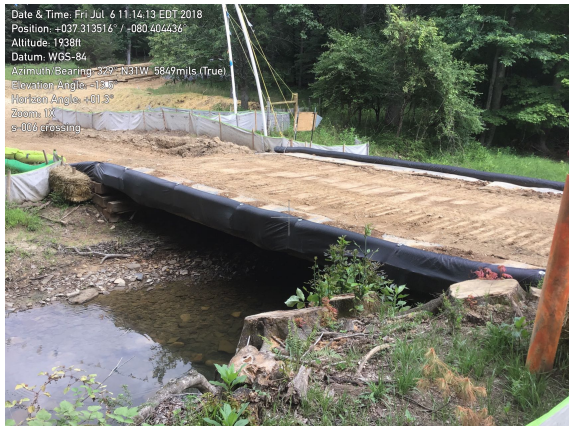
GPS Location	37.296667252702, -80.361066078842	GPS Location	37.296667252702, -80.361066078842		
Description	Crossing s-006. GPS coordinates in photo above.	Description	Stabilization on topsoil pile. GPS coordinates in photo above.

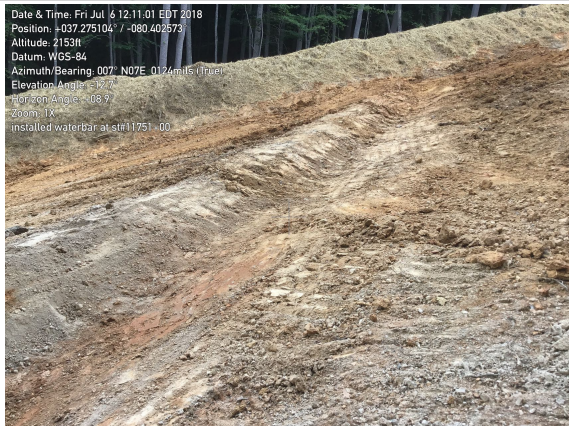
GPS Location	37.296667252702, -80.361066078842	GPS Location	37.296667252702, -80.361066078842		
Description	Installed waterbar at st#11751+00. GPS coordinates in photo above.	Description	Installed compost sock. GPS coordinates in photo above.
