Visual Site Inspection Report

Project Name	H-600 Pipeline Spread G	AFE	124300137	Spread	H-600 Pipeline Spread G
Contractor	Precision			Report #	6081
Inspector	Brian Shields			Date/Time	8/9/2018 5:36 PM
Permit #	TBD	Inspection Type	VA SWPP	Station Begin	11788+43
State	VA	Inspection Area	Partial	Station End	11669+08
County	Montgomery	Ground	Dry	Temperature (°F)	85.00
Municipality	N/A	Weather	Sunny	Rain Gauge (in)	0.00
GPS Location	37.2960166493778, -80.3678827454153			Rain Accumulation Time (days)	1.00

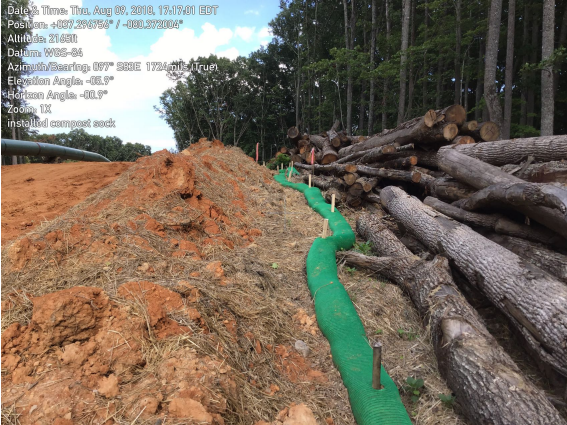
GPS Location	37.2960166493778, -80.3678827454153	GPS Location	37.2960166493778, -80.3678827454153		
Description	Installed compost sock in good working condition.	Description	Sump and end treatment in good working condition.
