Visual Site Inspection Report

Project Name	H-600 Pipeline Spread G	A/E	124300137	Spread	H-600 Pipeline Spread G
Contractor	Precision			Report #	6379
Inspector	Brian Shields			Date/Time	8/15/2018 4:15 PM
Permit #	TBD	Inspection Type	VA SWPP	Station Begin	11669+08
State	VA	Inspection Area	Partial	Station End	11660+01
County	Montgomery	Ground	Dry	Temperature (°F)	85.00
Municipality	N/A	Weather	Sunny	Rain Gauge (in)	0.00
GPS Location	37.1638686520063, -80.4175304157367			Rain Accumulation Time (days)	1.00

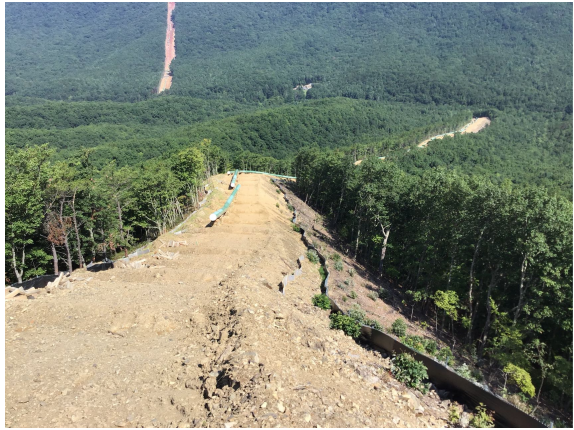
GPS Location	37.1638193413323, -80.4175096085549		GPS Location	37.1638595961519, -80.4174609689133	
Description	Installed waterbars down brush mountain.		Description	Installed super silt fence along Brush mountain functioning as designed.

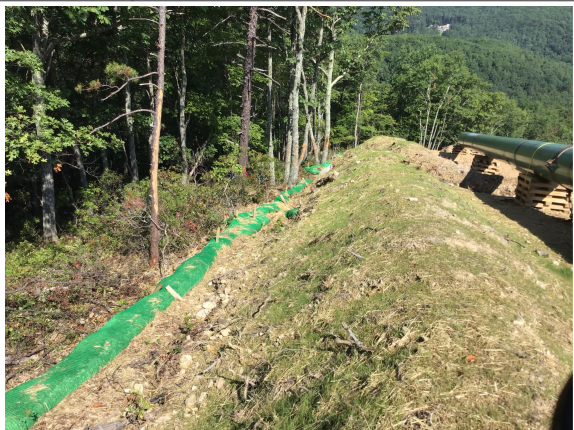
GPS Location	37.1639075514711, -80.4174028600356		GPS Location	37.1639080899162, -80.4173989276312	
Description	Installed compost filter sock.		Description	Installed sump and end treatment. Sump is clear of sediment and dry.

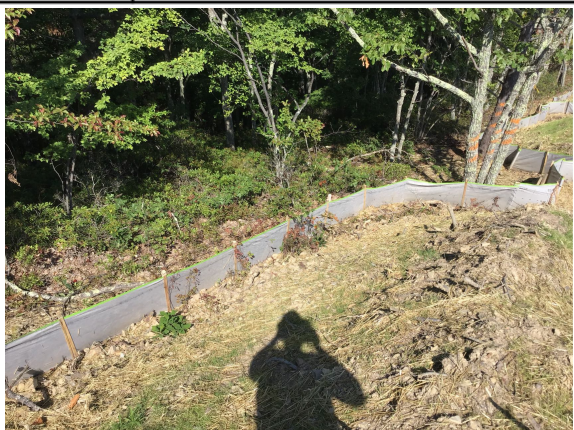
GPS Location	37.1639077773565, -80.4173990857287		GPS Location	37.1640137760949, -80.4174296908343	
Description	Installed silt fence along Brush mountain in good working condition.		Description	Undercut end treatment that has been repaired.

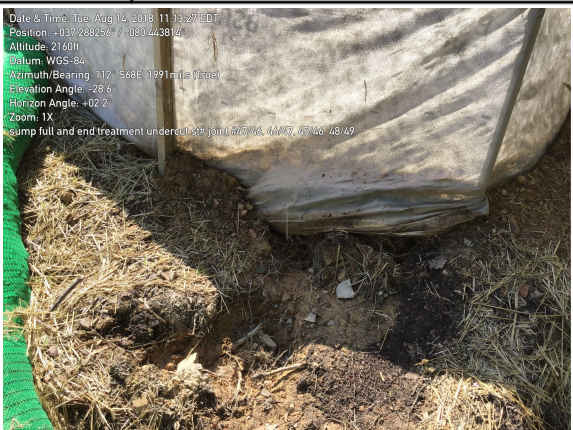
7. Identify all remedial measures that have been taken since the previous inspection was conducted.					
Comments (Reference above questions as appropriate.)					
VA SWPPP inspection MP 220.7 to 219.5 Installed compost filter sock is in good working condition with no maintenance needed. Rock construction entrances have been refreshed since last rain event and are functioning as designed. Installed silt fence is in good working condition with no maintenance needed. Installed super silt fence is in good working condition with no maintenance needed. Multiple sumps are full and in need of clean out. Item has been punch listed. Temporary diversion berms are in good working condition and appear to be functioning as designed. Areas requiring temporary stabilization have been stabilized and all areas where growth was scarce have recently been reseeded. Waterbars are in good working condition and are functioning as designed. Multiple end treatments have been undercut crews have been made aware, and repairs have been made.
