# Visual Site Inspection Report

<b>Project Name</b>	H-600 Pipeline Spread G	<b>AFE</b>	124300137	<b>Spread</b>	H-600 Pipeline Spread G
<b>Contractor</b>	Precision			<b>Report #</b>	6707
<b>Inspector</b>	Brian Shields			<b>Date/Time</b>	8/21/2018 7:41 PM
<b>Permit #</b>	TBD	<b>Inspection Type</b>	VA SWPP	<b>Station Begin</b>	11768+63
<b>State</b>	VA	<b>Inspection Area</b>	Partial	<b>Station End</b>	11669+08
<b>County</b>	Montgomery	<b>Ground</b>	Muddy	<b>Temperature (°F)</b>	76.00
<b>Municipality</b>	N/A	<b>Weather</b>	Cloudy	<b>Rain Gauge (in)</b>	0.50
<b>GPS Location</b>	37.1361201923733, -80.3941692483519			<b>Rain Accumulation Time (days)</b>	1.00

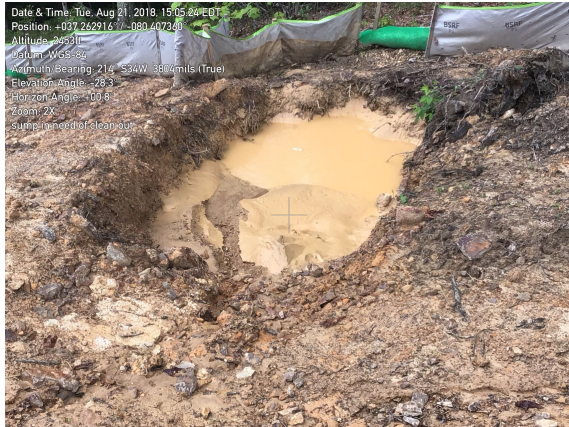
<p>Date &amp; Time: Tue, Aug 21, 2018, 15:05:44 EDT Position: +037 262916 / -080 407340 Altitude: 7653ft Datum: WGS 84 Azimuth Bearing: 214 S44W 384mils (True) Elevation Angle: -28.3 Horizon Angle: -101.8 Zoom: 2X Summary: end of clean up</p>

<p>Date &amp; Time: Tue, Aug 21, 2018, 15:04:33 EDT Position: +037 266420 / -080 408000 Altitude: 7653ft Datum: WGS 84 Azimuth Bearing: 132 S48E 2347mils (True) Elevation Angle: -28.0 Horizon Angle: -89.0 Zoom: 1X Summary: installed silt fence</p>			
GPS Location	37.1361205724844, -80.3941684045424	GPS Location	37.1361238426851, -80.3941705177243		
Description	Installed sump in need of clean out.	Description	Installed silt fence with no maintenance needed.

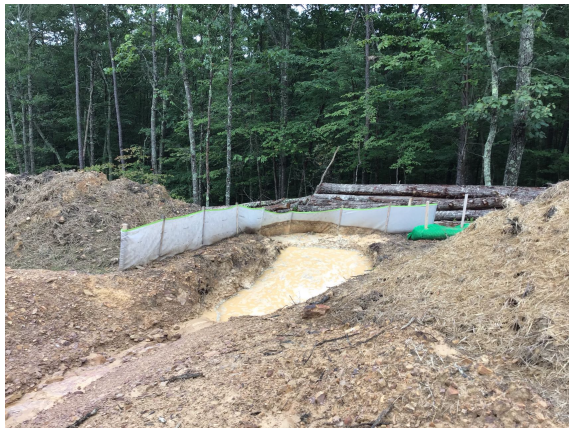
GPS Location	37.1361237131052, -80.3941706001729	GPS Location	37.1361237127712, -80.394170600384		
Description	Sump full and in need of clean out.	Description	Undercut end treatment.crews on site making repairs.

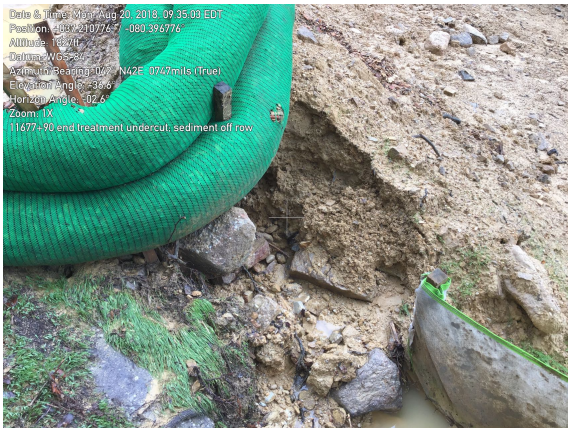
<p>Date &amp; Time: Mon, Aug 20, 2018, 09:35:03 EDT Position: +037 2107647 / -080 394776 Altitude: 7651ft Datum: WGS 84 Azimuth Bearing: 117 N42E 0747mils (True) Elevation Angle: -36.6 Horizon Angle: -102.6 Zoom: 1X Summary: 11677+70 end treatment undercut, sediment off row</p>

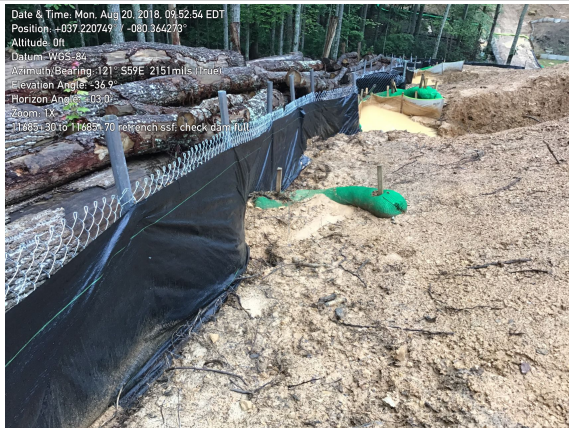
<p>Date &amp; Time: Mon, Aug 20, 2018, 09:52:54 EDT Position: +037 220749 / -080 364273 Altitude: 0ft Datum: WGS 84 Azimuth Bearing: 121 S89E 2151mils (True) Elevation Angle: -36.3 Horizon Angle: -101.0 Zoom: 1X Summary: 11685+30 to 11685+70 retrenchesft check dam with</p>

GPS Location	37.136123913715, -80.3941704748612	GPS Location	37.1361239834524, -80.3941703136411		
Description	Super silt fence at st#11685+30 needing retrenched.	Description	Installed compost filter sock in good working condition with no maintenance needed.
