## Visual Site Inspection Report

<b>Project Name</b>	H-600 Pipeline Spread G	<b>AFE</b>	124300137	<b>Spread</b>	H-600 Pipeline Spread G
<b>Contractor</b>	Precision	<b>Report #</b>	6712		
<b>Inspector</b>	Brian Shields	<b>Date/Time</b>	8/21/2018 9:01 PM		
<b>Permit #</b>	TBD	<b>Inspection Type</b>	VA SWPP	<b>Station Begin</b>	11669+08
<b>State</b>	VA	<b>Inspection Area</b>	Partial	<b>Station End</b>	11553+66
<b>County</b>	Montgomery	<b>Ground</b>	Muddy	<b>Temperature (°F)</b>	75.00
<b>Municipality</b>	N/A	<b>Weather</b>	Cloudy	<b>Rain Gauge (in)</b>	0.15
<b>GPS Location</b>	37.1361236258259, -80.3941709227249			<b>Rain Accumulation Time (days)</b>	1.00

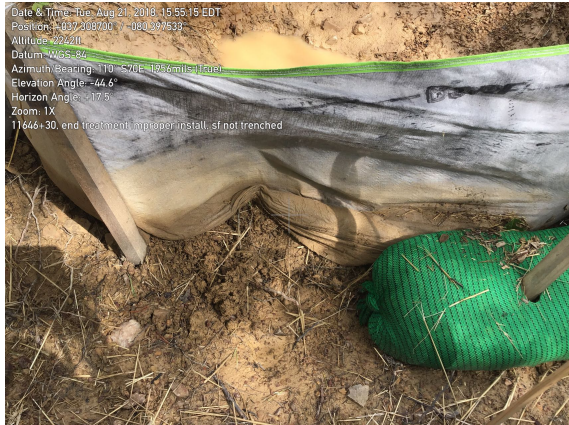
A/E	124300137	Date/Time	8/21/2018 9:01 PM	Report #	6712
Pictures					
<p>Date &amp; Time: Tue Aug 21, 2018 15:55:15 EDT Position: -037.308700 / -80.397532 Altitude: 2227ft Datum: WGS-84 Azimuth/Bearing: 130° S80W 220 ft (True) Elevation Angle: -48.2° Horizon Angle: -80.9° Zoom: 1X 11646+30, end treatment, riprap not install, sf not trenched</p>

GPS Location	37.136123615955, -80.3941690811993	GPS Location	37.1361236344039, -80.3941691765513		
Description	End treatment in need of reinstall. Silt fence not trenched in. St#11646+30	Description	End treatment undercut st st#11647+40.		
<p>Date &amp; Time: Tue Aug 21, 2018 15:55:38 EDT Position: -037.307887 / -80.397552 Altitude: 2346ft Datum: WGS-84 Azimuth/Bearing: 189° S09W 3360mils (True) Elevation Angle: -13° Horizon Angle: -07° Zoom: 1X 11653+00 clean out cfs</p>

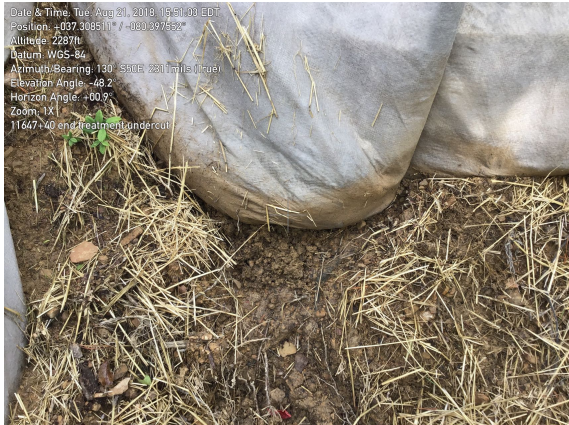
<p>Date &amp; Time: Tue Aug 21, 2018 15:51:00 EDT Position: -037.308511 / -80.397532 Altitude: 2287ft Datum: WGS-84 Azimuth/Bearing: 130° S80W 220 ft (True) Elevation Angle: -48.2° Horizon Angle: -80.9° Zoom: 1X 11647+40 end treatment undercut</p>

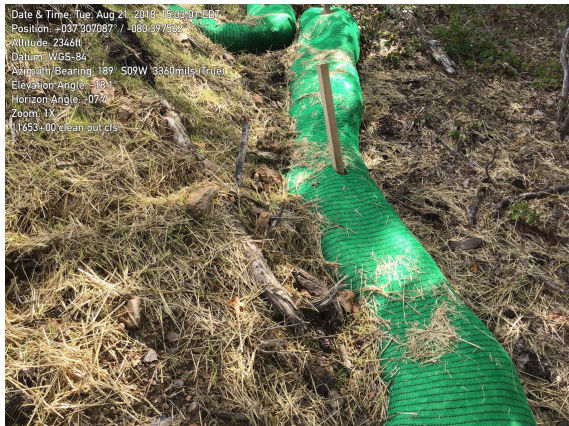
GPS Location	37.1361235984552, -80.3941691829728	GPS Location	37.136123511258, -80.3941692022728		
Description	11653+00. Stockpile stacked upon cfs. Cfs non functional and in need of clean out.	Description	Undercut end treatment at st#11655+60; sediment off ROW.		
<p>Date &amp; Time: Tue Aug 21, 2018 10:25:46 EDT Position: -037.303316 / -80.426549 Altitude: 2124ft Datum: WGS-84 Azimuth/Bearing: 090° N49E 3877mils (True) Elevation Angle: -23° Horizon Angle: -16.7° Zoom: 1X 11582+50 perimeter control, adjustment needed; add stakes to drive into back of end treatment</p>

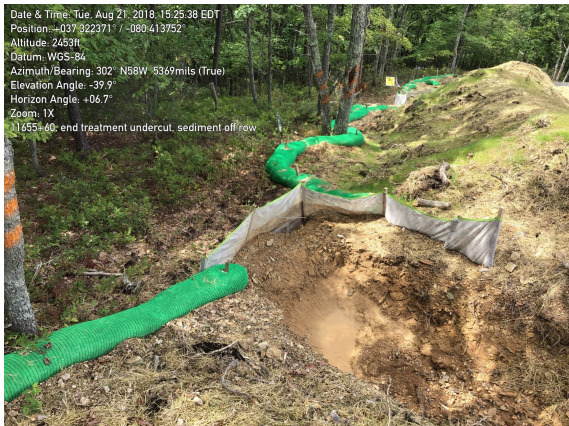
<p>Date &amp; Time: Tue Aug 21, 2018 15:25:38 EDT Position: -037.322371 / -80.413752 Altitude: 2453ft Datum: WGS-84 Azimuth/Bearing: 302° N88W 5369mils (True) Elevation Angle: -39.9° Horizon Angle: +06.7° Zoom: 1X 11655+60, end treatment undercut, sediment off row</p>

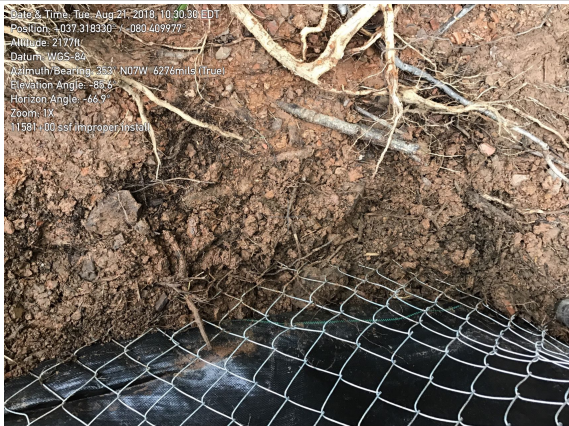
<p>Date &amp; Time: Tue Aug 21, 2018 10:30:50 EDT Position: -037.318330 / -80.409777 Altitude: 2177ft Datum: WGS-84 Azimuth/Bearing: 088° N67W 6276mils (True) Elevation Angle: -26.9° Horizon Angle: -44.9° Zoom: 1X 11581+00 ssf not properly trenched</p>

Description	11682+50, sump full and in need of clean out.	Description	11581+00; ssf not properly trenched, ssf undercut, sediment off row.
