Visual Site Inspection Report

Project Name	H-600 Pipeline Spread G		AFE	124300137	Spread	H-600 Pipeline Spread G	
Contractor	Precision				Report #	7000	
Inspector	Brian Shields				Date/Time	8/27/2018 12:06 PM	
Permit #	TBD	Inspection Type	VA SWPP		Station Begin	10458+91	
State	VA	Inspection Area	Partial		Station End	10459+03	
County	Giles	Ground	Dry		Temperature (°F)	82.00	
Municipality	N/A	Weather	Sunny		Rain Gauge (in)	0.00	
GPS Location	37.2771067411406, -80.3942077590691				Rain Accumulation Time (days)	1.00

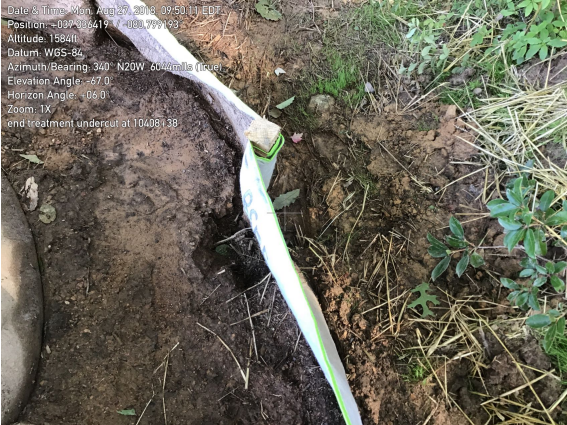
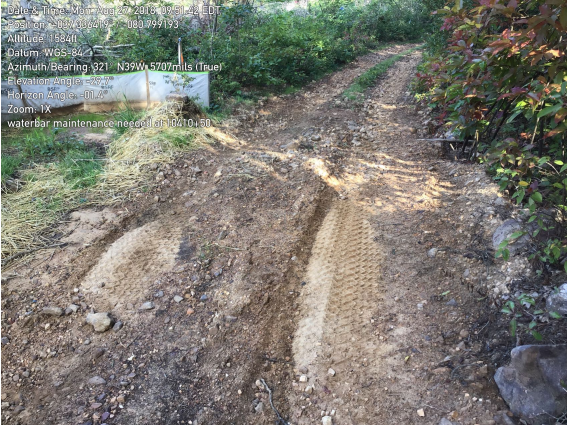
GPS Location	37.2771067411406, -80.3942077590691	GPS Location	37.2771067411406, -80.3942077590691		
Description	End treatment undercut at st10408+38 along Mystery ridge. GPS coordinates in photo above.	Description	Waterbar maintenance needed along Mystery ridge. Throat needs cleaned out. GPS coordinates in photo above.

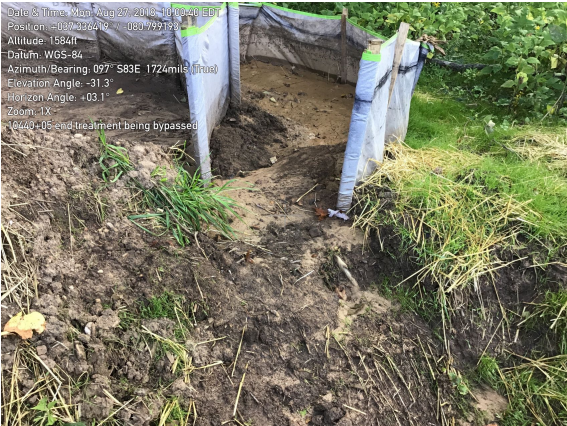
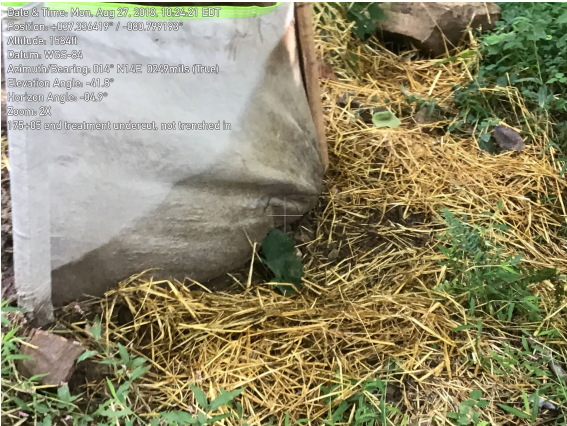
GPS Location	37.2771067411406, -80.3942077590691	GPS Location	37.2771067411406, -80.3942077590691		
Description	End treatments bypassed along Mystery ridge. GPS coordinates in photo above.	Description	End treatment undercut, silt fence not properly trenched. Pocahontas rd, st#175+05. GPS coordinates in photo above.

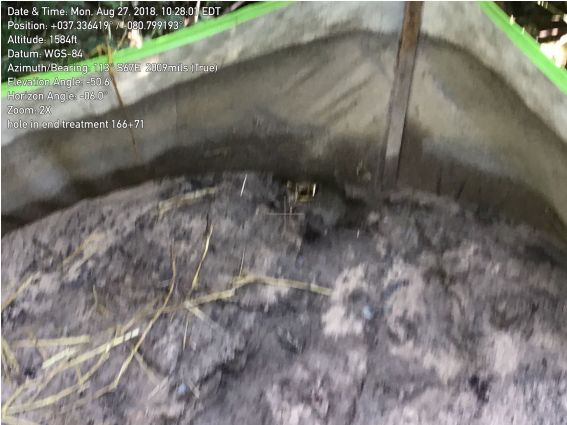
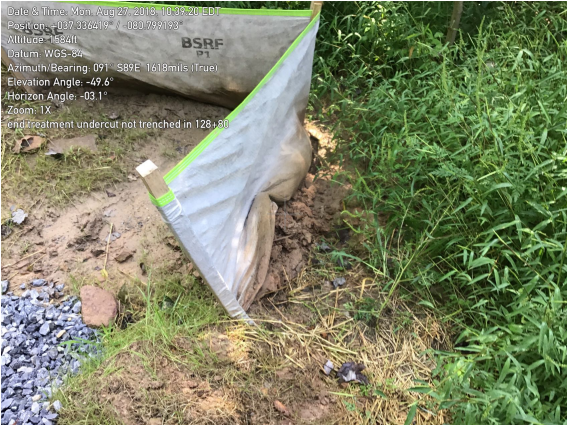
GPS Location	37.2771067411406, -80.3942077590691	GPS Location	37.2771067411406, -80.3942077590691		
Description	Hole in end treatment needing repair. Pocahontas road, st#166+71. GPS coordinates in photo above.	Description	End treatment undercut, silt fence not properly trenched. Pocahontas rd, st#128+80. GPS coordinates in photo above.
