# Visual Site Inspection Report

<b>Project Name</b>	H-600 Pipeline Spread G	<b>AFE</b>	124300137	<b>Spread</b>	H-600 Pipeline Spread G
<b>Contractor</b>	Precision			<b>Report #</b>	7763
<b>Inspector</b>	Brian Shields			<b>Date/Time</b>	9/12/2018 4:04 PM
<b>Permit #</b>	TBD	<b>Inspection Type</b>	VA SWPP	<b>Station Begin</b>	11788+43
<b>State</b>	VA	<b>Inspection Area</b>	Partial	<b>Station End</b>	11669+00
<b>County</b>	Montgomery	<b>Ground</b>	Muddy	<b>Temperature (°F)</b>	77.00
<b>Municipality</b>	N/A	<b>Weather</b>	Cloudy	<b>Rain Gauge (in)</b>	1.30
<b>GPS Location</b>	37.2727260111658, -80.3932524265708			<b>Rain Accumulation Time (days)</b>	1.00

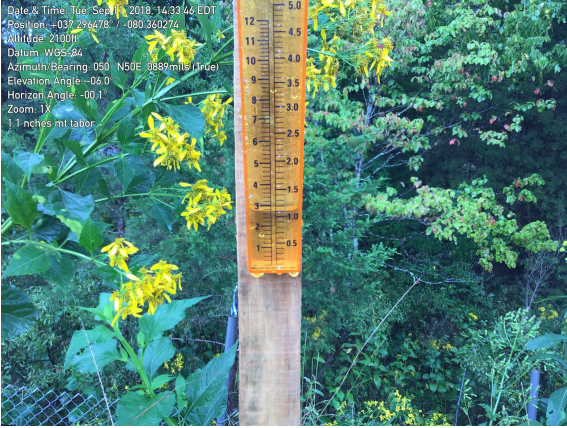
<p>Date &amp; Time: Tue, Sep 11, 2018, 14:33:46 EDT Position: +037.272726° / -080.393252° Altitude: 2153ft Datum: WGS-84 Azimuth/Bearing: 050° N50E 0882mils (True) Elevation Angle: -06.0° Horizon Angle: -00.1° Zoom: 1X 1.1 inches mt tabor</p>

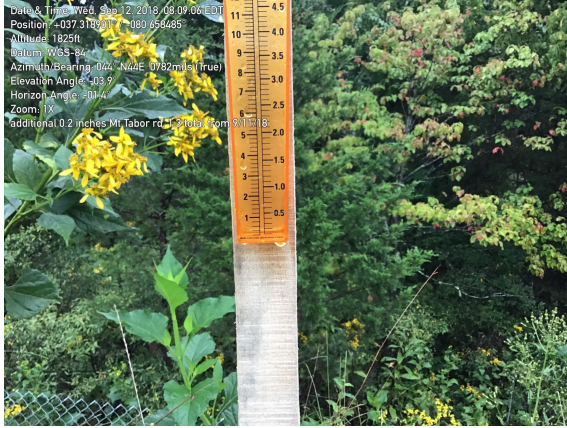
<p>Date &amp; Time: Wed, Sep 12, 2018, 08:09:00 EDT Position: +037.272726° / -080.393252° Altitude: 2153ft Datum: WGS-84 Azimuth/Bearing: 050° N50E 0882mils (True) Elevation Angle: -06.0° Horizon Angle: -00.1° Zoom: 1X Additional 0.2 inches Mt Tabor rd. Station from 9/11/18</p>		<b>GPS Location</b> 37.2727260111658, -80.3932524265708	
<b>Description</b>		<b>Description</b>		1.1 inches observed from afternoon rain event on 9/11.

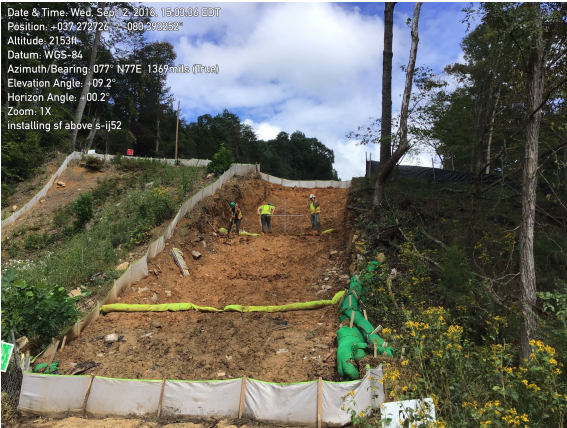
<p>Date &amp; Time: Wed, Sep 12, 2018, 15:04:50 EDT Position: +037.272726° / -080.393252° Altitude: 2153ft Datum: WGS-84 Azimuth/Bearing: 077° N77E 1365mils (True) Elevation Angle: -09.2° Horizon Angle: -00.2° Zoom: 1X installing sf above s-ij52</p>

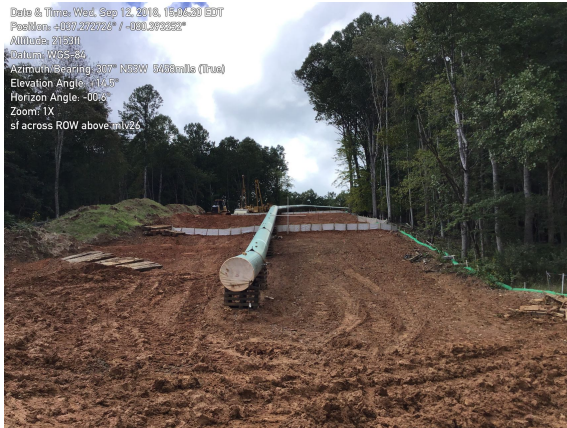
<p>Date &amp; Time: Wed, Sep 12, 2018, 15:06:50 EDT Position: +037.272726° / -080.393252° Altitude: 2153ft Datum: WGS-84 Azimuth/Bearing: 267° N267W 0403mils (True) Elevation Angle: -10.0° Horizon Angle: -00.6° Zoom: 1X sf across ROW above mlv26</p>		<b>GPS Location</b> 37.2727260111658, -80.3932524265708

<b>Description</b>		<b>Description</b>		Crew installing additional ECDs above stream s-ij52.

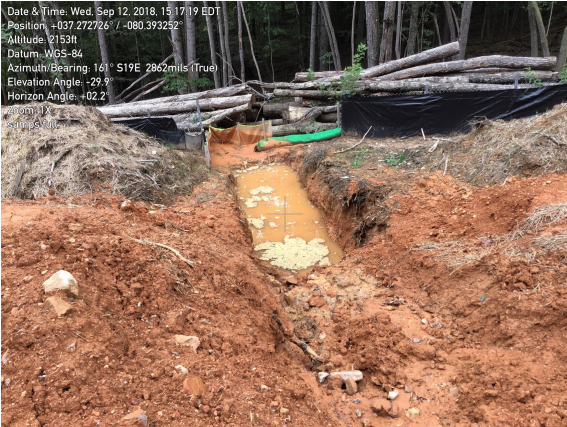
<p>Date &amp; Time: Wed, Sep 12, 2018, 15:17:19 EDT Position: +037.272726° / -080.393252° Altitude: 2153ft Datum: WGS-84 Azimuth/Bearing: 161° S19E 2862mils (True) Elevation Angle: -29.4° Horizon Angle: -02.2° Zoom: 1X water in pond and treatment</p>

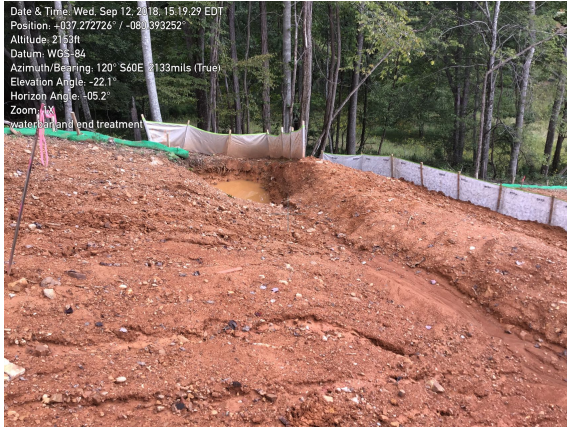
<p>Date &amp; Time: Wed, Sep 12, 2018, 15:19:29 EDT Position: +037.272726° / -080.393252° Altitude: 2153ft Datum: WGS-84 Azimuth/Bearing: 120° S60E 2133mils (True) Elevation Angle: -22.1° Horizon Angle: -05.2° Zoom: 1X water in pond and treatment</p>		<b>GPS Location</b> 37.2727260111658, -80.3932524265708	
<b>Description</b>		<b>Description</b>		Sump holding water after 9/11 storm event.	
<b>Description</b>		<b>Description</b>		Installed waterbar.
