Visual Site Inspection Report

Project Name	H-600 Pipeline Spread G	AFE	124300137	Spread	H-600 Pipeline Spread G
Contractor	Precision			Report #	8860
Inspector	Brian Shields			Date/Time	10/4/2018 5:10 PM
Permit #	TBD	Inspection Type	VA SWPP	Station Begin	10558+91
State	VA	Inspection Area	Partial	Station End	10459+03
County	Giles	Ground	Dry	Temperature (°F)	82.00
Municipality	N/A	Weather	Sunny	Rain Gauge (in)	0.00
GPS Location	37.1361465331692, -80.394159171458			Rain Accumulation Time (days)	1.00

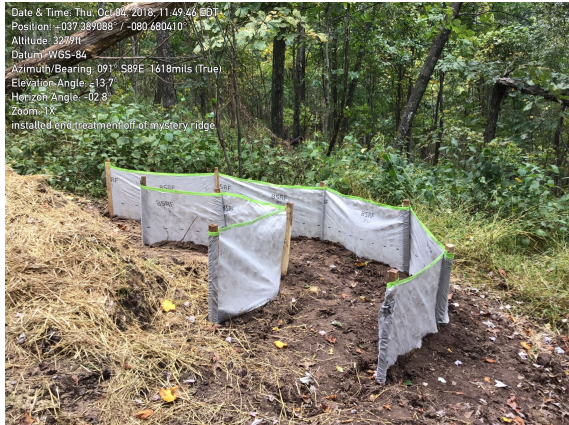
A/E	124300137	Date/Time	10/4/2018 5:10 PM	Report #	8860
Pictures					
<div><div><div>Date & Time: Thu, Oct 04, 2018, 11:49:46 EDT Position: +037.385088° / -080.680410° Altitude: 329ft Datum: WGS-84 Azimuth/Bearing: 091° S89E 1618mils (True) Elevation Angle: -13.7° Horizon Angle: -02.8° Zoom: 1X Installed end treatment off of Mystery ridge</div><div>

</div></div></div>			
GPS Location	37.1359512163672, -80.3940393962715		GPS Location	37.1359512163672, -80.3940393962715	
Description	Installed end treatment off of Mystery ridge road.		Description	Installed end treatment along Pocahontas rd at 224+57

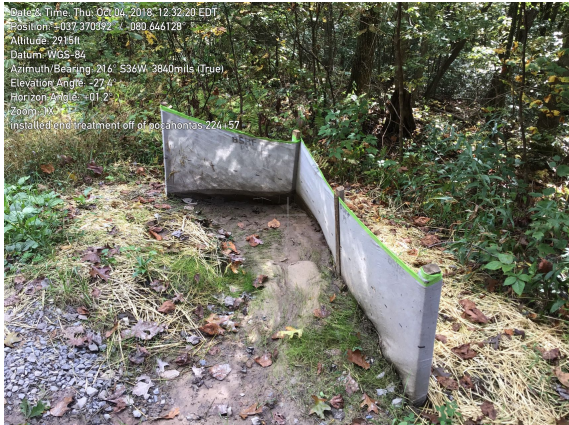
</div></div></div>		<div><div><div>Date & Time: Thu, Oct 04, 2018, 12:32:28 EDT Position: +037.370342° / -080.646128° Altitude: 291ft Datum: WGS-84 Azimuth/Bearing: 216° S86W 3840mils (True) Elevation Angle: -27.7° Horizon Angle: -01.2° Zoom: 1X Installed end treatment off of pocahontas rd at 224+57</div><div>

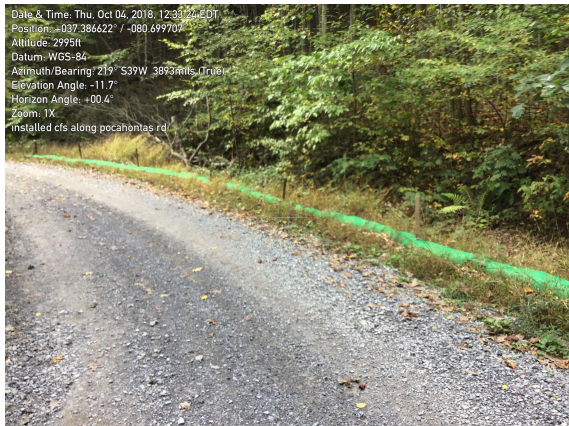
<div><div><div>Date & Time: Thu, Oct 04, 2018, 12:31:01 EDT Position: +037.386622° / -080.699702° Altitude: 299ft Datum: WGS-84 Azimuth/Bearing: 215° S39W 3893mils (True) Elevation Angle: -11.7° Horizon Angle: +00.4° Zoom: 1X Installed cfs along pocahontas rd</div><div>

</div></div></div>			
GPS Location	37.1359512163672, -80.3940393962715		GPS Location	37.1361514450282, -80.3941546973774	
Description	Installed compost filter sock along Pocahontas road.		Description	Installed waterbar and end treatment along Pocahontas rd at 175+05	
<div><div><div>Date & Time: Thu, Oct 04, 2018, 12:40:47 EDT Position: +037.383622° / -080.684428° Altitude: 312ft Datum: WGS-84 Azimuth/Bearing: 141° S89E 3003mils (True) Elevation Angle: -60.1° Horizon Angle: +08.0° Zoom: 1X End treatment at 174+50 not trenched</div><div>

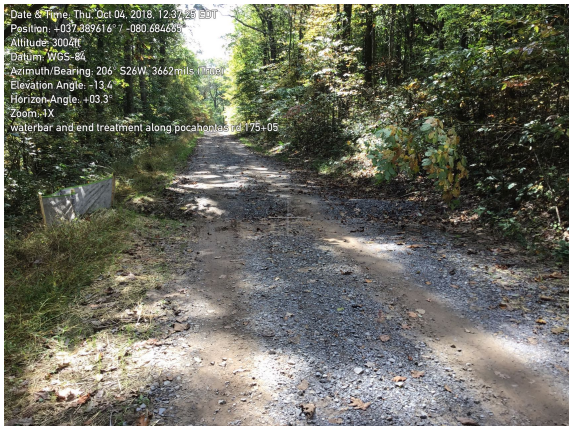
</div></div></div>		<div><div><div>Date & Time: Thu, Oct 04, 2018, 12:37:20 EDT Position: +037.389616° / -080.684034° Altitude: 300ft Datum: WGS-84 Azimuth/Bearing: 206° S26W 3662mils (True) Elevation Angle: -13.4° Horizon Angle: +03.3° Zoom: 1X Waterbar and end treatment along pocahontas rd at 175+05</div><div>

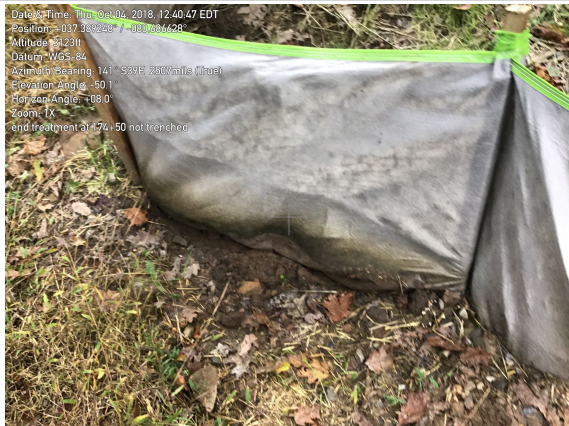
GPS Location	37.1360882185745, -80.3941788711402		GPS Location		
Description	End treatment observed to be improperly trenched along Pocahontas rd at 173+60		Description

4. E&S BMPs (List BMPs and note if installed and maintained as per the plan. If corrective action is needed, a picture is required.)					
E&S BMPs	Compliance Level	Corrective Action		Corrective Time Frame	Date Repaired
Compost Filter Sock	Acceptable				
Silt Fence (Filter Fabric Fence)	Acceptable				
Waterbar Outlet Protection	Communication	Retrench silt fence per spec		24 Hours	
Waterbar	Acceptable
