Visual Site Inspection Report

Project Name	H-600 Pipeline Spread G		AFE	124300137	Spread	H-600 Pipeline Spread G	
Contractor	Precision				Report #	3656	
Inspector	Clinton Banks				Date/Time	6/26/2018 7:52 AM	
Permit #	TBD	Inspection Type	VA SWPP		Station Begin	+37	
State	WV	Inspection Area	Full		Station End	+37	
County	Monroe	Ground	Wet		Temperature (°F)	68.00	
Municipality	N/A	Weather	Cloudy		Rain Gauge (in)	0.42	
GPS Location	37.4171948008482, -80.7418929284083				Rain Accumulation Time (days)	2.00

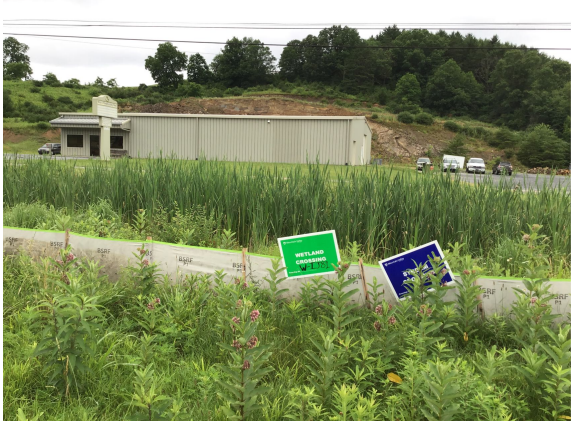
GPS Location	37.4174986733472, -80.7424002607174		GPS Location	37.4164442655067, -80.7442568211384	
Description	Wetland Crossing W-IJ81 at LY 37		Description	Culvert with 18" Sock at LY 37	
Insert image here			Insert image here		
GPS Location			GPS Location		
Description			Description		
Insert image here			Insert image here		
GPS Location			GPS Location		
Description			Description
