# Visual Site Inspection Report

| <b>Project Name</b> | H-600 Pipeline Spread G | <b>AFE</b> | 124300137 | <b>Spread</b> | H-600 Pipeline Spread G |
| <b>Contractor</b> | Precision | | | <b>Report #</b> | 3660 |
| <b>Inspector</b> | Clinton Banks | | | <b>Date/Time</b> | 6/26/2018 9:05 AM |

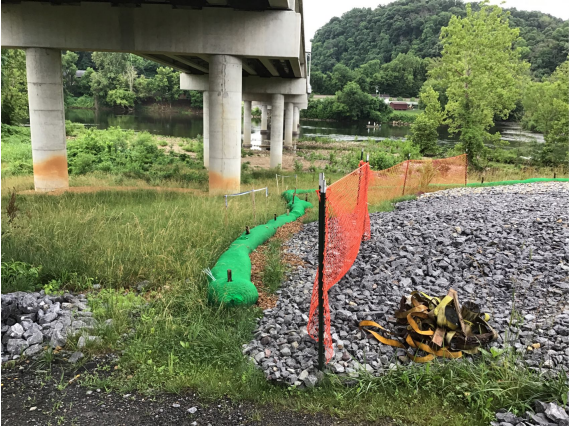
| <b>Description</b> | At LY 28 | | <b>Description</b> | 18" Sock Double Stack LY 26 | |

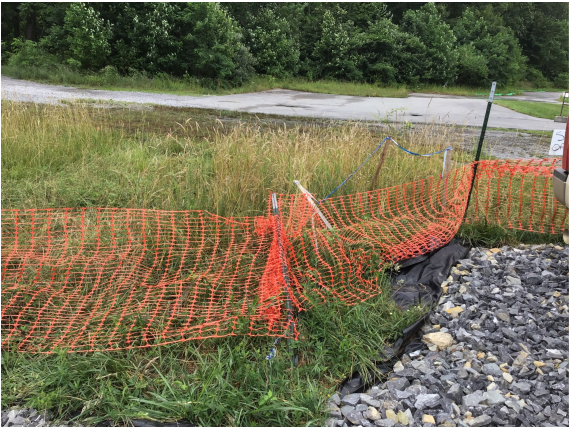
| <b>Description</b> | Safety Fence down (Been Back Over) in LY 26 | | <b>Description</b> | 18" Sock in LY 26 Behind Northern Clearing | |
