# Visual Site Inspection Report

| <b>Project Name</b> | H-600 Pipeline Spread G | <b>AFE</b> | 124300137 | <b>Spread</b> | H-600 Pipeline Spread G |
| <b>Contractor</b> | Precision | | | <b>Report #</b> | 3701 |
| <b>Inspector</b> | Clinton Banks | | | <b>Date/Time</b> | 6/27/2018 7:23 AM |

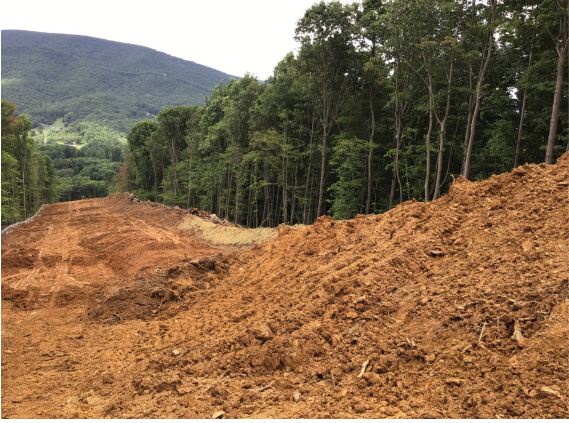
| <b>Description</b> | Looking down stream from Station 11545+10 | <b>Description</b> | Rolling back Top Soil at Station 11521+33 | | |

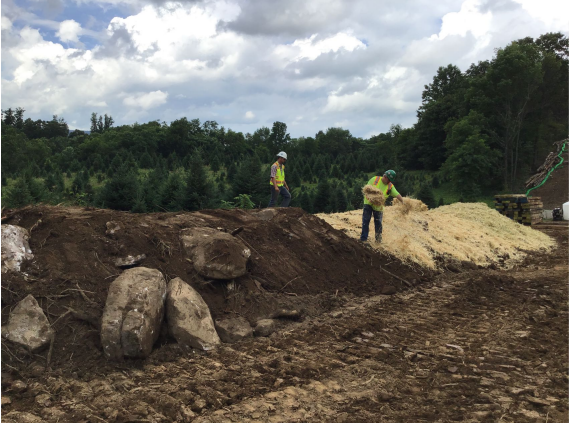
| <b>Description</b> | Stabilizing Top Soil | <b>Description</b> | | | |
