# Visual Site Inspection Report

| <b>Project Name</b> | H-600 Pipeline Spread G | <b>A/E</b> | 124300137 | <b>Spread</b> | H-600 Pipeline Spread G |
| <b>Contractor</b> | Precision | | | <b>Report #</b> | 3939 |
| <b>Inspector</b> | Clinton Banks | | | <b>Date/Time</b> | 7/2/2018 9:36 AM |

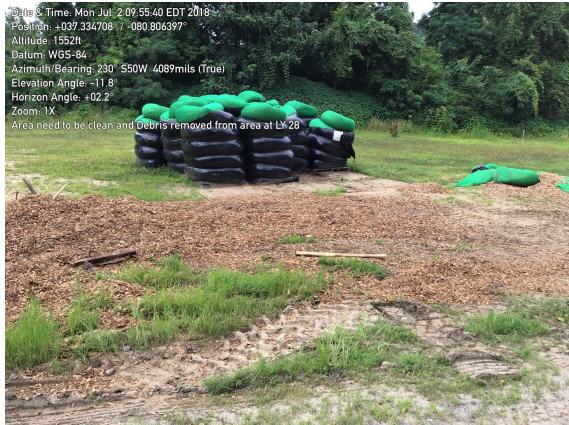
| E&S BMPs | Compliance Level | Corrective Action | Corrective Time Frame |
|---|---|---|---|
| Much need to be removed | Problem Area | Much & Debris need to be clean off of | Addressed |

| Description | Much & Debris need to be removed from area at LY 28 | | Description | Diesel Storage Tank LY 26 | |

| Conducted Weekly SWPP Inspection at LY 28 & LY 26. One area at LY28 where there was two pallets of old Sock and much and Debris on the ground that needed to be removed. Fork Lift arrived while EI Inspector Clinton Banks was at that area and stated that he had a dump truck on the way to removed all of the old socks and he would also clean the much and debris off of the ground and haul it away. EI stated that would be fine, that I would write it up as being addressed, that would be back too check and make sure it was taken care of. | | | | | |

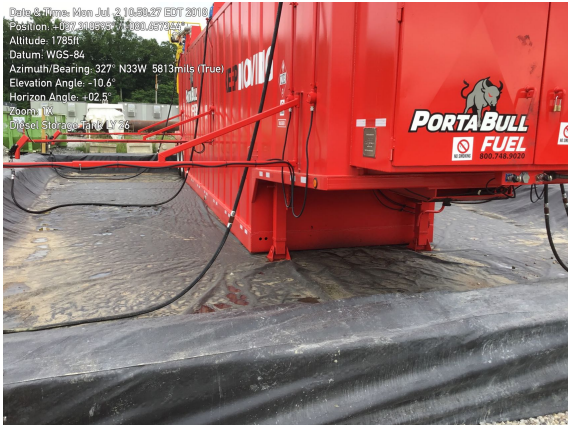
| E&S BMPs | Compliance Level | Corrective Action | Corrective Time Frame |
|---|---|---|---|
| Diesel Storage Containment Area | Acceptable | LY 26 | |

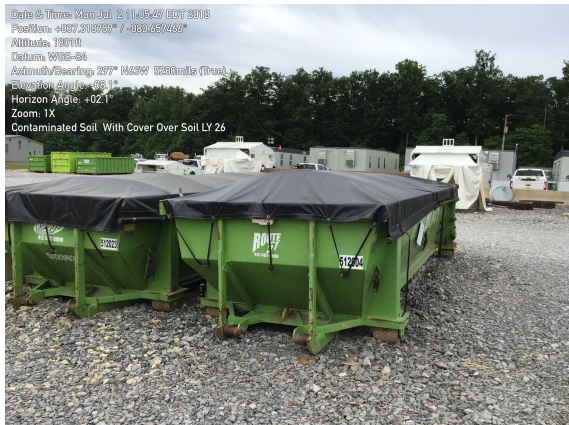
| E&S BMPs | Compliance Level | Corrective Action | Corrective Time Frame |
|---|---|---|---|
| Contaminated Soil Storage With Cover | Acceptable | LY 26 | |

| Description | Contaminated Soil With Cover Over Soil at LY 26. | | Description | | |
