# Visual Site Inspection Report

<b>Project Name</b>	H-600 Pipeline Spread G	<b>AFE</b>	124300137	<b>Spread</b>	H-600 Pipeline Spread G
<b>Contractor</b>	Precision			<b>Report #</b>	5451
<b>Inspector</b>	Clinton Banks			<b>Date/Time</b>	7/30/2018 12:51 PM
<b>Permit #</b>	TBD	<b>Inspection Type</b>	VA SWPP	<b>Station Begin</b>	11552+77
<b>State</b>	VA	<b>Inspection Area</b>	Full	<b>Station End</b>	11489+62
<b>County</b>	Craig	<b>Ground</b>	Dry	<b>Temperature (°F)</b>	78.00
<b>Municipality</b>	N/A	<b>Weather</b>	Cloudy	<b>Rain Gauge (in)</b>	0.00
<b>GPS Location</b>	37.3221464983626, -80.4366036878042			<b>Rain Accumulation Time (days)</b>	1.00

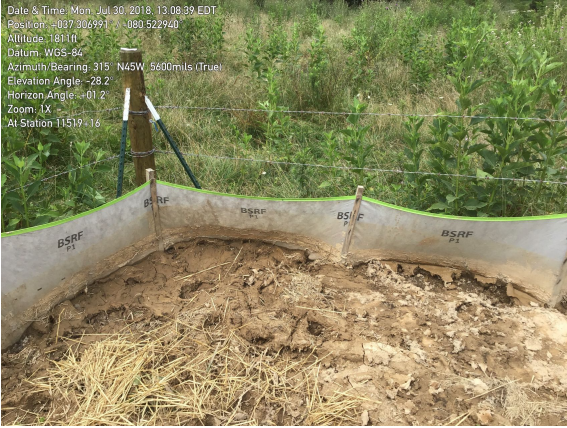
<p>Date &amp; Time: Mon, Jul 30, 2018, 13:08:39 EDT Position: +037.306991 / -080.522920 Altitude: 1811ft Datum: WGS-84 Azimuth/Bearing: 315° N45W, 5600mils (True) Elevation Angle: -28.2° Horizon Angle: -01.2° Zoom: 1X At Station 11519+16</p>

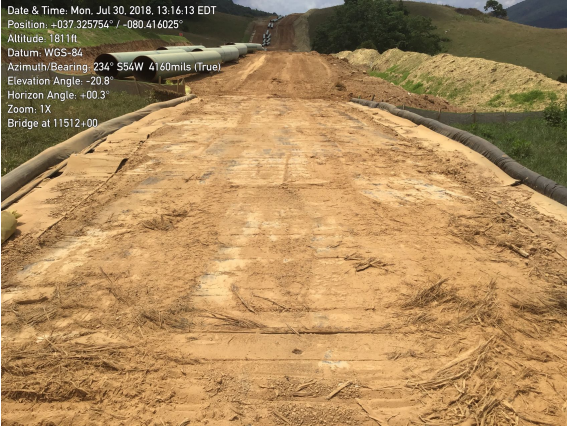
<p>Date &amp; Time: Mon, Jul 30, 2018, 13:16:13 EDT Position: +037.325754 / -080.416025° Altitude: 1811ft Datum: WGS-84 Azimuth/Bearing: 234° S54W 4160mils (True) Elevation Angle: -20.8° Horizon Angle: +00.3° Zoom: 1X Bridge at 11512+00</p>			
<b>GPS Location</b>	37.3091734100212, -80.5105092342	<b>GPS Location</b>	37.3070621626339, -80.5225359249043		
<b>Description</b>	Could be a Problem Area Station 11519+16	<b>Description</b>	Bridge at Station 11512+00		
  <p>Date &amp; Time: Mon, Jul 30, 2018, 13:23:56 EDT Position: +037.322974 / -080.431889° Altitude: 1811ft Datum: WGS-84 Azimuth/Bearing: 152° S28E 2702mils (True) Elevation Angle: -12.3° Horizon Angle: -00.3° Zoom: 1X Plunge Pool at Station 11506+00</p>		<p>Insert image here</p>
