Visual Site Inspection Report

Project Name	H-600 Pipeline Spread G		AFE	124300137	Spread	H-600 Pipeline Spread G	
Contractor	Precision				Report #	5747	
Inspector	Clinton Banks				Date/Time	8/3/2018 2:53 PM	
Permit #	TBD	Inspection Type	VA SWPP		Station Begin	+26	
State	VA	Inspection Area	Full		Station End	+28	
County	Giles	Ground	Wet		Temperature (°F)	74.00	
Municipality	N/A	Weather	Light Rain		Rain Gauge (in)	1.90	
GPS Location	37.3192879058495, -80.6578238573293				Rain Accumulation Time (days)	1.00

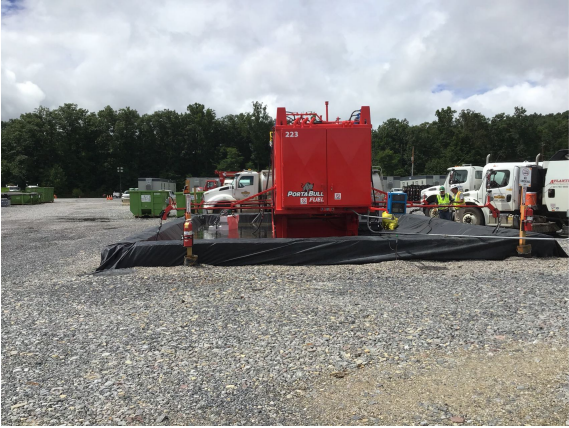
GPS Location	37.3185125459333, -80.6573189143843		GPS Location	37.3347638713802, -80.8024124045478	
Description	Containment For Diesel Fuel at LY 26		Description	Sock at LY 28	
Insert image here			Insert image here		
GPS Location			GPS Location		
Description			Description		
Insert image here			Insert image here		
GPS Location			GPS Location		
Description			Description
