Visual Site Inspection Report

Project Name	H-600 Pipeline Spread G	AFE	124300137	Spread	H-600 Pipeline Spread G
Contractor	Precision			Report #	6356
Inspector	Clinton Banks			Date/Time	8/15/2018 7:56 AM
Permit #	TBD	Inspection Type	VA SWPP	Station Begin	+28
State	VA	Inspection Area	Full	Station End	+26
County	Giles	Ground	Damp	Temperature (°F)	62.00
Municipality	N/A	Weather	Cloudy	Rain Gauge (in)	0.00
GPS Location	37.4172330012678, -80.7418088490742			Rain Accumulation Time (days)	1.00

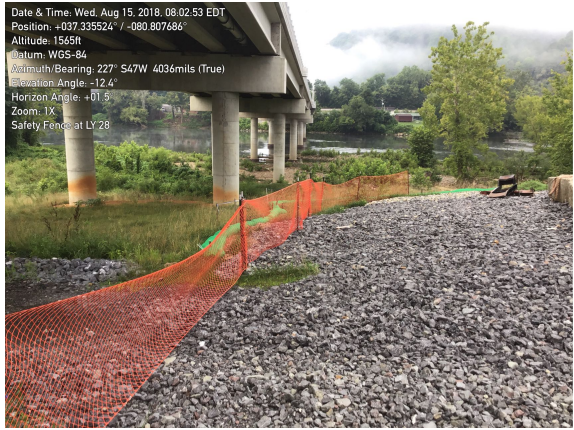
AFE	124300137	Date/Time	8/15/2018 7:56 AM	Report #	6356
Pictures					
<div><div><div>Date & Time: Wed, Aug 15, 2018, 08:02:53 EDT Position: +037.335524° / -080.807686° Altitude: 1565ft Datum: WGS-84 Azimuth/Bearing: 227° S47W 4036mils (True) Elevation Angle: -12.4° Horizon Angle: +01.5° Zoom: 1X Safety Fence at LY 28</div>

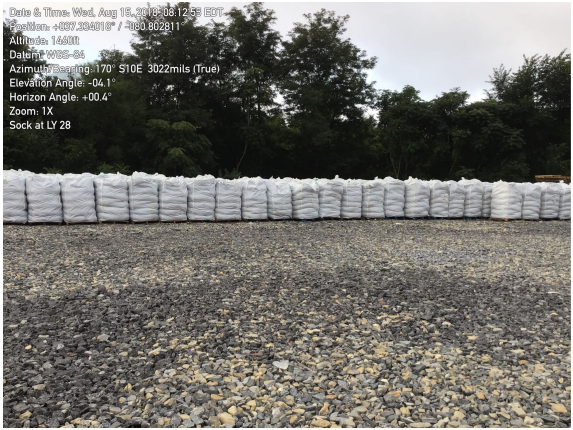
</div></div>		<div><div><div>Date & Time: Wed, Aug 15, 2018, 08:12:58 EDT Position: +037.334019° / -080.802811° Altitude: 1460ft Datum: WGS-84 Azimuth/Bearing: 170° S10E 3022mils (True) Elevation Angle: -04.1° Horizon Angle: +00.4° Zoom: 1X Sock at LY 28</div>

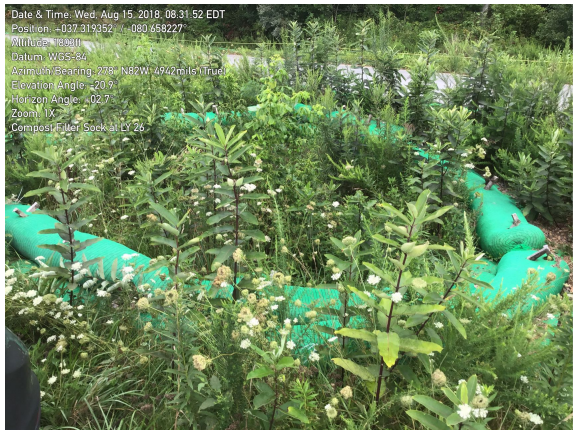
</div></div>			
GPS Location	37.3356151068931, -80.8077971265473		GPS Location	37.3340093857025, -80.8031564020373	
Description	Safety at LY 28		Description	Sock at LY 28	
<div><div><div>Date & Time: Wed, Aug 15, 2018, 08:31:52 EDT Position: +037.319352° / -080.658227° Altitude: 1561ft Datum: WGS-84 Azimuth/Bearing: 278° N82W 4942mils (True) Elevation Angle: -20.3° Horizon Angle: -02.7° Zoom: 1X Compost Filter Sock at LY 26</div>

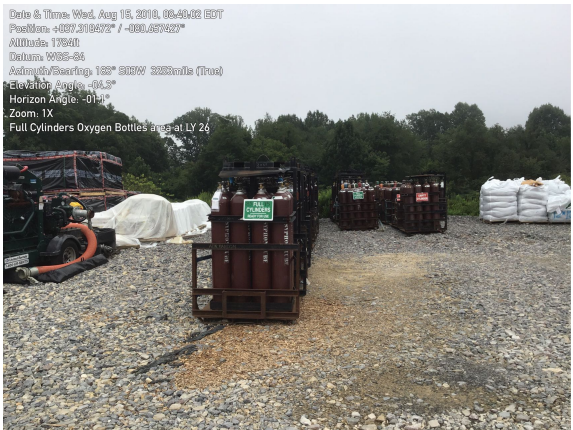
</div></div>		<div><div><div>Date & Time: Wed, Aug 15, 2018, 08:48:02 EDT Position: +037.318334° / -080.657440° Altitude: 1764ft Datum: WGS-84 Azimuth/Bearing: 163° S83W 3282mils (True) Elevation Angle: -04.3° Horizon Angle: -01.9° Zoom: 1X Full Cylinders Oxygen Bottles Area at LY 26</div>
