Visual Site Inspection Report

| Project Name | H-600 Pipeline Spread G | AFE | 124300137 | Spread | H-600 Pipeline Spread G |
| Inspector | Clinton Banks | | | Date/Time | 9/18/2018 5:31 AM |

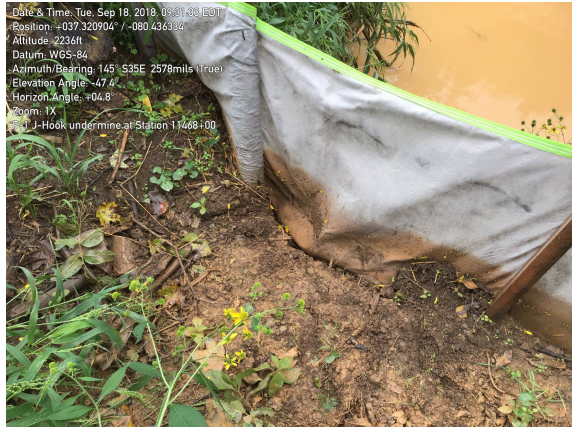
| <p>Date & Time: Tue, Sep 18, 2018, 05:13:07 EDT Position: +037.321601 / -080.435762 Altitude: 2256ft Datum: WGS-84 Azimuth/Bearing: 194° S14W 3449mils (True) Elevation Angle: -02.3° Horizon Angle: -02.3° Zoom: 1X Rain Gauge at Steel Acres</p> | | <p>Date & Time: Tue, Sep 18, 2018, 05:01:38 EDT Position: +037.320904 / -080.436347 Altitude: 2236ft Datum: WGS-84 Azimuth/Bearing: 145° S35E 2578mils (True) Elevation Angle: -47.4° Horizon Angle: +04.8° Zoom: 1X P-1 J-Hook undermine at Station 11468+00</p> | | | |
| Description | Rain Gauge At Steel Acres | Description | P-1 J-Hook undermine at Station 11468+00 | | |

| P-1 J-Hook | Communication | Need to be Key In Undermine | Addressed | 9/18/2018 | |

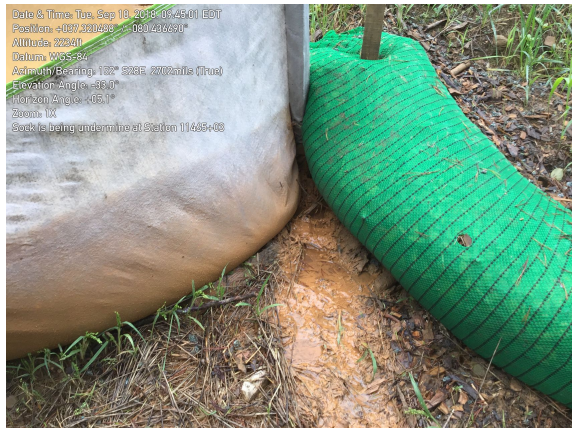
| <p>Date & Time: Tue, Sep 18, 2018, 05:00:49 EDT Position: +037.320556 / -080.436297 Altitude: 2232ft Datum: WGS-84 Azimuth/Bearing: 180° S00W 3207mils (True) Elevation Angle: -65.5° Horizon Angle: -07.1° Zoom: 1X P-1 J-Hook undermine at Station 11468+50</p> | | <p>Date & Time: Tue, Sep 18, 2018, 05:41:04 EDT Position: +037.319626 / -080.436697 Altitude: 2224ft Datum: WGS-84 Azimuth/Bearing: 120° S38E 2702mils (True) Elevation Angle: -68.0° Horizon Angle: +05.1° Zoom: 1X Sock is being undermine at Station 11465+49</p> | | | |
| Description | P-1 J-Hook Undermine at Station 11468+50 | Description | Sock being undermine at Station 11465+49 Slop Drain Pipe Steel Acres | | |

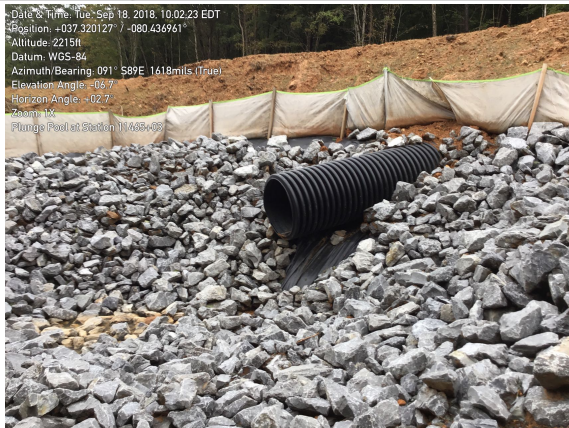
| <p>Date & Time: Tue, Sep 18, 2018, 10:02:23 EDT Position: +037.320127 / -080.436961 Altitude: 2215ft Datum: WGS-84 Azimuth/Bearing: 091° S89E 1618mils (True) Elevation Angle: -05.7° Horizon Angle: -02.7° Zoom: 1X Plunge Poole at Station 11465+03</p> | | <p>Date & Time: Tue, Sep 18, 2018, 10:02:26 EDT Position: +037.319626 / -080.439232 Altitude: 2223ft Datum: WGS-84 Azimuth/Bearing: 341° N19W 6062mils (True) Elevation Angle: -30.1° Horizon Angle: -15.2° Zoom: 1X EndTreatment Overwhelmed at Station 11456+00</p> | | | |
| Description | Plunge Poole at Station 11465+03 | Description | EndTreatment Overwhelmed at Station 11456+00 Slop Drain Pipe | | |
