Visual Site Inspection Report

Project Name	H-600 Pipeline Spread G	AFE	124300137	Spread	H-600 Pipeline Spread G
Contractor	Precision			Report #	1438
Inspector	Garrett Barclay			Date/Time	5/4/2018 5:05 PM
Permit #	TBD	Inspection Type	Weekly	Station Begin	+0
State	VA	Inspection Area	Full	Station End	+0
County	Giles	Ground	Dry	Temperature (°F)	80.00
Municipality	N/A	Weather	Sunny	Rain Gauge (in)	0.00
GPS Location	37.2682993719701, -80.3198857885602			Rain Accumulation Time (days)	1.00

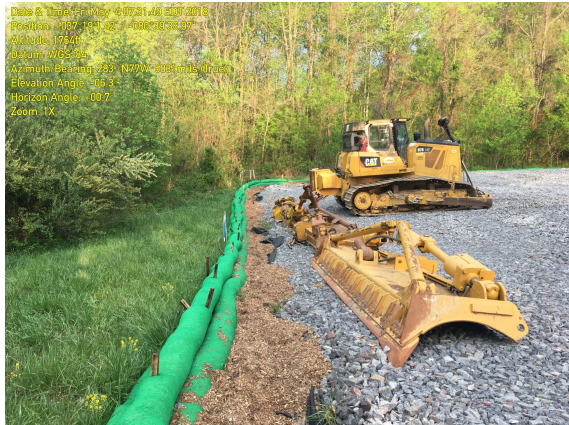
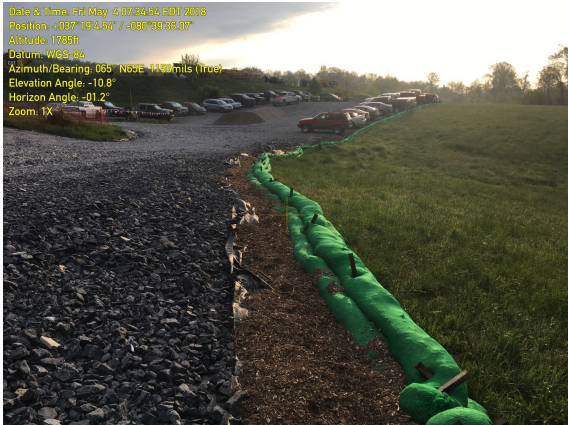
</div></div></div>			
GPS Location	37.2682626592342, -80.3199582082036		GPS Location	37.2681300156166, -80.319924932048	
Description	CFS @ Yard 26		Description	CFS @ Yard 26	
<div><div><div>Date & Time: Fri May 4 07:24:48 EDT 2018 Position: +037°17'10.08" / -080°28'24.64" Altitude: 1754ft Datum: WGS-84 Azimuth/Bearing: 135° S45E 2400mils (True) Elevation Angle: -23.8° Horizon Angle: +03.0° Zoom: 1X</div><div>

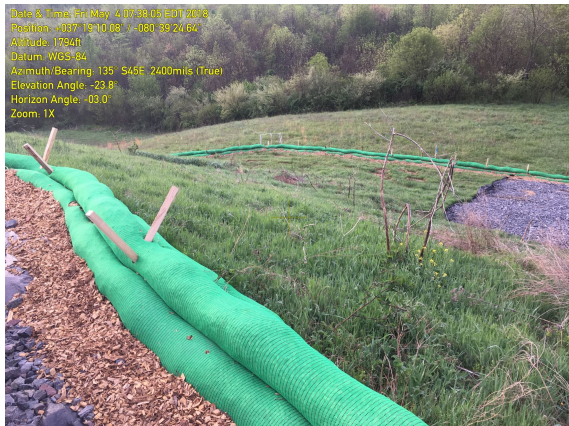
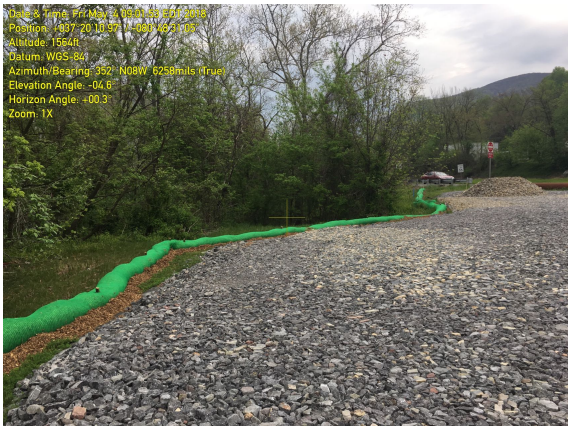
GPS Location	37.2682105237965, -80.3199210763726		GPS Location	37.2682105237965, -80.3199210763726	
Description	CFS @ Yard 26		Description	CFS @ Yard 28	
<div><div><div>Date & Time: Fri May 4 08:41:57 EDT 2018 Position: +037°20'10.93" / -080°28'31.07" Altitude: 1556ft Datum: WGS-84 Azimuth/Bearing: 118° S62E 2098mils (True) Elevation Angle: -11.2° Horizon Angle: +01.2° Zoom: 1X</div><div>

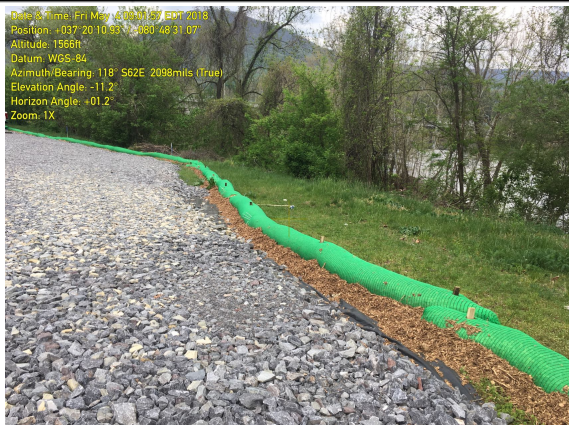
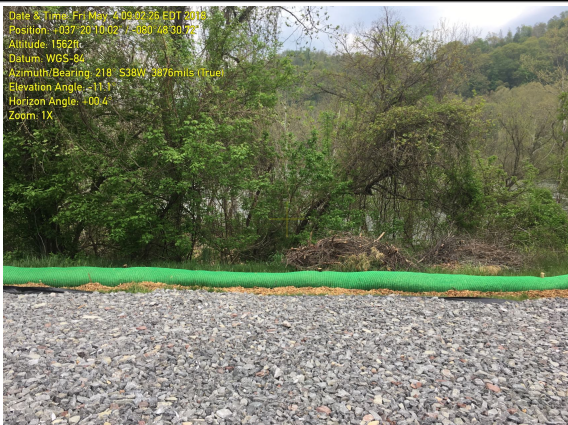
</div></div></div>			
GPS Location	37.2682105237965, -80.3199210763726		GPS Location	37.2682105237965, -80.3199210763726	
Description	CFS @ Yard 28		Description	CFS @ Yard 28
