Visual Site Inspection Report

Project Name	H-600 Pipeline Spread G		AFE	124300137	Spread	H-600 Pipeline Spread G	
Contractor	Precision				Report #	2358	
Inspector	Garrett Barclay				Date/Time	5/29/2018 2:53 PM	
Permit #	TBD	Inspection Type	VA SWPP		Station Begin	+0	
State	VA	Inspection Area	Full		Station End	+0	
County	Giles	Ground	Damp		Temperature (°F)	67.00	
Municipality	N/A	Weather	Cloudy		Rain Gauge (in)	0.01	
GPS Location	37.2879357822587, -80.4582717642937				Rain Accumulation Time (days)	1.00

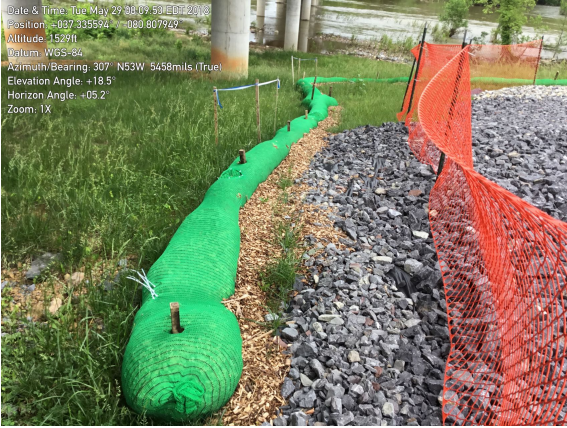
GPS Location	37.2884625429635, -80.4598519206796	GPS Location	37.2884625429635, -80.4598519206796		
Description	CFS @ Yard 28	Description	Damaged CFS @ Yard 28

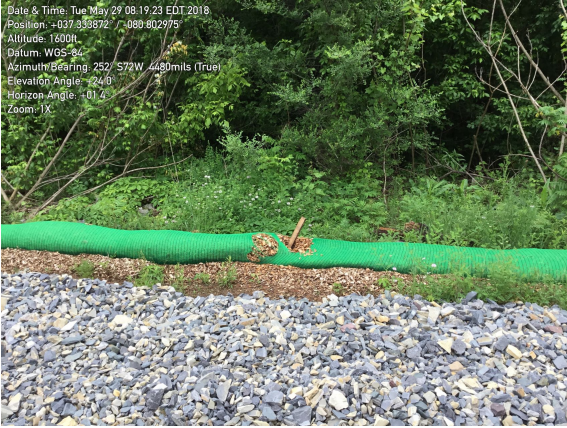
7. Identify all remedial measures that have been taken since the previous inspection was conducted.					
Comments (Reference above questions as appropriate.)					
Performed SWPP for Yard 26 & Yard 28 During SWPP installed minor damage to one log of CFS @ Yard 28 No other damage was observed or environmental concerns to report from Yard 26 & Yard 28 No compliance issues at this time					
Note: It is a condition of National Pollutant Discharge Elimination System and Erosion and Sediment permits that a maintenance program be conducted to provide for the operation and maintenance of all BMPs to be inspected on a weekly basis and after each stormwater event. Please list in the space provided comments to note if repairs or replacement are needed or have been made for BMPs as a result of the inspection. Failure to conduct the required inspection may result in permit suspension or the imposition of civil penalties. If supplemental monitoring is required as part of a permit condition this form may be used to meet those monitoring requirements.

4. E&S BMPs (List BMPs and note if installed and maintained as per the plan. If corrective action is needed, a picture is required.)							
E&S BMPs		Compliance Level		Corrective Action		Corrective Time Frame	
Compost Filter Sock		Problem Area		Repair CFS		See Comments	
Rock Construction Entrance		Acceptable		NA		See Comments

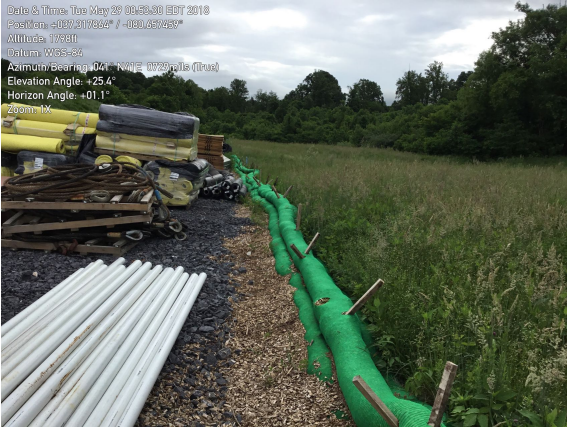
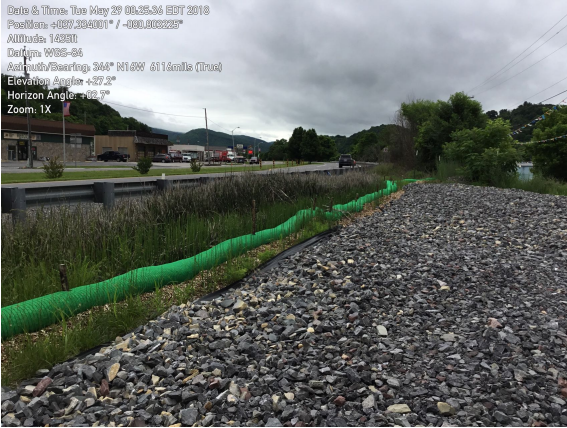
GPS Location	37.2881634766583, -80.4586444237087	GPS Location	37.2881244169895, -80.4584666435425		
Description	CFS @ Yard 26	Description	CFS @ Yard 28

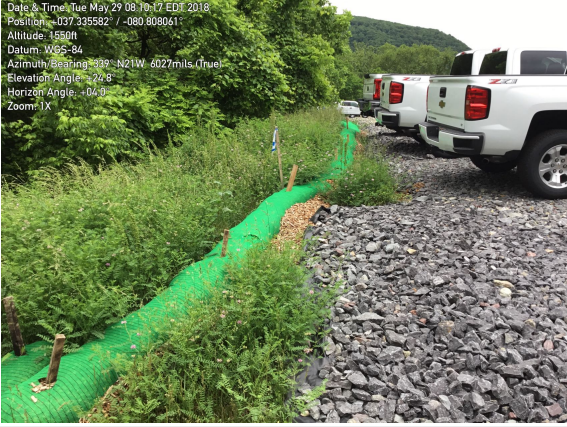
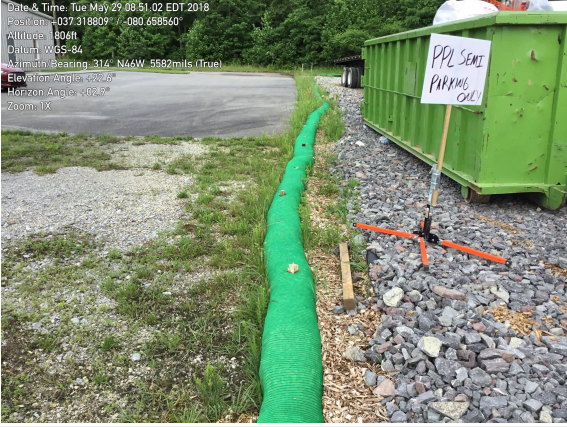
GPS Location	37.2881244169895, -80.4584666435425	GPS Location	37.2881244169895, -80.4584666435425		
Description	CFS @ Yard 28	Description	CFS @ Yard 26
