Visual Site Inspection Report

| Project Name | H-600 Pipeline Spread G | AFE | 124300137 | Spread | H-600 Pipeline Spread G |
| Inspector | Garrett Barclay | | | Date/Time | 7/18/2018 11:01 AM |

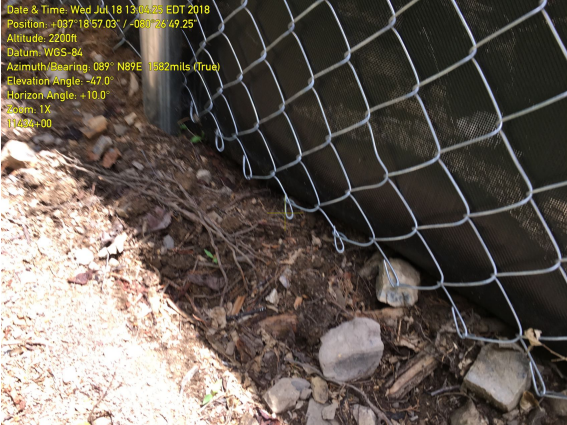
| Improperly installed SS @ 11434+00 | | RCE @ 256.02 | | | |

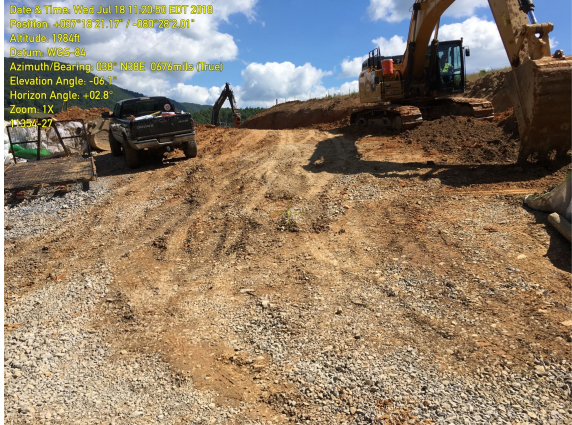
| Observed crews working from MP 215 - MP 218.5 Performed SWPP from MP 215 - MP 218.5 Observed multiple locations of improperly installed SS fence. Also found a few areas with perimeter controls have been damaged due work in the area. These items were listed in detail on today's punch list. Also observed multiple problems with the water bars behind grade. Noted the water bars and end treatments on punch list as well. Crews worked on grade in several different locations from MP 215 - MP 218 with 2 crews Observed perimeter controls overwhelmed and at capacity due to grading activities Talked with the foreman about my concerns with the top soil and sun soil segregation. Also talked with an operator about my observations and concerns. I observed many of the sumps at the end of the water bars did not have end treatments. RCE @ 256.02 needs additional rock. Added items listed above on today's punch list. | | | | | |

| Rock Construction Entrance | | Problem Area | Add additional rock | 24 Hours | |

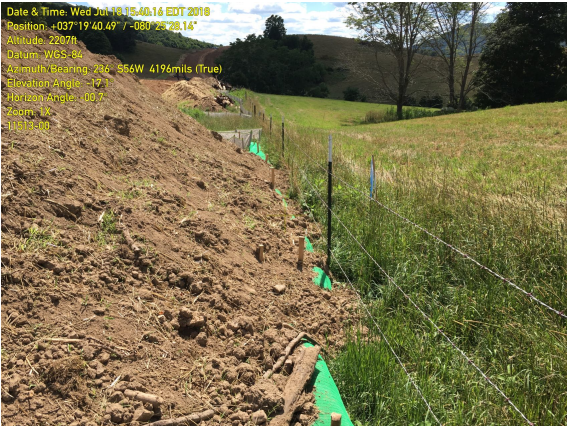
| Perimeter controls overwhelmed from grade @ 11513+00 | | Top soil and sub soil from grading @ 11404+00 | | | |

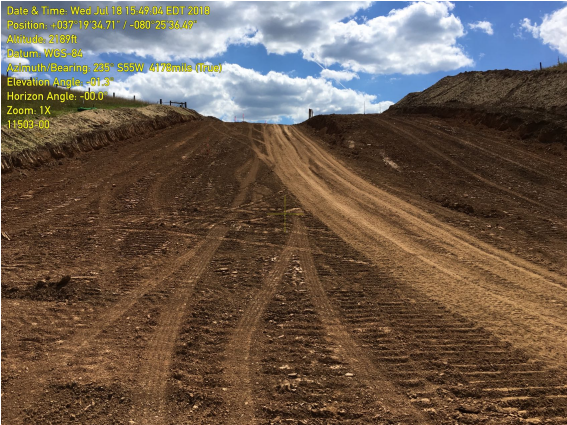
| Water bars missing @ 11503+00 | | P1 damaged @ 11457+96 | | | |

| Waterbar | | Problem Area | Install to spec | 24 Hours | |
