Visual Site Inspection Report

Project Name	H-600 Pipeline Spread G	AFE	124300137	Spread	H-600 Pipeline Spread G
Contractor	Precision			Report #	3668
Inspector	Jared Saunders			Date/Time	6/26/2018 11:11 AM
Permit #	TBD	Inspection Type	VA SWPP	Station Begin	11670+00
State	VA	Inspection Area	Partial	Station End	11900+00
County	Montgomery	Ground	Muddy	Temperature (°F)	65.00
Municipality	N/A	Weather	Light Rain	Rain Gauge (in)	0.57
GPS Location	37.2913449118261, -80.3334481269869			Rain Accumulation Time (days)	1.00

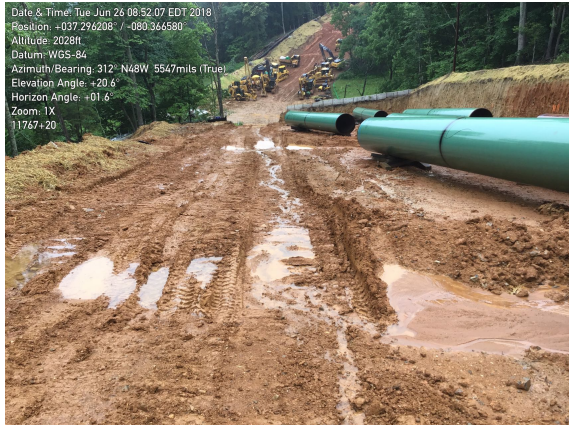
A/E	124300137	Date/Time	6/26/2018 11:11 AM	Report #	3668
Pictures					
<p>Date & Time: Tue Jun 26 08:52:07 EDT 2018 Position: +037.296208° / -080.366580° Altitude: 2028ft Datum: WGS-84 Azimuth/Bearing: 312° N48W 5547mils (True) Elevation Angle: +20.6° Horizon Angle: +01.6° Zoom: 1X 11767+20</p>

GPS Location	37.2963434430094, -80.3609557157003		GPS Location	37.2965121874933, -80.3611278534684	
Description	See photo for GPS location and station number. Water breaker improperly installed. Water is channeling down ROW.		Description	See photo for GPS location and station number. Sump pit properly functioning.	
<p>Date & Time: Tue Jun 26 09:33:44 EDT 2018 Position: +037.293716° / -080.360751° Altitude: 2130ft Datum: WGS-84 Azimuth/Bearing: 310° N50W 5511mils (True) Elevation Angle: +17.7° Horizon Angle: +03.8° Zoom: 1X 11812+00</p>

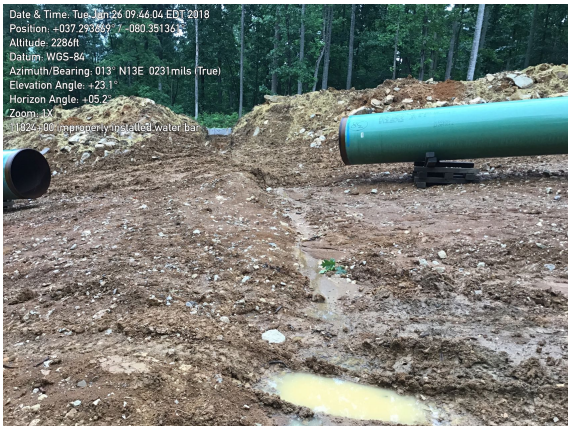
<p>Date & Time: Tue Jun 26 09:46:04 EDT 2018 Position: +037.293583° / -080.351365° Altitude: 2286ft Datum: WGS-84 Azimuth/Bearing: 013° N13E 0231mils (True) Elevation Angle: +23.1° Horizon Angle: +05.2° Zoom: 1X 11822+00 improperly installed water bar</p>

GPS Location	37.2965121874933, -80.3611278534684		GPS Location	37.2964561963801, -80.3610618878904	
Description	See photo for GPS location and station number.		Description	See photo for GPS location and station number. Water breaker improperly installed.	
<p>Date & Time: Tue Jun 26 09:59:30 EDT 2018 Position: +037.295750° / -080.348870° Altitude: 2283ft Datum: WGS-84 Azimuth/Bearing: 087° N88E 6883mils (True) Elevation Angle: +23.4° Horizon Angle: +00.6° Zoom: 1X 11840+00</p>

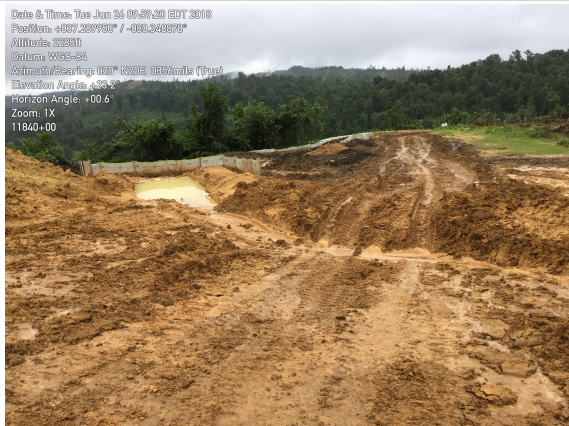
GPS Location	37.2964498680432, -80.3610512428734		GPS Location	37.2964498680432, -80.3610512428734	
Description	See photo for GPS location and station number. Water breaker and sump pit properly installed and working effectively.		Description	See photo for GPS location and station number. RCE at AR 266.03. RCE is in good condition.
