Visual Site Inspection Report

Project Name	H-600 Pipeline Spread G	AFE	124300137	Spread	H-600 Pipeline Spread G
Contractor	Precision			Report #	6384
Inspector	Jared Saunders			Date/Time	8/15/2018 5:15 PM
Permit #	TBD	Inspection Type	VA SWPP	Station Begin	10883+50
State	VA	Inspection Area	Partial	Station End	11025+00
County	Giles	Ground	Dry	Temperature (°F)	88.00
Municipality	N/A	Weather	Sunny	Rain Gauge (in)	0.00
GPS Location	37.2060816470739, -80.3943324103999			Rain Accumulation Time (days)	1.00

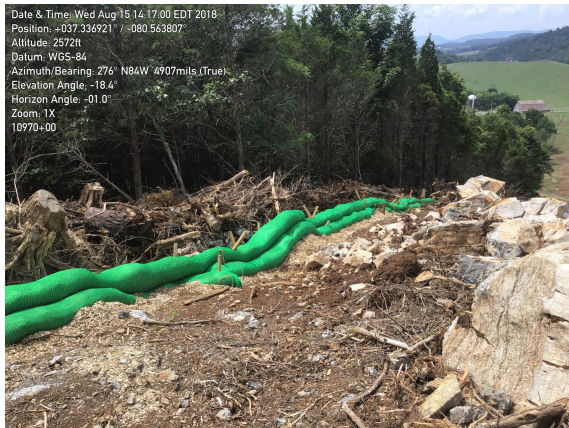
<p>Date & Time: Wed Aug 15 12:47:05 EDT 2018 Position: +037 334534 / -080 594818 Altitude: 2339ft Datum: WGS-84 Azimuth/Bearing: 186° S06W 3307mils (True) Elevation Angle: -18.1° Horizon Angle: -05.6° Zoom: 1X 10890+00</p>  			
GPS Location	37.206027376058, -80.3942190023665	GPS Location	37.2060893057261, -80.393808139563		
Description	See photo for GPS location and station number. Mat placed in stream bed during bridge installation.	Description	See photo for GPS location and station number. Water breaker and end treatment.		
<p>Date & Time: Wed Aug 15 14:17:00 EDT 2018 Position: +037 336921 / -080 563807 Altitude: 2572ft Datum: WGS-84 Azimuth/Bearing: 276° N84W 4907mils (True) Elevation Angle: -18.4° Horizon Angle: -01.0° Zoom: 1X 10970+00</p>

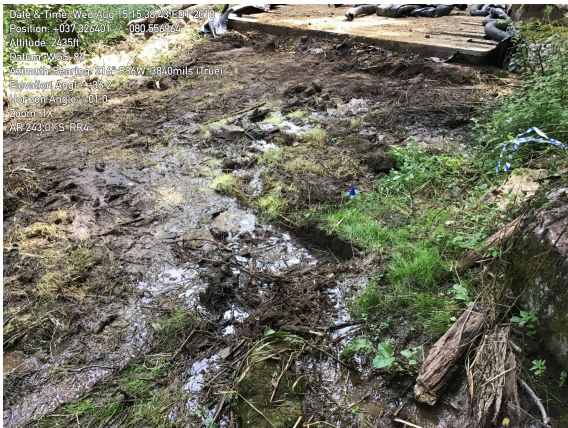
<p>Date & Time: Wed Aug 15 15:13:06 EDT 2018 Position: +037 326201 / -080 566740 Altitude: 2435ft Datum: WGS-84 Azimuth/Bearing: 142° S18E 3840mils (True) Elevation Angle: -07.8° Horizon Angle: -01.0° Zoom: 1X 10970+00</p>

GPS Location	37.2060511060272, -80.3942183005055	GPS Location	37.20605062392, -80.3942222908458		
Description	See photo for GPS location and station number. Triple stack 18" CFS.	Description	See photo for GPS location and station number. Mat removed from stream bed.		
<p>Date & Time: Wed Aug 15 16:34:36 EDT 2018 Position: +037 323503 / -080 555523 Altitude: 2387ft Datum: WGS-84 Azimuth/Bearing: 315° N31W 5336mils (True) Elevation Angle: -10.1° Horizon Angle: -01.0° Zoom: 1X 11015+75 S-RR5</p>

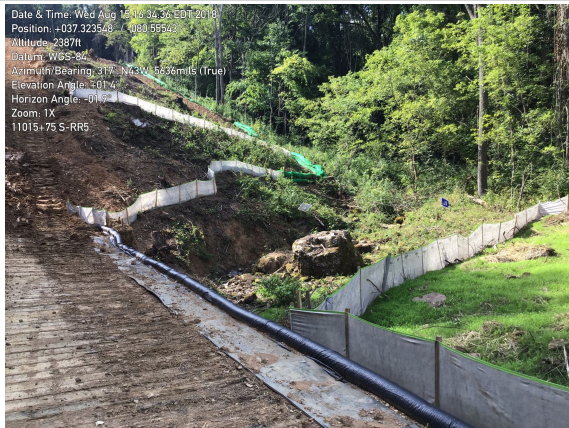
<p>Date & Time: Wed Aug 15 16:39:00 EDT 2018 Position: +037 322651 / -080 553010 Altitude: 2410ft Datum: WGS-84 Azimuth/Bearing: 142° S18E 2880mils (True) Elevation Angle: -07.8° Horizon Angle: -01.0° Zoom: 1X 11018+75</p>  			
GPS Location	37.2060511261571, -80.3942182660852	GPS Location	37.2060511261571, -80.3942182660852		
Description	See photo for GPS location and station number. Priority one site fence used at stream as controls.	Description	See photo for GPS location and station number. Spoil pile stabilized.
