Visual Site Inspection Report

Project Name	H-600 Pipeline Spread G	AFE	124300137	Spread	H-600 Pipeline Spread G
Contractor	Precision			Report #	7440
Inspector	Jared Saunders			Date/Time	9/6/2018 3:59 PM
Permit #	TBD	Inspection Type	VA SWPP	Station Begin	10883+50
State	VA	Inspection Area	Partial	Station End	11237+00
County	Giles	Ground	Dry	Temperature (°F)	85.00
Municipality	N/A	Weather	Sunny	Rain Gauge (in)	0.00
GPS Location	37.2060109937874, -80.3941368298835			Rain Accumulation Time (days)	1.00

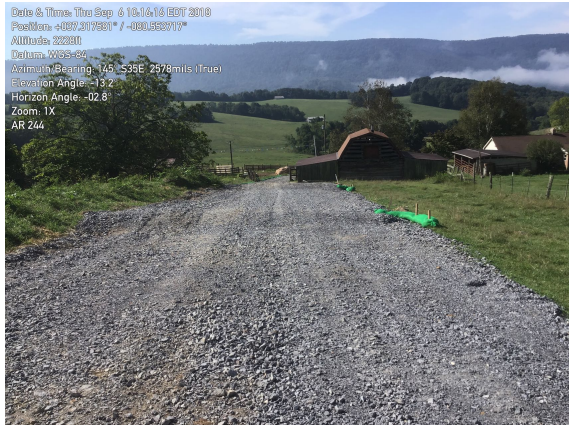
GPS Location	37.205799139738, -80.3942227085516	GPS Location	37.2062246315528, -80.3942435794327		
Description	See photo for GPS location and station number. Broad base dip in place.	Description	See photo for GPS location and station number. Sensitive resource buffer zone.		
<p>Date & Time: Thu Sep 6 10:42:28 EDT 2018 Position: +037.337082° / -080.570994° Altitude: 2426ft Datum: WGS-84 Azimuth/Bearing: 129° 551E 2293mils (True) Elevation Angle: -13.3° Horizon Angle: -04.3° Zoom: 1X 10291+00</p>

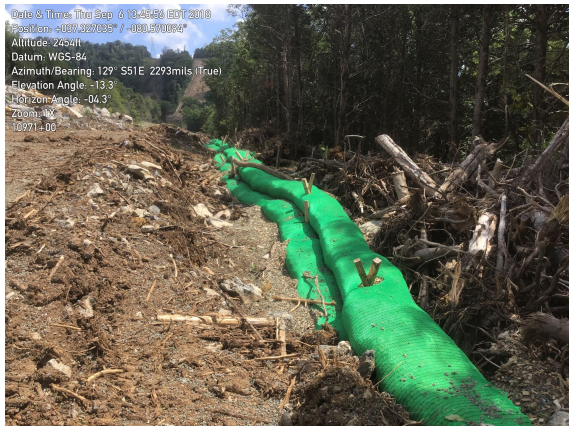
GPS Location	37.2061674250636, -80.3942057770494	GPS Location	37.206185488065, -80.3942004964504		
Description	See photo for GPS location and station number. Triple stack 18" CFS in place.	Description	See photo for GPS location and station number. RCE in place at ROW crossing of Kow Camp Road.		
<p>Date & Time: Thu, Sep 06, 2018, 11:29:42 EDT Position: +037.311638° / -080.516294° Altitude: 1807ft Datum: WGS-84 Azimuth/Bearing: 302° N13W 6169mils (True) Elevation Angle: +31.6° Horizon Angle: +04.2° Zoom: 1X Arnold's seeding helicopter dropping pellets at AR-249 00</p>

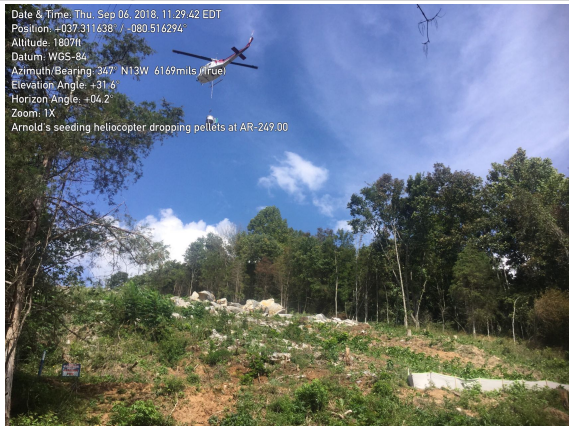
Description	See photo for GPS location and station number. Helicopter temporarily stabilizing ROW.	Description	See photo for GPS location and station number. Temporary end treatment and waterbar.

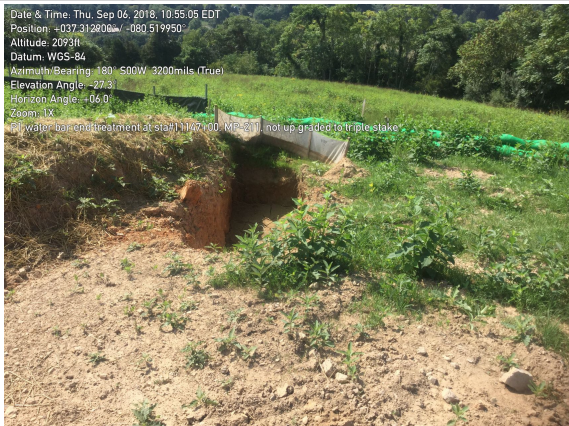
<p>Date & Time: Thu, Sep 06, 2018, 10:55:05 EDT Position: +037.312800° / -080.519950° Altitude: 2093ft Datum: WGS-84 Azimuth/Bearing: 180° S00W 3200mils (True) Elevation Angle: -27.3° Horizon Angle: -04.0° Zoom: 1X Gravel bar construction at station 1102+00. M-301 not up graded to triple lake</p>
