Visual Site Inspection Report

Project Name	H-600 Pipeline Spread G	AFE	124300137	Spread	H-600 Pipeline Spread G
Contractor	Precision			Report #	8059
Inspector	Jared Saunders			Date/Time	9/18/2018 3:33 PM
Permit #	TBD	Inspection Type	VA SWPP	Station Begin	10983+50
State	VA	Inspection Area	Partial	Station End	11237+00
County	Giles	Ground	Muddy	Temperature (°F)	78.00
Municipality	N/A	Weather	Light Rain	Rain Gauge (in)	0.50
GPS Location	37.3187005939309, -80.5532984063779			Rain Accumulation Time (days)	1.00

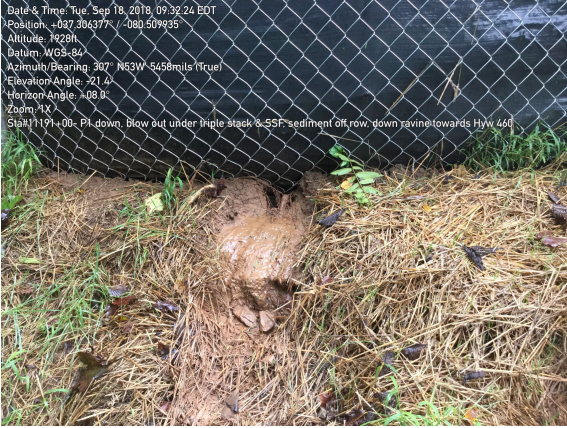
<p>Date & Time: Tue Sep 18, 2018, 09:32:24 EDT Position: +037.306377, -80.50935 Altitude: 1928ft Datum: WGS-84 Azimuth Bearing: 307.583W-5456mils (True) Elevation Angle: -21.4 Horizon Angle: -08.0 Zoom: 1X Stake 1191+00: Pit down, blow out under triple stack & SSP sediment off row down ravine towards Hwy 460</p>		GPS Location 37.3187280865734, -80.5533557385956	
Description See photo for GPS location and station number. 0.5" of rain fall at AR 244.		Description See photo for GPS location and station number. Super silt fence undermined.		GPS Location 37.3187280865734, -80.5533557385956

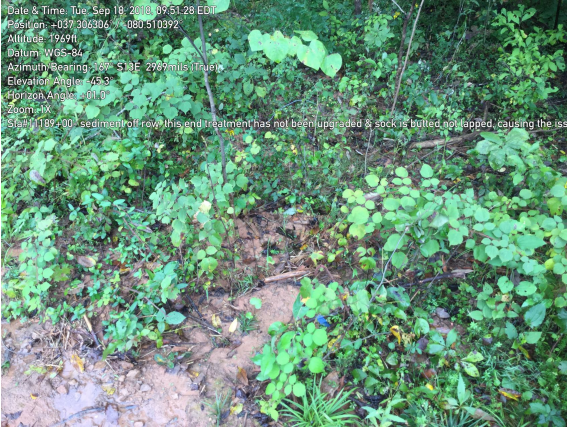
<p>Date & Time: Tue Sep 18 2018 09:51:28 EDT Position: +037.306306, -80.510372 Altitude: 1969ft Datum: WGS-84 Azimuth Bearing: 307.513E-2997mils (True) Elevation Angle: -45.3 Horizon Angle: -01.0 Zoom: 1X Stake 1189+00: Sediment off row. This end treatment has not been updated & stock is pulled not topped, causing the iss</p>

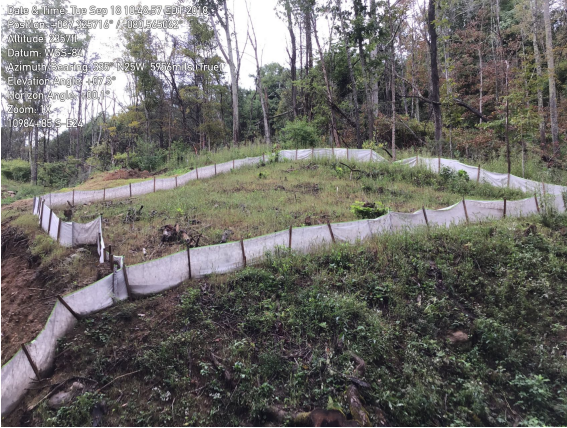
<p>Date & Time: Tue Sep 18 10:06:07 EDT 2018 Position: +037.311413, -80.50935 Altitude: 1928ft Datum: WGS-84 Azimuth Bearing: 307.583W-5456mils (True) Elevation Angle: -21.4 Horizon Angle: -08.0 Zoom: 1X 10930+00</p>		GPS Location 37.3187280865734, -80.5533557385956

Description See photo for GPS location and station number. Sediment outside the LOD.		Description See photo for GPS location and station number. Sensitive resource buffer zone in place.		GPS Location 37.3187160166328, -80.5534683075552

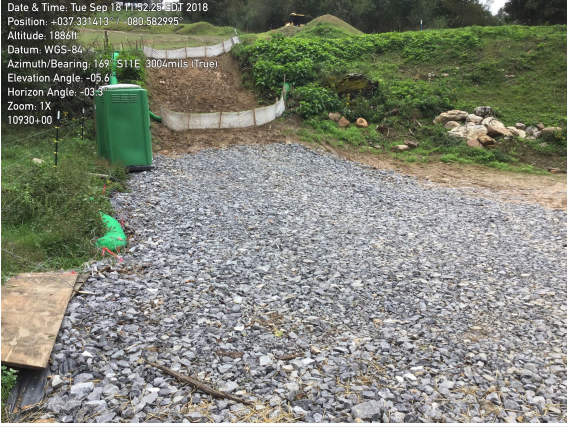
<p>Date & Time: Tue Sep 18 11:52:26 EDT 2018 Position: +037.331413, -80.582995 Altitude: 1886ft Datum: WGS-84 Azimuth Bearing: 169.511E-3004mils (True) Elevation Angle: -05.6 Horizon Angle: -03.9 Zoom: 1X 10930+00</p>		GPS Location 37.3187160166328, -80.5534683075552	
Description See photo for GPS location and station number. Sediment build up along triple stack 18" CFS.		Description See photo for GPS location and station number. RCE at Doe Creek Rd crossing.		GPS Location 37.3187160166328, -80.5534683075552
