Visual Site Inspection Report

Project Name	H-600 Pipeline Spread G	AFE	124300137	Spread	H-600 Pipeline Spread G
Contractor	Precision			Report #	8291
Inspector	Len Kruizenga			Date/Time	9/24/2018 6:24 AM
Permit #	TBD	Inspection Type	VA SWPP	Station Begin	11237+00
State	VA	Inspection Area	Full	Station End	11050+00
County	Giles	Ground	Muddy	Temperature (°F)	64.00
Municipality	N/A	Weather	Light Rain	Rain Gauge (in)	0.00
GPS Location	37.3063662881379, -80.5102265720074			Rain Accumulation Time (days)	1.00

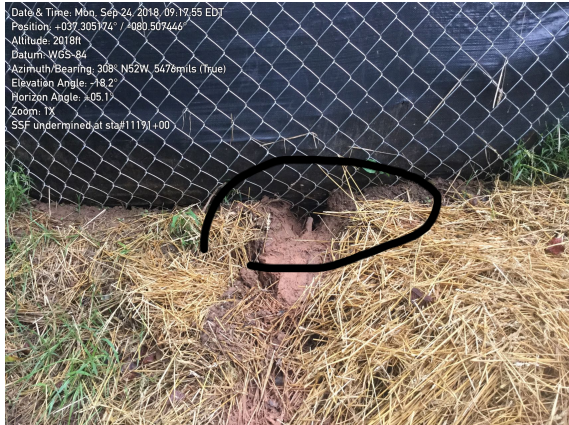
GPS Location	37.3064413480808, -80.5099114962672		GPS Location	37.306686225382, -80.5109736510371	
Description	Sta#11191+00- SSF undermined		Description	Sta#11188+20- P1 end treatment undermined over topped 18" perimeter control, sediment off row

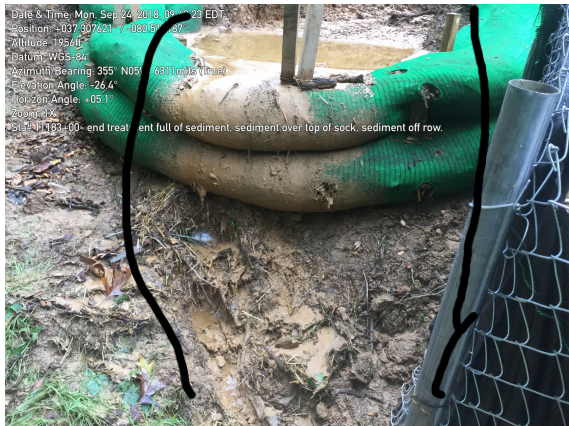
GPS Location	37.3075758386751, -80.5121936370437		GPS Location	37.3141842568641, -80.5315972399717	
Description	Sta#11183+00- end treatment full of sediment, sediment off row		Description	Sta#11106+00- SSF washed out on slope,

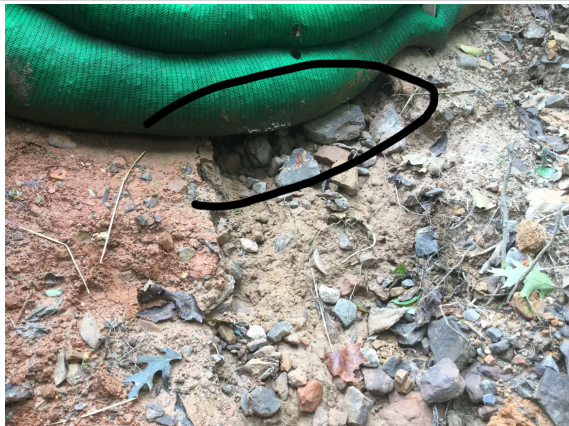
Insert image here			
GPS Location	37.3181513278161, -80.5476055853819		GPS Location		
Description	Sta#11050+50 -triple stack undermined		Description
