Visual Site Inspection Report

Project Name	H-600 Pipeline Spread G	AFE	124300137	Spread	H-600 Pipeline Spread G
Contractor	Precision			Report #	8824
Inspector	Len Kruizenga			Date/Time	10/4/2018 6:21 AM
Permit #	TBD	Inspection Type	VA SWPP	Station Begin	11237+00
State	VA	Inspection Area	Full	Station End	10931+00
County	Giles	Ground	Damp	Temperature (°F)	85.00
Municipality	N/A	Weather	Sunny	Rain Gauge (in)	0.00
GPS Location	37.3291255340105, -80.4850281433362			Rain Accumulation Time (days)	5.00

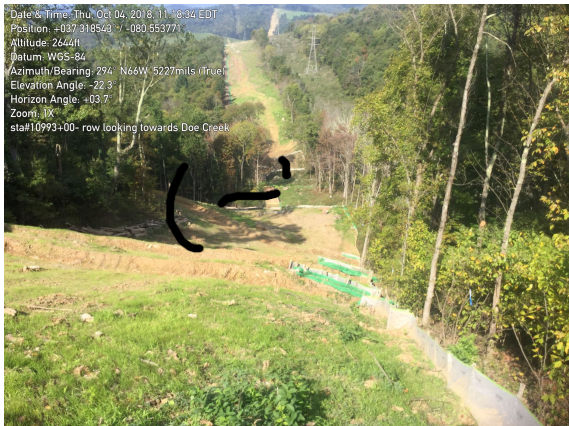
<p>Date & Time: Thu, Oct 04, 2018, 10:10:00 EDT Position: +037.319524 / -80.550477 Altitude: 2279ft Datum: WGS-84 Azimuth/Bearing: 024 / N22E 4027mils (True) Elevation Angle: -28.1 Horizon Angle: -00.1 Zoom: 1X Sta#11045+00- gap in perimeter control. LD driveway, needs at least 20ft more waddle to close gap to prevent run off</p>  		<p>Date & Time: Thu, Oct 04, 2018, 11:18:34 EDT Position: +037.319524 / -80.563777 Altitude: 2644ft Datum: WGS-84 Azimuth/Bearing: 294 / N66W 5227mils (True) Elevation Angle: -22.3 Horizon Angle: -03.7 Zoom: 1X sta#10993+00- row looking towards Doe Creek</p>

GPS Location	37.3195385747005, -80.550195928738	GPS Location	37.3259102460345, -80.5647174921637		
Description	Sta#11045+00- close gap at perimeter control to prevent run off	Description	Sta#10993+00- row looking toward Doe Creek		
<p>Date & Time: Thu, Oct 04, 2018, 10:16:05 EDT Position: +037.318702 / -80.549468 Altitude: 2310ft Datum: WGS-84 Azimuth/Bearing: 104 / S76E 1849mils (True) Elevation Angle: -28.2 Horizon Angle: -03.5 Zoom: 1X Sta#11047+00 to 11050+00- slope going down to stream SJ1-17, water bars & ECD's look good</p>

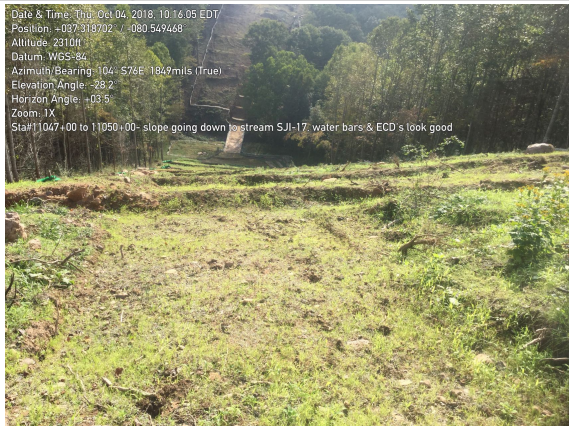
GPS Location	37.3200127808725, -80.5529959034925	GPS Location			
Description	Sta#11047+00 to 11050+00- slope going down to stream SJ1-17, water bars & ECD's look good, good growth	Description
