Visual Site Inspection Report

Project Name	H-600 Pipeline Spread G	AFE	124300137	Spread	H-600 Pipeline Spread G
Contractor	Precision			Report #	8053
Inspector	Rob Robertson			Date/Time	9/18/2018 8:25 AM
Permit #	TBD	Inspection Type	VA SWPP	Station Begin	11553+66
State	VA	Inspection Area	Full	Station End	11596+94
County	Montgomery	Ground	Muddy	Temperature (°F)	79.00
Municipality	N/A	Weather	Cloudy	Rain Gauge (in)	3.80
GPS Location	37.13364145, -80.39471332			Rain Accumulation Time (days)	3.00

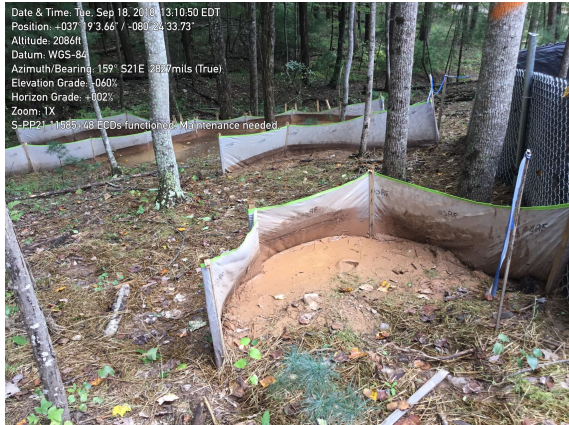
A/E	124300137	Date/Time	9/18/2018 8:25 AM	Report #	8053
Pictures					
<p>Date & Time: Tue, Sep 18, 2018, 13:10:50 EDT Position: +037° 19' 3.66" / -080° 24' 33.73" Altitude: 2086ft Datum: WGS-84 Azimuth/Bearing: 159° S21E 33.7mils (True) Elevation Grade: +040% Horizon Grade: +02% Zoom: 1X S-PP21 11569+08 EODs functional. Maintenance needed</p>

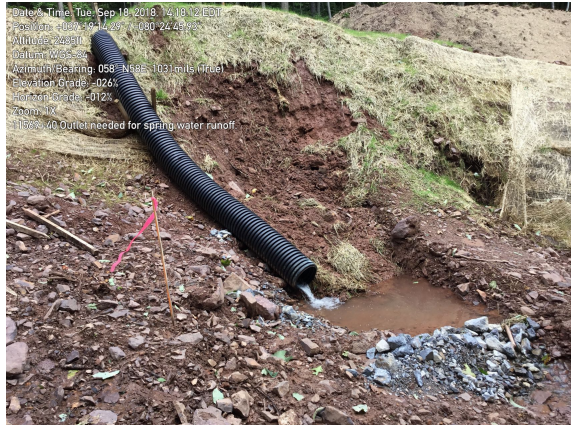
<p>Date & Time: Tue, Sep 18, 2018, 14:18:12 EDT Position: +037° 19' 4.79" / -080° 24' 24.93" Altitude: 2250ft Datum: WGS-84 Azimuth/Bearing: 058° N88E 103mils (True) Elevation Grade: +02% Horizon Grade: +12% Zoom: 1X Shore 20 Outlet needed for spring water runoff</p>

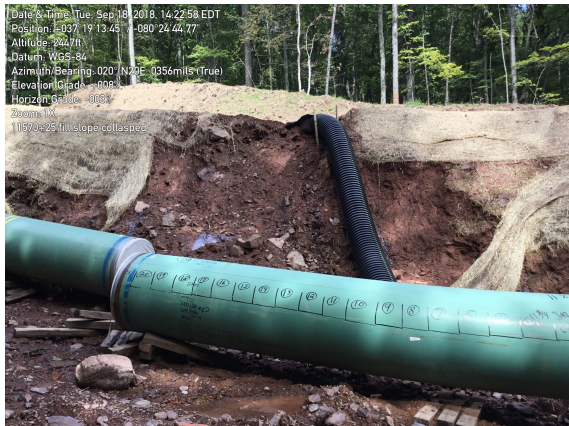
<p>Date & Time: Tue, Sep 18, 2018, 14:22:58 EDT Position: +037° 19' 13.45" / -080° 24' 44.77" Altitude: 2427ft Datum: WGS-84 Azimuth/Bearing: 020° N03E 0356mils (True) Elevation Grade: +00% Horizon Grade: +00% Zoom: 1X 11570+25 Fill slope collapse</p>

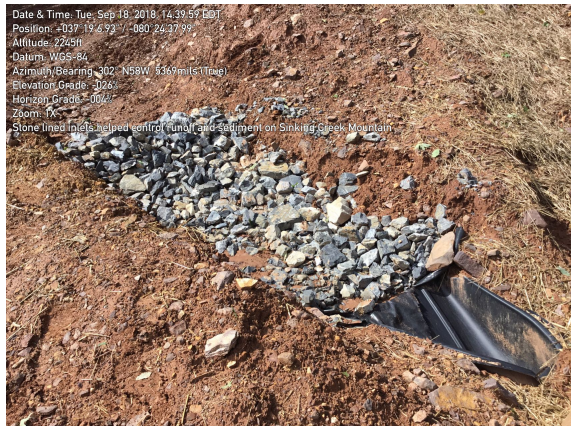
<p>Date & Time: Tue, Sep 18, 2018, 14:29:57 EDT Position: +037° 19' 4.79" / -080° 24' 24.93" Altitude: 2249ft Datum: WGS-84 Azimuth/Bearing: 302° N58W 3369mils (True) Elevation Grade: +02% Horizon Grade: +00% Zoom: 1X Stone lined inlets helped control runoff and sediment on Sinking Creek Mountain</p>

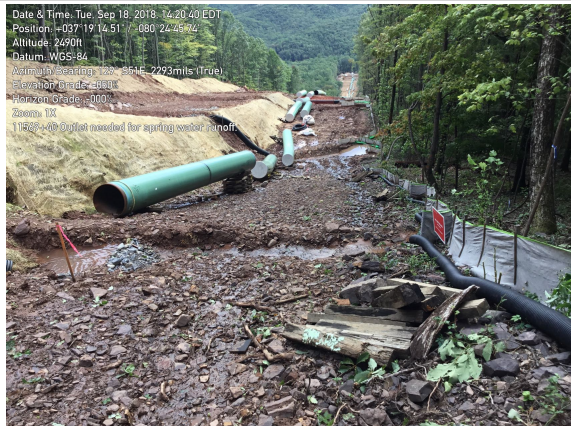
<p>Date & Time: Tue, Sep 18, 2018, 14:20:40 EDT Position: +037° 19' 14.51" / -080° 24' 25.74" Altitude: 2490ft Datum: WGS-84 Azimuth/Bearing: 000° S01E 2293mils (True) Elevation Grade: +00% Horizon Grade: +00% Zoom: 1X 11569+40 Outlet needed for spring water runoff</p>
