# Visual Site Inspection Report

<b>Project Name</b>	H-600 Pipeline Spread G		<b>AFE</b>	124300137	<b>Spread</b>	H-600 Pipeline Spread G	
<b>Contractor</b>	Precision				<b>Report #</b>	5742	
<b>Inspector</b>	Timothy Watson				<b>Date/Time</b>	8/3/2018 10:00 AM	
<b>Permit #</b>	TBD	<b>Inspection Type</b>	VA SWPP		<b>Station Begin</b>	10510+78	
<b>State</b>	VA	<b>Inspection Area</b>	Partial		<b>Station End</b>	10883+85	
<b>County</b>	Giles	<b>Ground</b>	Wet		<b>Temperature (°F)</b>	78.00	
<b>Municipality</b>	N/A	<b>Weather</b>	Heavy Rain		<b>Rain Gauge (in)</b>	0.20	
<b>GPS Location</b>	37.3685700966066, -80.6830792331808				<b>Rain Accumulation Time (days)</b>	1.00

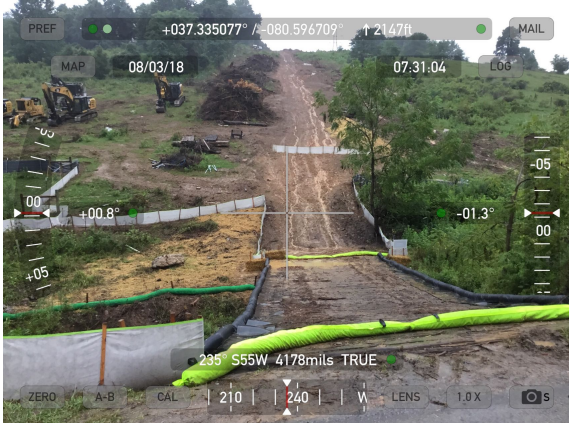
<b>GPS Location</b>	37.3641240131458, -80.674283215812	<b>GPS Location</b>	37.3641240131458, -80.674283215812		
<b>Description</b>	Kow Camp Rd 2 Ecds working installed yesterday	<b>Description</b>	Buffalo Anklets And Row no issues use photo gps

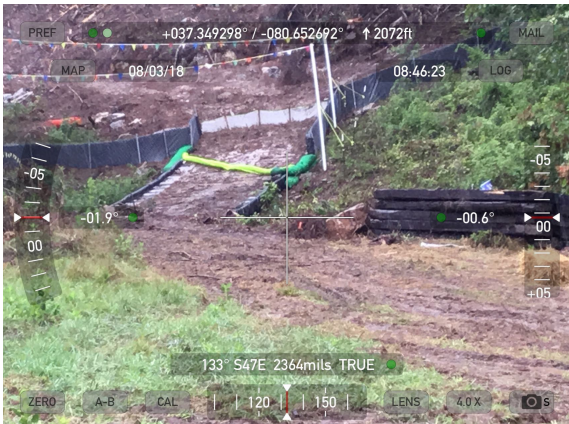
<b>GPS Location</b>	37.3641102668246, -80.6744456571347	<b>GPS Location</b>	37.3640263220643, -80.6742289011187		
<b>Description</b>	Buffalo Anklets Rd and stream crossing 10698+16	<b>Description</b>	Buffalo Anklets looking north station 10693+50

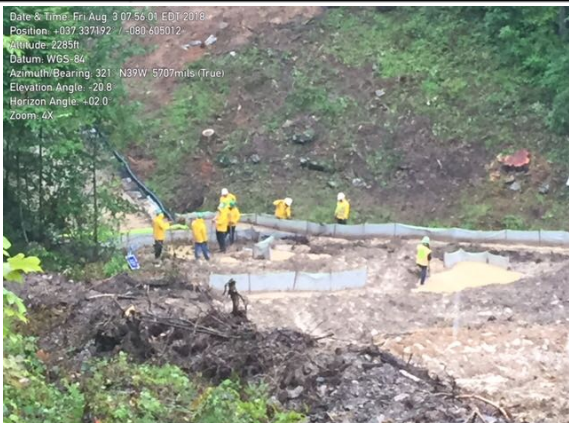
<b>GPS Location</b>	37.3640862107625, -80.6742500235147	<b>GPS Location</b>	37.3587896861484, -80.6821670663363		
<b>Description</b>	Crew checking and or replacing silt fence off Kow Camp Rd 1 station 10854+70 Use photo Gps	<b>Description</b>	Norcross Rd no issues use photo Gps MP 200.5
