Visual Site Inspection Report

Project Name	H-600 Pipeline Spread G	AFE	124300137	Spread	H-600 Pipeline Spread G
Contractor	Precision			Report #	6679
Inspector	Timothy Watson			Date/Time	8/21/2018 8:43 AM
Permit #	TBD	Inspection Type	VA SWPP	Station Begin	10510+78
State	VA	Inspection Area	Partial	Station End	10885+00
County	Giles	Ground	Damp	Temperature (°F)	87.00
Municipality	N/A	Weather	Cloudy	Rain Gauge (in)	1.00
GPS Location	37.3508745725221, -80.6033008452947			Rain Accumulation Time (days)	0.50

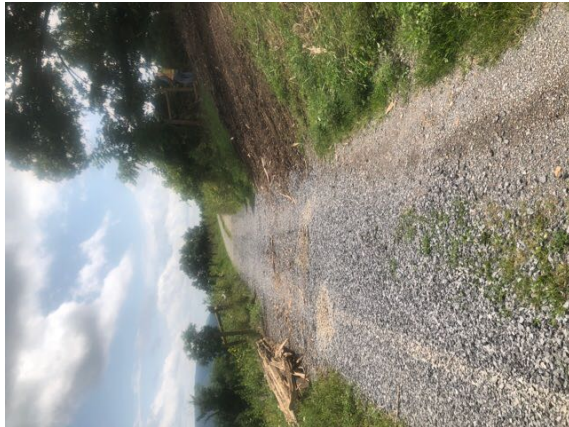
<p>Date & Time: Tue, Aug 21, 2018, 10:44:44 EDT Position: +037.337456° / -080.605522° Altitude: 2197ft Datum: WGS-84 Azimuth/Bearing: 000° N00E 0000mils (Error) Elevation Angle: -10.3° Horizon Angle: +05.7° Zoom: 1X off kow camp rd</p>

GPS Location	37.3321776972401, -80.6837613409631	GPS Location	37.3321776972401, -80.6837613409631		
Description	Drive between Kow Camp Rd station 10875+00 use photo gps	Description	Use photo gps temporary straw in area off Kow Camp Rd 1

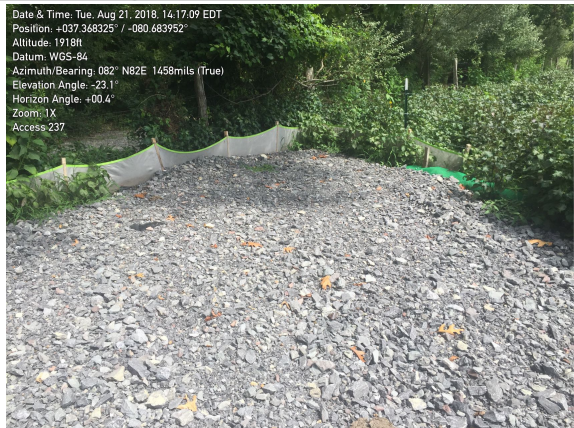
<p>Date & Time: Tue, Aug 21, 2018, 14:17:09 EDT Position: +037.368325° / -080.683952° Altitude: 1918ft Datum: WGS-84 Azimuth/Bearing: 082° N82E 1458mils (True) Elevation Angle: -23.1° Horizon Angle: +00.4° Zoom: 1X Access 237</p>

GPS Location	37.342178430443, -80.6768906582898	GPS Location	37.342178430443, -80.6768906582898		
Description	Access 234 water bar at gate worked use photo gps	Description	Access 237 checked low area no issues use photo gps
