# Visual Site Inspection Report

<b>Project Name</b>	H-600 Pipeline Spread G	<b>AFE</b>	124300137	<b>Spread</b>	H-600 Pipeline Spread G
<b>Contractor</b>	Precision			<b>Report #</b>	6720
<b>Inspector</b>	Timothy Watson			<b>Date/Time</b>	8/21/2018 6:30 PM
<b>Permit #</b>	TBD	<b>Inspection Type</b>	VA SWPP	<b>Station Begin</b>	11237+00
<b>State</b>	VA	<b>Inspection Area</b>	Partial	<b>Station End</b>	11049+84
<b>County</b>	Giles	<b>Ground</b>	Wet	<b>Temperature (°F)</b>	85.00
<b>Municipality</b>	N/A	<b>Weather</b>	Light Rain	<b>Rain Gauge (in)</b>	0.20
<b>GPS Location</b>	37.3192743539415, -80.6577910175469			<b>Rain Accumulation Time (days)</b>	1.00

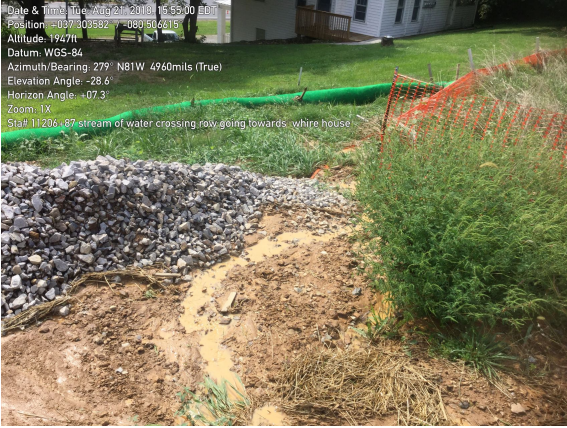
<p>Date &amp; Time: Tue, Aug 21, 2018 15:55:40 EDT  Position: -037.302582, -80.506515  Altitude: 192ft  Datum: WGS-84  Azimuth/Bearing: 279° N81W 4960mils (True)  Elevation Angle: -28.6°  Horizon Angle: -07.3°  Zoom: 1X  Staff 11206+87 stream of water crossing row going towards white house</p>

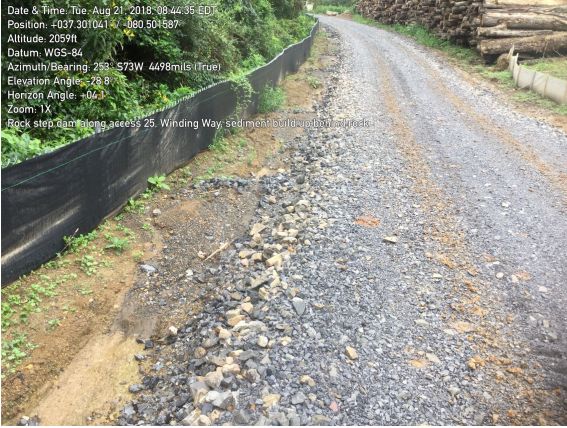
<p>Date &amp; Time: Tue, Aug 21, 2018 08:44:35 EDT  Position: -037.301041, -80.501587  Altitude: 205ft  Datum: WGS-84  Azimuth/Bearing: 252° S73W 4498mils (True)  Elevation Angle: -28.8°  Horizon Angle: -04.1°  Zoom: 1X  Rock step dam along access 25. Winding Way sediment build up on road rock</p>		<b>GPS Location</b> 37.3193341819917, -80.6580171269185	
<b>Description</b>		<b>Description</b>		<b>GPS Location</b> 37.3192954995086, -80.6578077469772	
Station 11206+87 water leaving Row toward home and Hwy 460		Access to valve 25 off Winding Way check dams full

4. E&S BMPs (List BMPs and note if installed and maintained as per the plan. If corrective action is needed, a picture is required.)					
<b>E&amp;S BMPs</b>		<b>Compliance Level</b>	<b>Corrective Action</b>	<b>Corrective Time Frame</b>	
Compost Filter Sock		Problem Area	Clean out	24 Hours	
Roadside Ditch		Problem Area	Need cleaning out add p1 up stream	24 Hours

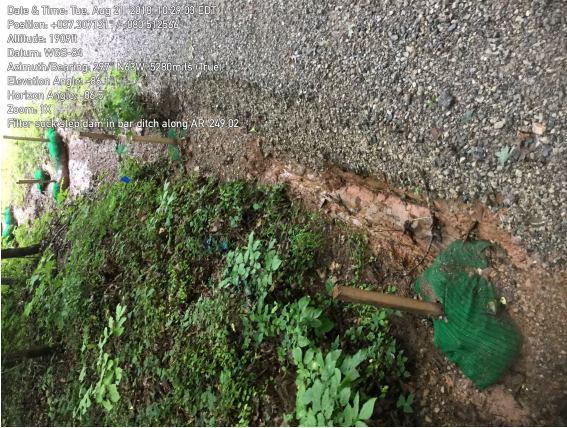
<p>Date &amp; Time: Tue, Aug 21, 2018 08:00:00 EDT  Position: -037.302582, -80.506515  Altitude: 190ft  Datum: WGS-84  Azimuth/Bearing: 279° N81W 4960mils (True)  Elevation Angle: -28.6°  Horizon Angle: -07.3°  Zoom: 1X  Filter sock dam in bar ditch along AR 242.02</p>		<p>Insert image here</p>			
<b>GPS Location</b>		<b>GPS Location</b>

37.3193372413864, -80.6578140334046					
<b>Description</b>		<b>Description</b>			
Step downs in bar ditch full need cleaning					
<p>Insert image here</p>		<p>Insert image here</p>			
<b>GPS Location</b>		<b>GPS Location</b>			
<b>Description</b>		<b>Description</b>
