# Visual Site Inspection Report

<b>Project Name</b>	H-600 Pipeline Spread G	<b>AFE</b>	124300137	<b>Spread</b>	H-600 Pipeline Spread G
<b>Contractor</b>	Precision			<b>Report #</b>	8520
<b>Inspector</b>	Timothy Watson			<b>Date/Time</b>	9/28/2018 8:55 AM
<b>Permit #</b>	TBD	<b>Inspection Type</b>	VA SWPP	<b>Station Begin</b>	10510+78
<b>State</b>	VA	<b>Inspection Area</b>	Partial	<b>Station End</b>	10929+71
<b>County</b>	Giles	<b>Ground</b>	Wet	<b>Temperature (°F)</b>	75.00
<b>Municipality</b>	N/A	<b>Weather</b>	Cloudy	<b>Rain Gauge (in)</b>	2.00
<b>GPS Location</b>	37.3769812187825, -80.6707523755252			<b>Rain Accumulation Time (days)</b>	1.00

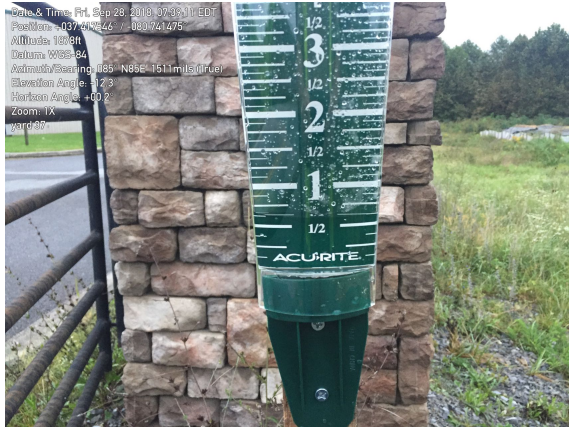
<p>Date &amp; Time: Fri, Sep 28, 2018, 08:31:37 EDT Position: +037.374262° / -88.669247° Altitude: 1205ft Datum: WGS-84 Azimuth/Bearing: 085° N85E 129mils (True) Elevation Angle: +01.1° Horizon Angle: +00.3° Zoom: 1X buffet-Anklets 1.70</p>			
GPS Location	37.3776036366025, -80.6693432585847		GPS Location	37.3776036366025, -80.6693432585847	
Description	Yard 37 rain gauge .6"		Description	Buffalo Anklets Rd 1.6" in Rain gauge

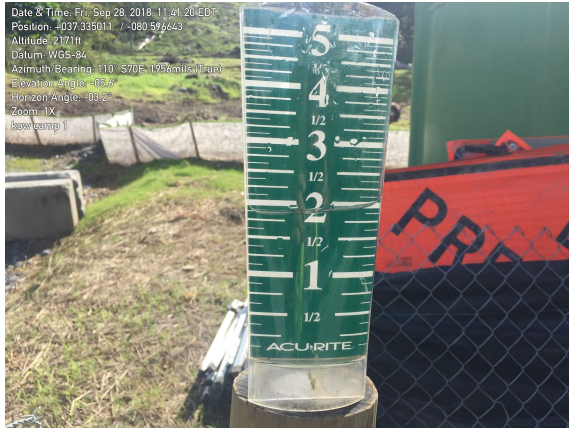
GPS Location	37.3776036366025, -80.6693432585847		GPS Location	37.3776036366025, -80.6693432585847	
Description	Kow Camp Rd 1 rain In gauge 2"		Description	Access 234 rain gauge @ 1.35"

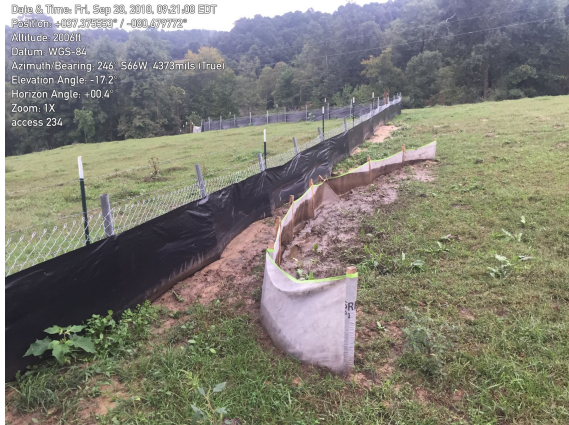
<p>Date &amp; Time: Fri, Sep 28, 2018, 09:35:12 EDT Position: +037.372722° / -88.672884° Altitude: 1206ft Datum: WGS-84 Azimuth/Bearing: 089° N89E 086mils (True) Elevation Angle: +02.5° Horizon Angle: +01.5° Zoom: 1X access 234</p>			
GPS Location	37.3206246692856, -80.6321050864541		GPS Location	37.3206246692856, -80.6321050864541	
Description	ATWS at Row Access 234 P1 needs repaired and small washing hole in super silt fence crew repaired it.		Description	Access 234 ditch
