# Visual Site Inspection Report

<b>Project Name</b>	H-600 Pipeline Spread G	<b>AFE</b>	124300137	<b>Spread</b>	H-600 Pipeline Spread G
<b>Contractor</b>	Precision			<b>Report #</b>	3673
<b>Inspector</b>	Trey Ingram			<b>Date/Time</b>	6/26/2018 12:14 PM
<b>Permit #</b>	TBD	<b>Inspection Type</b>	VA SWPP	<b>Station Begin</b>	12002+00
<b>State</b>	VA	<b>Inspection Area</b>	Full	<b>Station End</b>	11900+00
<b>County</b>	Montgomery	<b>Ground</b>	Wet	<b>Temperature (°F)</b>	78.00
<b>Municipality</b>	N/A	<b>Weather</b>	Light Rain	<b>Rain Gauge (in)</b>	0.60
<b>GPS Location</b>	37.2963047353898, -80.3608760610971			<b>Rain Accumulation Time (days)</b>	1.00

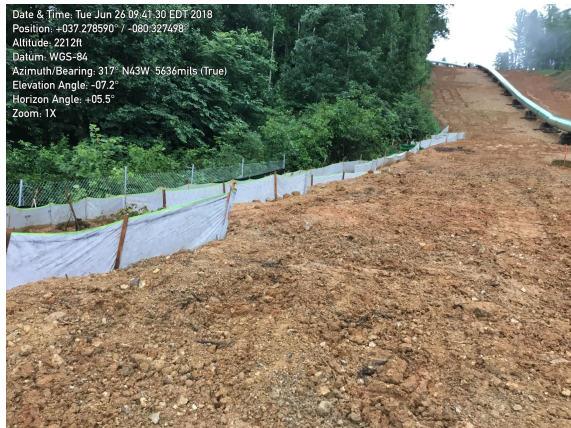
GPS Location	37.2963652124178, -80.3608018783173	GPS Location	37.2963510104275, -80.3608307364498		
Description	ECDs in good condition. Coordinates located in picture above	Description	11942+00 ECDs in good condition		
<p>Date &amp; Time: Tue Jun 26 09:39:23 EDT 2018 Position: +037.281302° / -080.329164° Altitude: 2261ft Datum: WGS-84 Azimuth/Bearing: 102.579E 1813mils (True) Elevation Angle: +14.0° Horizon Angle: -04.7° Zoom: 1X</p>  		<p>Date &amp; Time: Tue Jun 26 10:10:28 EDT 2018 Position: +037.269699° / -080.322904° Altitude: 1703ft Datum: WGS-84 Azimuth/Bearing: 045° N65E 1156mils (True) Elevation Angle: +27.4° Horizon Angle: +00.7° Zoom: 1X</p>  			
GPS Location	37.2963553201755, -80.3606878873709	GPS Location	37.2963211527674, -80.3607739672177		
Description	ECDs in good condition. Coordinates located in picture above	Description	ECDs in good condition. Coordinates located in picture above
