Visual Site Inspection Report

Project Name	H-600 Pipeline Spread G		AFE	124300137	Spread	H-600 Pipeline Spread G	
Contractor	Precision				Report #	7008	
Inspector	Trey Ingram				Date/Time	8/27/2018 5:05 PM	
Permit #	TBD	Inspection Type	VA SWPP		Station Begin	12005+00	
State	VA	Inspection Area	Full		Station End	11766+00	
County	Montgomery	Ground	Dry		Temperature (°F)	87.00	
Municipality	N/A	Weather	Sunny		Rain Gauge (in)	0.00	
GPS Location	37.2128263543309, -80.4016332854311				Rain Accumulation Time (days)	1.00

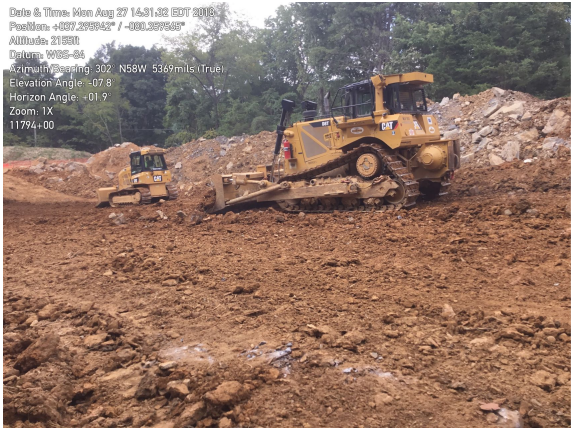
</div>		
GPS Location	37.2128337755994, -80.4016812190857		GPS Location	37.2126031341378, -80.4016536847506	
Description	11794+00 ECDs in good condition		Description	Crew roughing in grade 11794+00	
<div><div>Date & Time: Mon Aug 27 14:32:02 EDT 2018 Position: +037.295910° / -080.359804° Altitude: 2140ft Datum: WGS-84 Azimuth/Bearing: 257° 577W 4569mils (True) Elevation Angle: -19.9° Horizon Angle: +02.1° Zoom: 1X 11793+00</div> </div>			<div><div>Date & Time: Mon Aug 27 14:40:14 EDT 2018 Position: +037.292494° / -080.367435° Altitude: 2134ft Datum: WGS-84 Azimuth/Bearing: 030° N30E 0533mils (True) Elevation Angle: +02.0° Horizon Angle: -00.2° Zoom: 1X 11772+00</div> </div>
