# Visual Site Inspection Report

<b>Project Name</b>	H-600 Pipeline Spread G	<b>AFE</b>	124300137	<b>Spread</b>	H-600 Pipeline Spread G
<b>Contractor</b>	Precision			<b>Report #</b>	7770
<b>Inspector</b>	Trey Ingram			<b>Date/Time</b>	9/12/2018 5:40 PM
<b>Permit #</b>	TBD	<b>Inspection Type</b>	VA SWPP	<b>Station Begin</b>	12005+00
<b>State</b>	VA	<b>Inspection Area</b>	Full	<b>Station End</b>	11766+00
<b>County</b>	Montgomery	<b>Ground</b>	Muddy	<b>Temperature (°F)</b>	78.00
<b>Municipality</b>	N/A	<b>Weather</b>	Sunny	<b>Rain Gauge (in)</b>	0.25
<b>GPS Location</b>	37.342214011622, -80.6768780854351			<b>Rain Accumulation Time (days)</b>	1.00

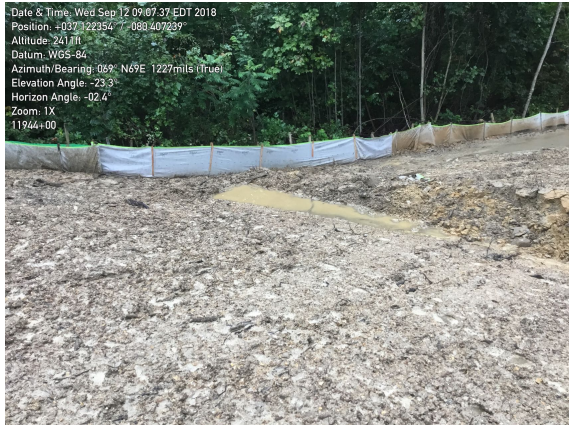
GPS Location	37.3423385247936, -80.676967855618	GPS Location	37.3424781253909, -80.6769089308387		
Description	ECDs in good condition 11944+00	Description	Rain gauge Catawba .25"		
<p>Date &amp; Time: Wed Sep 12 12:12:14 EDT 2018 Position: +037.291364 / -080.488334 Altitude: 2033ft Datum: WGS-84 Azimuth/Bearing: 024° N24E 0427mils (True) Elevation Angle: -19.0° Horizon Angle: -03.9° Zoom: 1X W-IJ46</p>

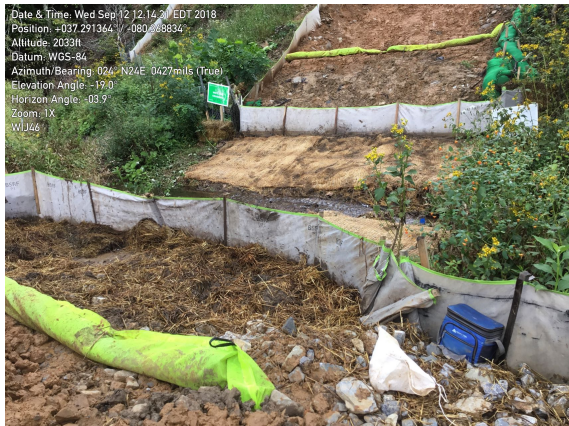
GPS Location	37.342192805407, -80.6766804401583	GPS Location	37.3421917157595, -80.6768572144962		
Description	W-IJ46 mats pulled	Description	11970+00 permanent water breaker		
<p>Date &amp; Time: Wed Sep 12 09:12:34 EDT 2018 Position: +037.276723 / -080.325947 Altitude: 2034ft Datum: WGS-84 Azimuth/Bearing: 125° S55E 2222mils (True) Elevation Angle: -24.1° Horizon Angle: -03.4° Zoom: 1X 11950+00</p>

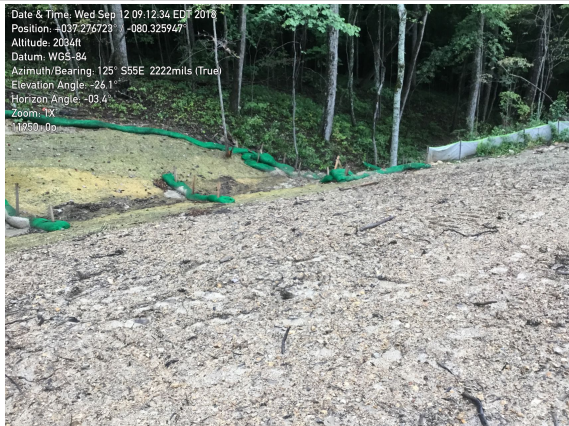
GPS Location	37.3422850063418, -80.6769216713316	GPS Location	37.3421698389923, -80.6768701226271		
Description	ECDs maintained 11950+00	Description	Row 11947+00
