Visual Site Inspection Report

Project Name	H-600 Pipeline Spread G		AFE	124300137	Spread	H-600 Pipeline Spread G	
Contractor	Precision				Report #	8070	
Inspector	Trey Ingram				Date/Time	9/18/2018 6:22 PM	
Permit #	TBD	Inspection Type	VA SWPP		Station Begin	12005+00	
State	VA	Inspection Area	Full		Station End	11788+00	
County	Montgomery	Ground	Muddy		Temperature (°F)	78.00	
Municipality	N/A	Weather	Sunny		Rain Gauge (in)	0.10	
GPS Location	37.3198236361481, -80.6379358475708				Rain Accumulation Time (days)	1.00

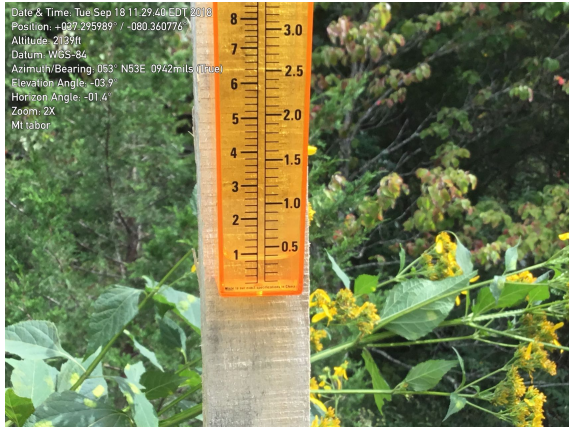
A/E	124300137	Date/Time	9/18/2018 6:22 PM	Report #	8070
Pictures					
<p>Date & Time: Tue Sep 18 11:29:40 EDT 2018 Position: +037 255989° / -080 360776° Altitude: 2137ft Datum: WGS-84 Azimuth/Bearing: 093° N93E 0942mils (True) Elevation Angle: -03.5° Horizon Angle: -01.4° Zoom: 2X Mt tabor</p>

GPS Location	37.3202622439366, -80.6413246208843		GPS Location	37.3202622439366, -80.6413246208843	
Description	.4" mt tabor		Description	.1" Catawba/AR266	
<p>Date & Time: Tue Sep 18 08:06:19 EDT 2018 Position: +037 270865° / -080 327634° Altitude: 2227ft Datum: WGS-84 Azimuth/Bearing: 201° S21W 3873mils (True) Elevation Angle: -17.3° Horizon Angle: -03.3° Zoom: 1X 11942+00 karst protection</p>

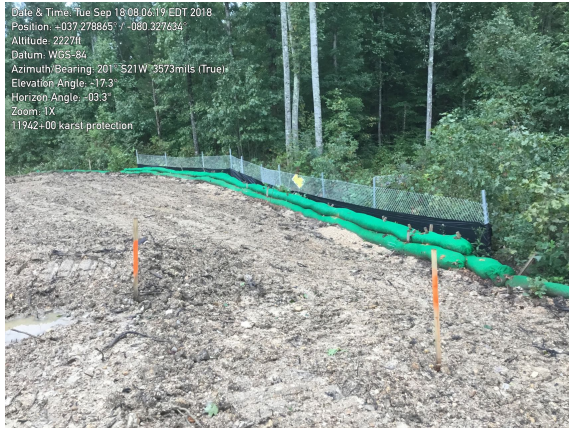
GPS Location	37.3202622439366, -80.6413246208843		GPS Location	37.3202622439366, -80.6413246208843	
Description	ECDs in good condition protecting karst 11942+00		Description	ECDs in need of sediment removed 11950+00	
<p>Date & Time: Tue Sep 18 11:13:28 EDT 2018 Position: +037 260624° / -080 345410° Altitude: 2126ft Datum: WGS-84 Azimuth/Bearing: 140° S30E 7800mils (True) Elevation Angle: -24.6° Horizon Angle: -07.0° Zoom: 1X 11780+00</p>

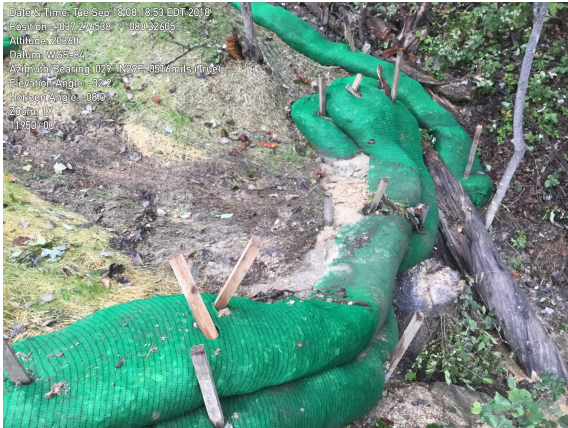
7. Identify all remedial measures that have been taken since the previous inspection was conducted.					
11950+00 sediment over run ECDs affecting Karst feature due to ineffective permanent controls (previously noted).— additional ECDs have been added 11979+00 sediment over run ECDs affecting Karst feature due to ineffective permanent controls (previously noted).— additional ECDs have been added 11968+00 to 11976+00 rills on slope due to ineffective water breakers not installed on full width of row. (Water breakers are built to MVP specs)— slope still needs maintenance					
Comments (Reference above questions as appropriate.)					
Walked row for SWPP inspection from 12005+00 to 11766+00 MP227.2 ~ MP222.7 checking ECDs after .1" of rainfall was recorded at Catawba rd, observed several area where ECDs were to capacity with sediment. Notable areas of concern- 11939+00 End treatment undermined 11940+00 11951+00 ECD maintenance sediment build up on (silt fence, filter sock) 11950+00 Sediment off row 11968+00 Gap in perimeter controls 11969+00 11979+00 Erosion on final grade causing channeling (Rills) 11902+00 Damaged filter sock 11828+00 P1 damaged from fallen tree 11780+00 P1 failed/ fill slope slipping 11777+00 Sediment build up on ECDs/ fill slope slipping Environmental crew worked on ECDs maintenance. All problem areas have been listed in daily punch list (refer to punch list for all areas)

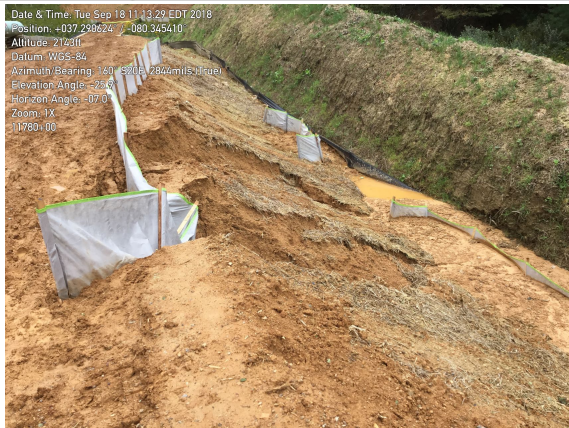
GPS Location	37.3202622439366, -80.6413246208843		GPS Location	37.3202622439366, -80.6413246208843	
Description	11780+00 ECDs beyond capacity with sediment		Description	Sediment build up on level spreader 11971+00
