Visual Site Inspection Report

Project Name	H-600 Pipeline Spread H	AFE	124300138	Spread	H-600 Pipeline Spread H
Contractor	Precision			Report #	1938
Inspector	Dawn McCullough			Date/Time	5/18/2018 7:09 PM
Permit #	TBD	Inspection Type	VA SWPP	Station Begin	+00
State	VA	Inspection Area	Partial	Station End	+00
County	Montgomery	Ground	Wet	Temperature (°F)	70.00
Municipality	N/A	Weather	Light Rain	Rain Gauge (in)	1.55
GPS Location	37.2732186844347, -80.0572191392549			Rain Accumulation Time (days)	1.00

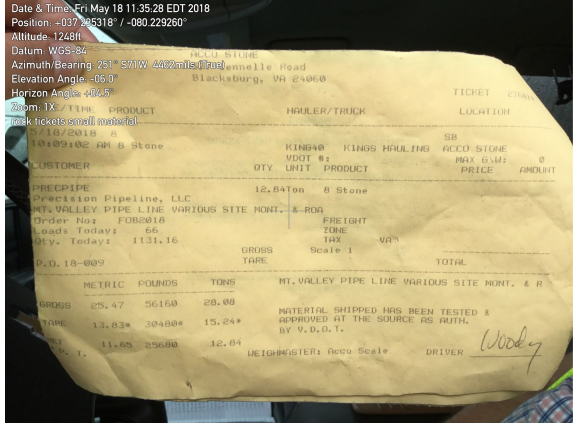
AFE	124300138	Date/Time	5/18/2018 7:09 PM	Report #	1938
Pictures					
<p>Date & Time: Fri May 18 11:35:28 EDT 2018 Position: +037.235318° / -080.229260° Altitude: 1248ft Datum: WGS-84 Azimuth/Bearing: 251° SSW 4492mils (True) Elevation Angle: -06.0° Horizon Angle: 402.5° Zoom: 1X MVP-PY-006 NW perimeter</p>

GPS Location	37.2732366354235, -80.0570511353339		GPS Location	37.2732528954034, -80.0571957339951	
Description	Please see photo for coordinates. MVP-PY-006, Kings Hauling delivering "8 Stone".		Description	Please see photo for coordinates. MVP-PY-006, CFS installed up to rock constructing entrance per E&S Plan.	
<p>Date & Time: Fri May 18 11:45:29 EDT 2018 Position: +037.235318° / -080.228779° Altitude: 1271ft Datum: WGS-84 Azimuth/Bearing: 053° N53E 0042mils (True) Elevation Angle: -07.8° Horizon Angle: +01.7° Zoom: 1X MVP-PY-00 NW perimeter</p>

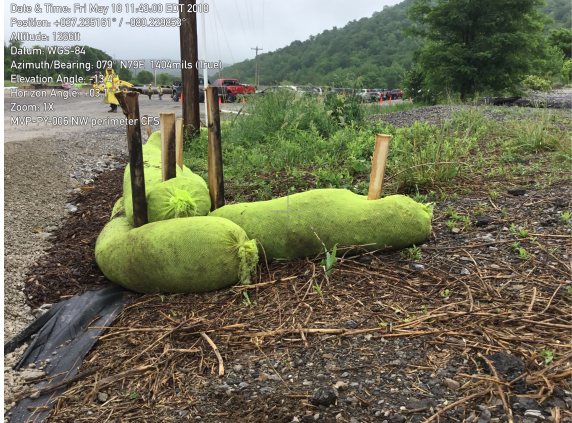
<p>Date & Time: Fri May 18 11:43:00 EDT 2018 Position: +037.235181° / -080.229063° Altitude: 1230ft Datum: WGS-84 Azimuth/Bearing: 079° N79E 120mils (True) Elevation Angle: -13.5° Horizon Angle: -0.1° Zoom: 1X MVP-PY-006 NW perimeter CFS</p>

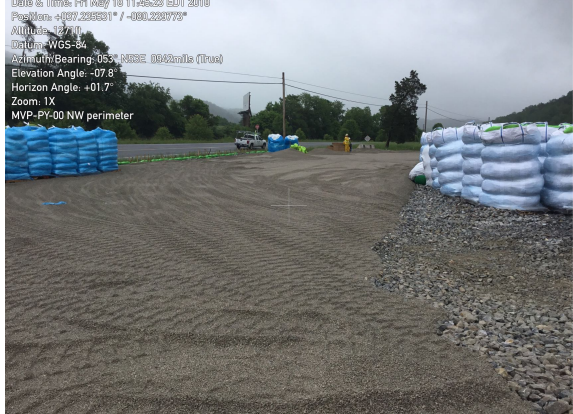
GPS Location	37.2732651583789, -80.0573026627492		GPS Location	37.2732660531998, -80.0573067715633	
Description	Please see photo for coordinates. MVP-PY-006, "8 Stone" spread across gravel surface.		Description	Please see photo for coordinates. MVP-PY-006, PPL installed CFS along North Fork entrance to be installed.	
<p>Date & Time: Fri May 18 11:52:32 EDT 2018 Position: +037.235761° / -080.228406° Altitude: 1252ft Datum: WGS-84 Azimuth/Bearing: 122° S58E 2169mils (True) Elevation Angle: -10.5° Horizon Angle: -10.4° Zoom: 1X MVP-PY-00 standing water portion of NW-008</p>

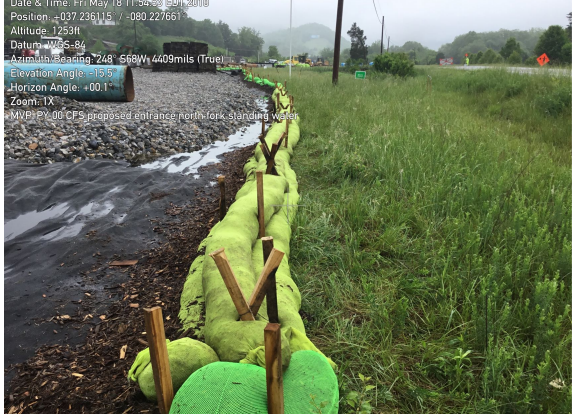
<p>Date & Time: Fri May 18 11:46:29 EDT 2018 Position: +037.236115° / -080.227661° Altitude: 1253ft Datum: WGS-84 Azimuth/Bearing: 248° S68W 4409mils (True) Elevation Angle: -15.5° Horizon Angle: +00.1° Zoom: 1X MVP-PY-00 CFS proposed entrance north fork standing water</p>

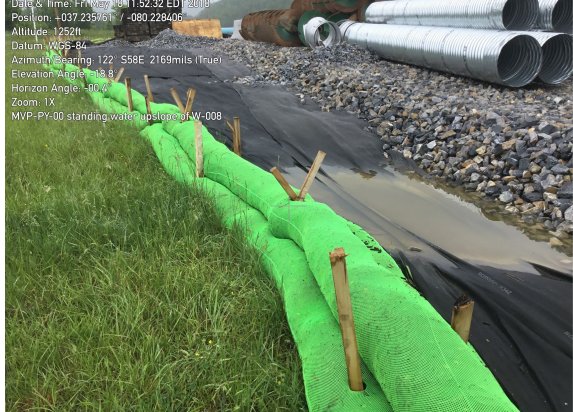
Description	Please see photo for coordinates. MVP-PY-006, CFS along N perimeter.		Description	Please see photo for coordinates. MVP-PY-006, port-o-johns moved, secondary containment to be installed.

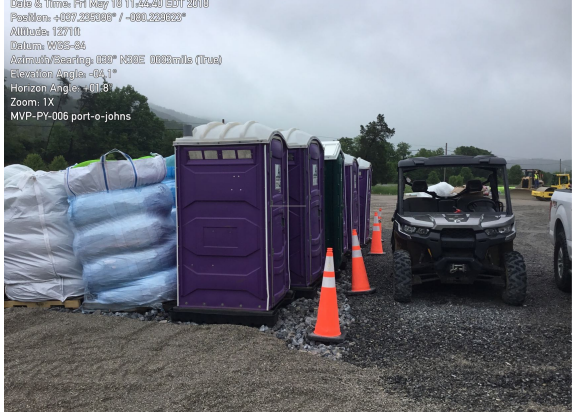
<p>Date & Time: Fri May 18 11:44:40 EDT 2018 Position: +037.235089° / -080.228623° Altitude: 1237ft Datum: WGS-84 Azimuth/Bearing: 089° N89E 0002mils (True) Elevation Angle: -04.1° Horizon Angle: -04.1° Zoom: 1X MVP-PY-006 port-o-johns</p>
