Visual Site Inspection Report

Project Name	H-600 Pipeline Spread H	A/E	124300138	Spread	H-600 Pipeline Spread H
Contractor	Precision			Report #	2709
Inspector	Dawn McCullough			Date/Time	6/5/2018 5:13 PM
Permit #	TBD	Inspection Type	VA SWPP	Station Begin	+00
State	VA	Inspection Area	Full	Station End	+00
County	Montgomery	Ground	Dry	Temperature (°F)	83.00
Municipality	N/A	Weather	Sunny	Rain Gauge (in)	0.25
GPS Location	37.2733278475674, -80.0571708095312			Rain Accumulation Time (days)	4.00

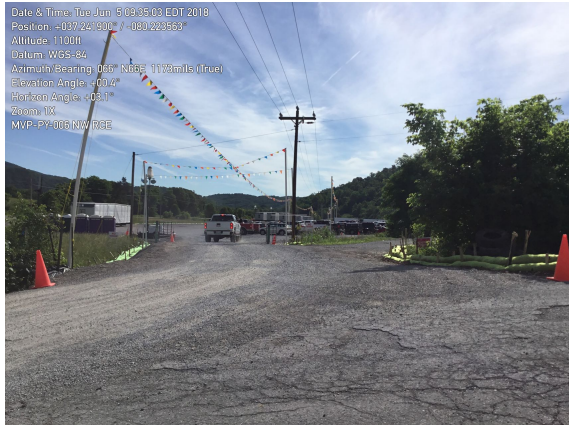
AFE	124300138	Date/Time	6/5/2018 5:13 PM	Report #	2709
Pictures					
<p>Date & Time: Tue Jun 5 09:35:03 EDT 2018 Position: +037.241900° / -080.223552° Altitude: 1100ft Datum: WGS-84 Azimuth/Bearing: 000° S00E 912mils (True) Elevation Angle: -01.2° Horizon Angle: +03.1° Zoom: 1X MVP-PY-006 NW RCE</p>

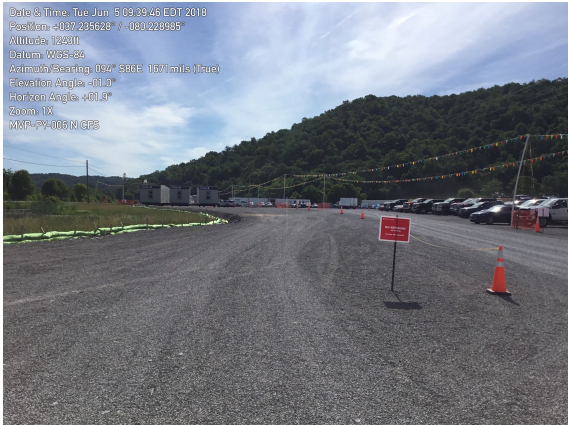
<p>Date & Time: Tue Jun 5 09:39:46 EDT 2018 Position: +037.235628° / -080.224985° Altitude: 1240ft Datum: WGS-84 Azimuth/Bearing: 000° S00E 1007mils (True) Elevation Angle: -01.0° Horizon Angle: +01.8° Zoom: 1X MVP-PY-006 N GPS</p>

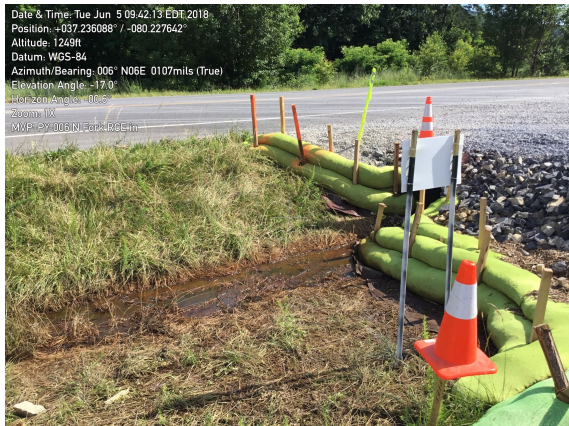
GPS Location	37.2732809728893, -80.0573099968207	GPS Location	37.2732656518949, -80.057017826536		
Description	Please see photo for coordinates. MVP-PY-006, NW RCE.	Description	Please see photo for coordinates. MVP-PY-006, 100 ft buffer marked at W-008.		
<p>Date & Time: Tue Jun 5 09:42:13 EDT 2018 Position: +037.236088° / -080.227642° Altitude: 1240ft Datum: WGS-84 Azimuth/Bearing: 006° N06E 0107mils (True) Elevation Angle: -17.0° Horizon Angle: -00.5° Zoom: 1X MVP-PY-006 N Fork RCE</p>

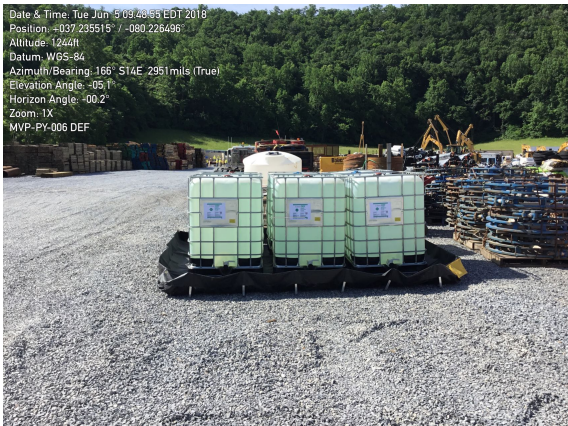
<p>Date & Time: Tue Jun 5 09:40:58 EDT 2018 Position: +037.235515° / -080.226496° Altitude: 1240ft Datum: WGS-84 Azimuth/Bearing: 166° S14E 2951mils (True) Elevation Angle: -05.1° Horizon Angle: -00.2° Zoom: 1X MVP-PY-006 DEF</p>

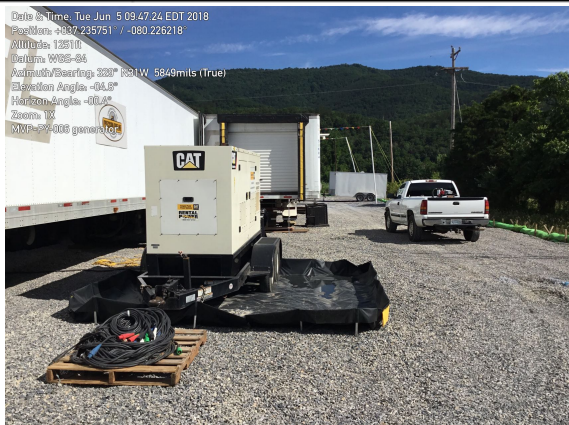
GPS Location	37.2732619607008, -80.0570183140841	GPS Location	37.2732618457194, -80.057018430477		
Description	Please see photo for coordinates. MVP-PY-006, North Fork Road RCE, ditch flow into culvert.	Description	Please see photo for coordinates. MVP-PY-006, DEF fluid storage containers in secondary containment.		
<p>Date & Time: Tue Jun 5 09:47:24 EDT 2018 Position: +037.235751° / -080.226218° Altitude: 1251ft Datum: WGS-84 Azimuth/Bearing: 330° S31W 5849mils (True) Elevation Angle: -04.5° Horizon Angle: +01.5° Zoom: 1X MVP-PY-006 generator</p>

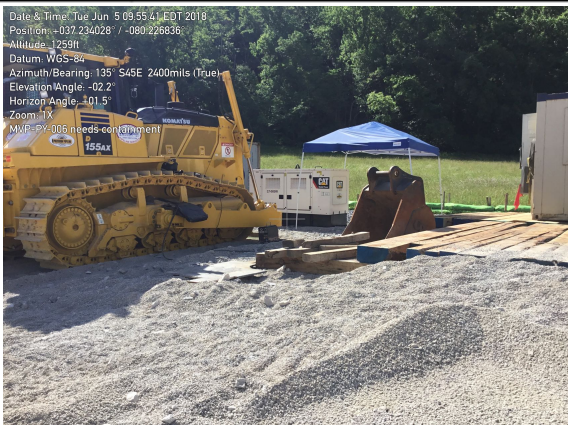
<p>Date & Time: Tue Jun 5 09:55:41 EDT 2018 Position: +037.234028° / -080.226836° Altitude: 1250ft Datum: WGS-84 Azimuth/Bearing: 135° S45E 2400mils (True) Elevation Angle: -02.2° Horizon Angle: +01.5° Zoom: 1X MVP-PY-006 needs containment</p>

Description	Please see photo for coordinates. MVP-PY-006, generator in secondary containment.	Description	Please see photo for coordinates. MVP-PY-006, generator needs secondary containment.

E&S BMPs	Compliance Level	Corrective Action	Corrective Time Frame
Compost Filter Sock	Acceptable		
Rock Construction Entrance	Acceptable		
Housekeeping	Acceptable		
Sensitive Resource Buffer	Acceptable		
Sensitive Resource Signage	Acceptable		
Other	Communication	Place generator in spill containment	48 Hours
