# Visual Site Inspection Report

<b>Project Name</b>	H-600 Pipeline Spread H	<b>AFE</b>	124300138	<b>Spread</b>	H-600 Pipeline Spread H
<b>Contractor</b>	Precision			<b>Report #</b>	6756
<b>Inspector</b>	Dawn McCullough			<b>Date/Time</b>	8/22/2018 3:21 PM
<b>Permit #</b>	TBD	<b>Inspection Type</b>	VA SWPP	<b>Station Begin</b>	13263+44
<b>State</b>	VA	<b>Inspection Area</b>	Partial	<b>Station End</b>	13415+26
<b>County</b>	Franklin	<b>Ground</b>	Damp	<b>Temperature (°F)</b>	79.00
<b>Municipality</b>	N/A	<b>Weather</b>	Cloudy	<b>Rain Gauge (in)</b>	0.30
<b>GPS Location</b>	37.3254512367914, -80.0287236642429			<b>Rain Accumulation Time (days)</b>	1.00

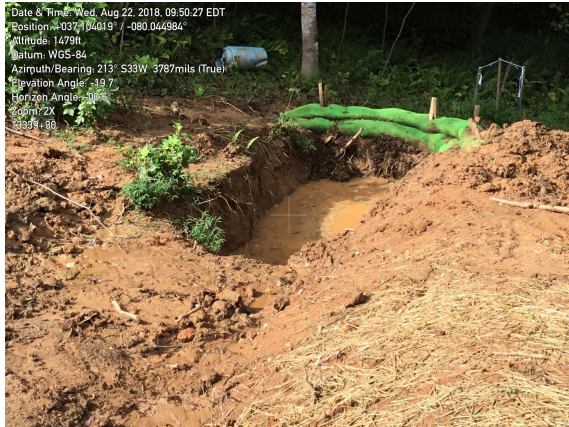
GPS Location	37.2356010061403, -80.2293725565447		GPS Location	37.2356010061403, -80.2293725565447	
Description	Please see photo for coordinates. Sump approximately half full at Sta. No. 13339+00.		Description	Please see photo for coordinates. Bridge across S-GH9, looking towards CIS.	
<p>Date &amp; Time: Wed, Aug 22, 2018, 11:39:47 EDT Position: +037.105720° / -080.049507° Altitude: 1514ft Datum: WGS-84 Azimuth/Bearing: 292° N35W 4889mils (True) Elevation Angle: +21.4° Horizon Angle: +00.7° Zoom: 1X S-GH14</p>

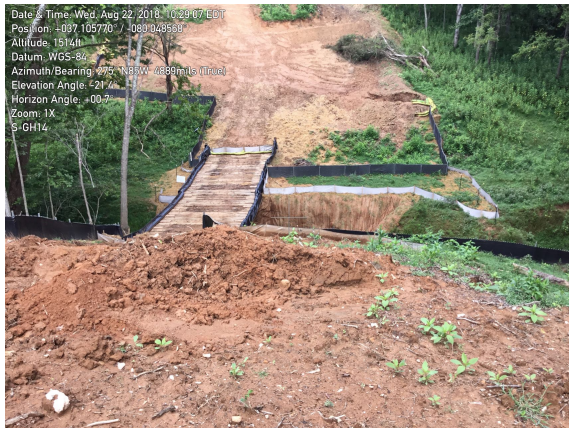
GPS Location	37.2356010061403, -80.2293725565447		GPS Location	37.2356010061403, -80.2293725565447	
Description	Please see photo for coordinates. Bridge across S-GH14, looking toward CIS. Stream banks stable.		Description	Please see photo for coordinates. Outlets need cleaned and upgraded.	
<p>Date &amp; Time: Wed, Aug 22, 2018, 11:55:17 EDT Position: +037.106545° / -080.054181° Altitude: 1372ft Datum: WGS-84 Azimuth/Bearing: 284° N76W 5049mils (True) Elevation Angle: +05.0° Horizon Angle: +00.7° Zoom: 1X 13308+45 S-GH7</p>

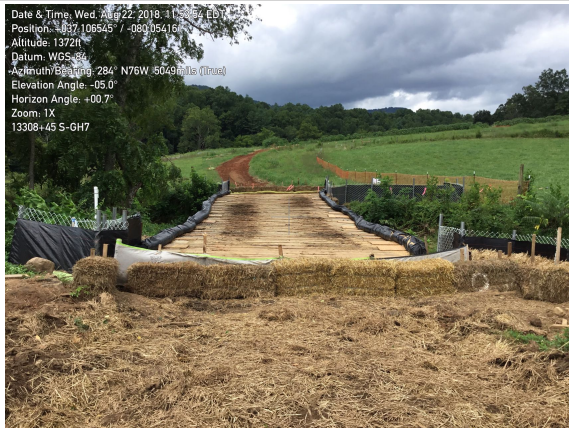
GPS Location	37.2356010061403, -80.2293725565447		GPS Location	37.2355851724356, -80.2293922624322	
Description	Please see photo for coordinates. Bridge across S-GH7, looking toward CIS. Electric fence installed across CIS.		Description	Please see photo for coordinates. Contractor stabilizing the ROW with seed, mulch, and erosion control blanket.
