Visual Site Inspection Report

Project Name	H-600 Pipeline Spread H	AFE	124300138	Spread	H-600 Pipeline Spread H
Contractor	Precision			Report #	7519
Inspector	Dawn McCullough			Date/Time	9/8/2018 7:03 AM
Permit #	TBD	Inspection Type	VA SWPP	Station Begin	13309+09
State	VA	Inspection Area	Partial	Station End	13415+41
County	Franklin	Ground	Dry	Temperature (°F)	85.00
Municipality	N/A	Weather	Sunny	Rain Gauge (in)	0.00
GPS Location	37.23565814, -80.22915245			Rain Accumulation Time (days)	1.00

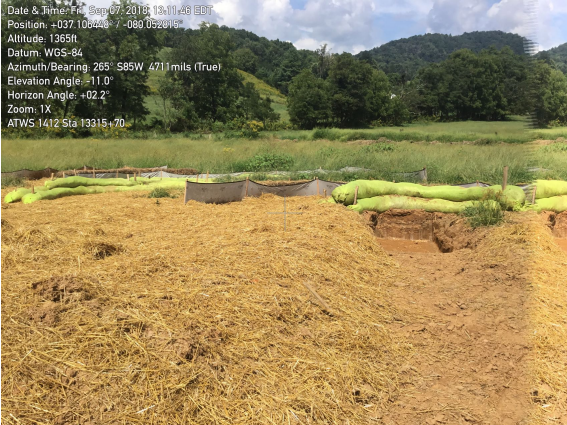
GPS Location	37.3211175987507, -79.9707997719844	GPS Location	37.3211175987507, -79.9707997719844		
Description	Please see photo for coordinates. ATWS 1412, outlet upgraded.	Description	Please see photo for coordinates. ROW, travel lane stabilized and ECDs functioning acceptably.		
<p>Date & Time: Fri, Sep 07, 2018 13:33:39 EDT Position: +037.106230° / -080.050912° Altitude: 1514ft Datum: WGS-84 Azimuth/Bearing: 302° N58W 5369mils (True) Elevation Angle: +24.5° Horizon Angle: +02.2° Zoom: 1X +13316+25</p>

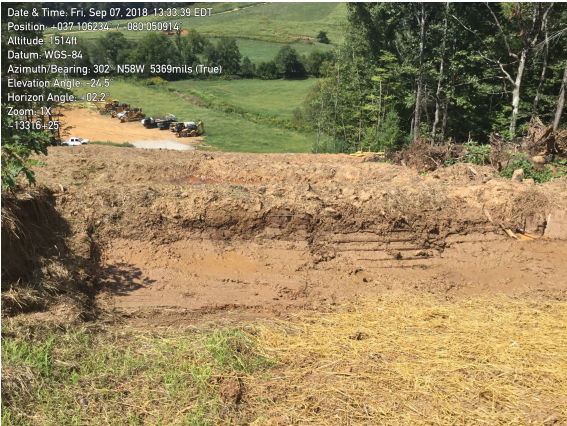
GPS Location	37.3211175987507, -79.9707997719844	GPS Location	37.3211175987507, -79.9707997719844		
Description	Please see photo for coordinates. ROW, temporary travel lane water bars ponding water were repaired.	Description	Please see photo for coordinates. ROW, water bar ponding water repaired.		
<p>Date & Time: Fri, Sep 07, 2018 13:52:20 EDT Position: +037.105938° / -080.049293° Altitude: 1462ft Datum: WGS-84 Azimuth/Bearing: 106° S74E 1984mils (True) Elevation Angle: +37.8° Horizon Angle: +01.1° Zoom: 1X S-GH14</p>

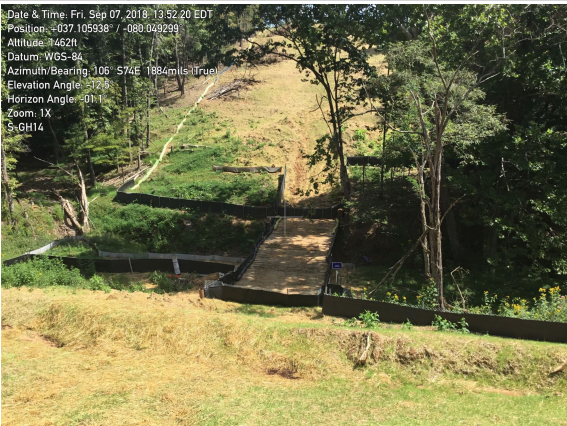
GPS Location	37.3211175987507, -79.9707997719844	GPS Location	37.3211175987507, -79.9707997719844		
Description	Please see photo for coordinates. S-GH14, ECDs installed and functioning acceptably; silt fence repaired. No environmental issues noted	Description	Please see photo for coordinates. S-RR08, ROW stabilized, seed germinating. No environmental concerns were noted.
