# Visual Site Inspection Report

<b>Project Name</b>	H-600 Pipeline Spread H	<b>AFE</b>	124300138	<b>Spread</b>	H-600 Pipeline Spread H
<b>Contractor</b>	Precision			<b>Report #</b>	8564
<b>Inspector</b>	Dawn McCullough			<b>Date/Time</b>	9/28/2018 8:47 PM
<b>Permit #</b>	TBD	<b>Inspection Type</b>	VA SWPP	<b>Station Begin</b>	13198+33
<b>State</b>	VA	<b>Inspection Area</b>	Partial	<b>Station End</b>	13415+83
<b>County</b>	Franklin	<b>Ground</b>	Wet	<b>Temperature (°F)</b>	72.00
<b>Municipality</b>	N/A	<b>Weather</b>	Sunny	<b>Rain Gauge (in)</b>	1.20
<b>GPS Location</b>	37.3256459576175, -80.0288199761779			<b>Rain Accumulation Time (days)</b>	1.00

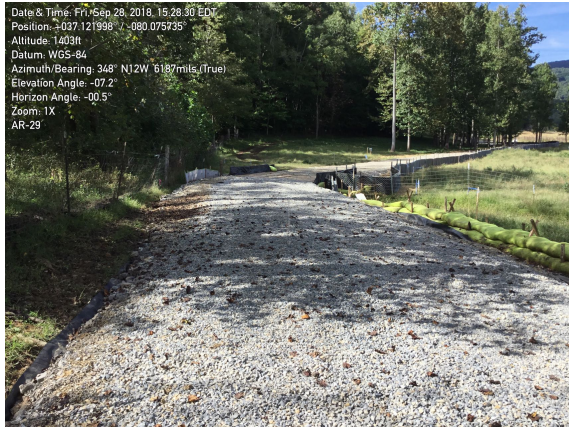
A/E	124300138	Date/Time	9/28/2018 8:47 PM	Report #	8564
Pictures					
<p>Date &amp; Time: Fri, Sep 28, 2018, 15:28:30 EDT Position: +037.121998° / -080.075735° Altitude: 1403ft Datum: WGS-84 Azimuth/Bearing: 348° N12W 5187mils (True) Elevation Angle: -07.2° Horizon Angle: -00.5° Zoom: 1X AR-29</p>

<p>13206+48 Stabilized and well vegetated ROW 2018-09-27 11:12:39-04:00</p>			
GPS Location	37.3256498404145, -80.0288018573708		GPS Location	37.3256501483684, -80.0288003106966	
Description	Please see photo for coordinates. MVP-AR-29, ECDs installed along access road.		Description	Please see photo for coordinates. Sta. No. 13206+48, ROW stabilized. No environmental issues noted.	
<p>Date &amp; Time: Thu, Sep 28, 2018, 11:22:12 EDT Position: +037.106066° / -080.030151° Altitude: 1437ft Datum: WGS-84 Azimuth/Bearing: 050° N60E 1057mils (True) Elevation Angle: -28.3° Horizon Angle: -02.3° Zoom: 1X S-GH12 downstream sediment from bridge</p>

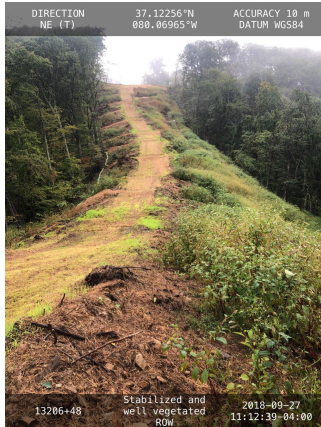
<p>DIRECTION: NE (T) 37.12256°N 080.06965°W ACCURACY: 10 m DATUM: WGS84</p>

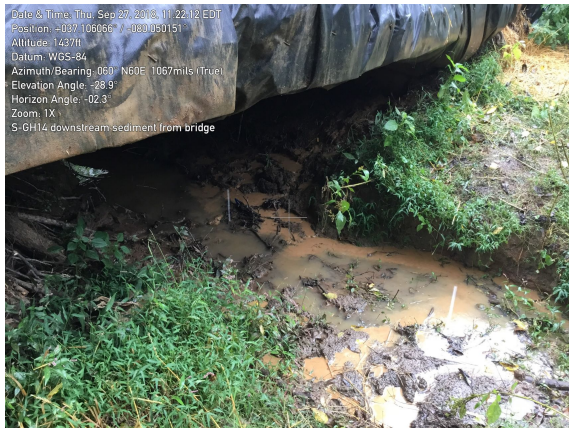
GPS Location	37.3256409403355, -80.0287910535673		GPS Location	37.3256333324074, -80.0287937118946	
Description	Please see photo for coordinates. S-GH15, turbid water from bridge.		Description	Please see photo for coordinates. ~Sta. No. 13344+00, drainage area culxerxed draining to outlet.	
<p>Date &amp; Time: Fri, Sep 28, 2018, 12:29:13 EDT Position: +037.101984° / -080.040077° Altitude: 1520ft Datum: WGS-84 Azimuth/Bearing: 130° S50E 2311mils (True) Elevation Angle: -01.5° Horizon Angle: -01.5° Zoom: 1X S-RR11</p>

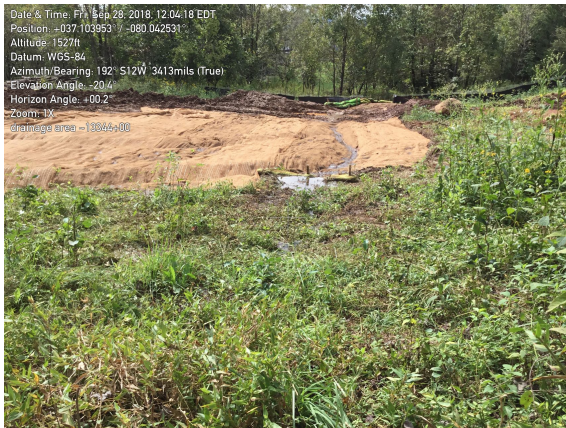
<p>Date &amp; Time: Fri, Sep 28, 2018, 12:04:16 EDT Position: +037.103953° / -080.042831° Altitude: 1527ft Datum: WGS-84 Azimuth/Bearing: 192° S12W 3413mils (True) Elevation Angle: -20.4° Horizon Angle: +00.2° Zoom: 1X Drainage area ~13344+00</p>

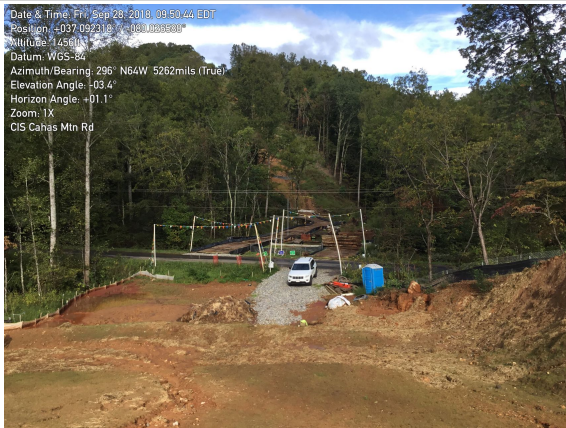
<p>Date &amp; Time: Fri, Sep 28, 2018, 09:50:44 EDT Position: +037.092318° / -080.038630° Altitude: 1456ft Datum: WGS-84 Azimuth/Bearing: 295° N64W 5262mils (True) Elevation Angle: -03.4° Horizon Angle: +01.1° Zoom: 1X CIS Cahas Mtn Rd</p>

GPS Location	37.3256326051036, -80.0287948412231		GPS Location	37.3256287811907, -80.0287974790723	
Description	Please see photo for coordinates. ~Sta. No. 13358+00, NCI clearing activities.		Description	Please see photo for coordinates. Sta. No. 13415+83, ROW crossing at Cahas Mountain Road.
