Visual Site Inspection Report

Project Name	H-600 Pipeline Spread H	AFE	124300138	Spread	H-600 Pipeline Spread H
Contractor	Precision			Report #	1934
Inspector	Dennis Evans			Date/Time	5/18/2018 6:52 PM
Permit #	TBD	Inspection Type	VA SWPP	Station Begin	12373+28
State	VA	Inspection Area	Partial	Station End	13415+50
County	Franklin	Ground	Wet	Temperature (°F)	71.00
Municipality	N/A	Weather	Heavy Rain	Rain Gauge (in)	2.40
GPS Location	37.2797096848153, -80.0295094699701			Rain Accumulation Time (days)	1.00

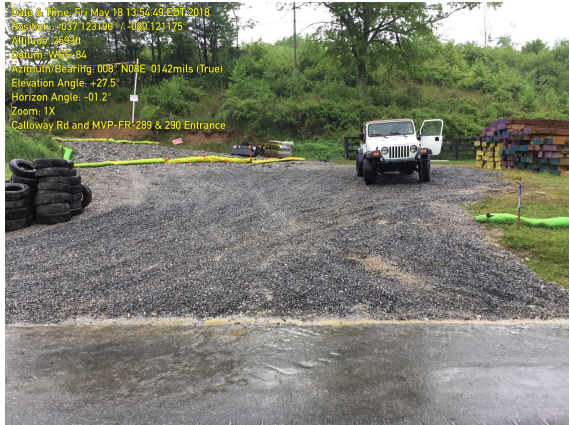
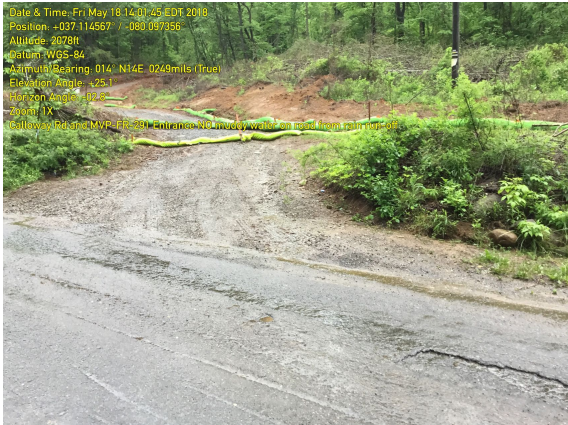
GPS Location	37.2800941839123, -80.0292107068657	GPS Location	37.2796976423504, -80.0295193485997		
Description	Calloway and MVP-FR-289 & 290. See photo for accurate coordinates.	Description	Calloway and MVP-FR-291. See photo for accurate coordinates.

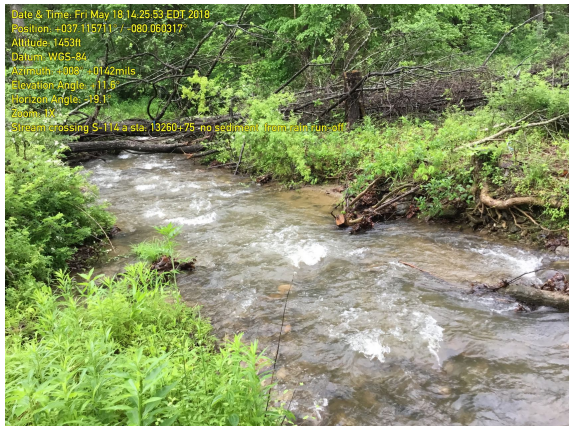
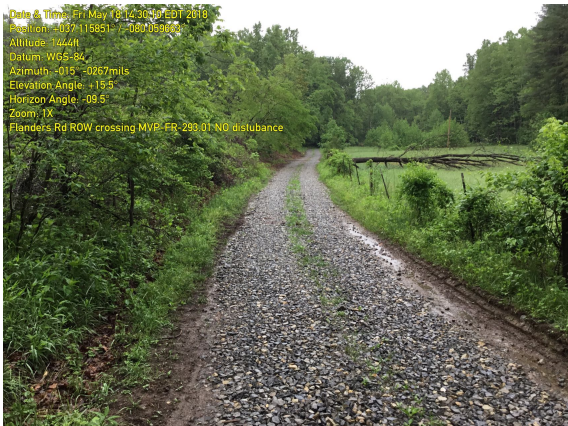
GPS Location	37.2800740402137, -80.0292956483928	GPS Location	37.2798647233147, -80.0293056737682		
Description	Stream crossing S-114. See photo for accurate coordinates.	Description	MVP -FR-293.01 (Flanders Rd) See photo for accurate coordinates.

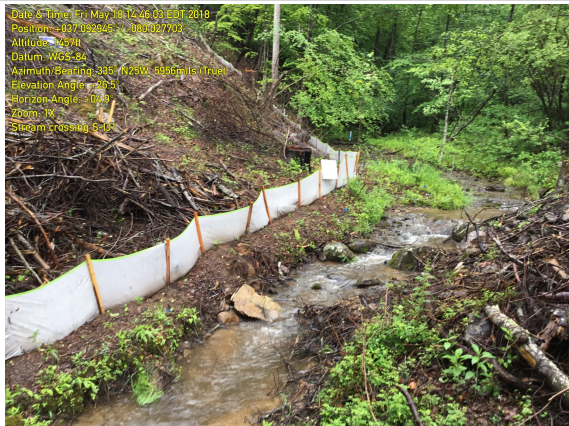
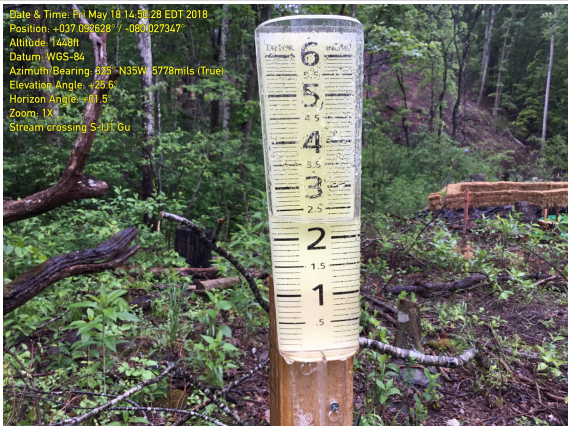
GPS Location	37.2796976423504, -80.0295193485997	GPS Location	37.2796976423504, -80.0295193485997		
Description	Stream crossing S-IJ1. See photo for accurate coordinates.	Description	Cahas Mountain Rd rain gauge 2.40" of rain. See photo for accurate coordinates.
