# Visual Site Inspection Report

<b>Project Name</b>	H-600 Pipeline Spread H	<b>AFE</b>	124300138	<b>Spread</b>	H-600 Pipeline Spread H
<b>Contractor</b>	Precision			<b>Report #</b>	2195
<b>Inspector</b>	Dennis Evans			<b>Date/Time</b>	5/24/2018 9:03 PM
<b>Permit #</b>	TBD	<b>Inspection Type</b>	VA SWPP	<b>Station Begin</b>	12071+80
<b>State</b>	VA	<b>Inspection Area</b>	Partial	<b>Station End</b>	12371+00
<b>County</b>	Montgomery	<b>Ground</b>	Damp	<b>Temperature (°F)</b>	76.00
<b>Municipality</b>	N/A	<b>Weather</b>	Sunny	<b>Rain Gauge (in)</b>	0.00
<b>GPS Location</b>	37.2797519152418, -80.0292454696898			<b>Rain Accumulation Time (days)</b>	1.00

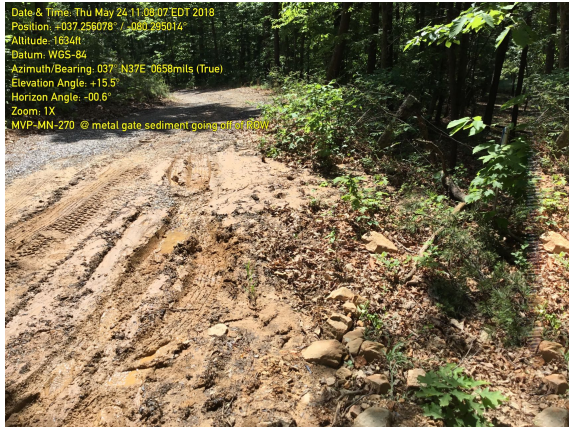
A/E	124300138	Date/Time	5/24/2018 9:03 PM	Report #	2195
Pictures					
<p>Date &amp; Time: Thu May 24 11:20:07 EDT 2018 Position: +037.256078° / -080.295014° Altitude: 1634ft Datum: WGS-84 Azimuth/Bearing: 037° N37E 0858mils (True) Elevation Angle: +15.5° Horizon Angle: -00.6° Zoom: 1X MVP-MN-270 © metal gate sediment going off 2 (RCE)</p>

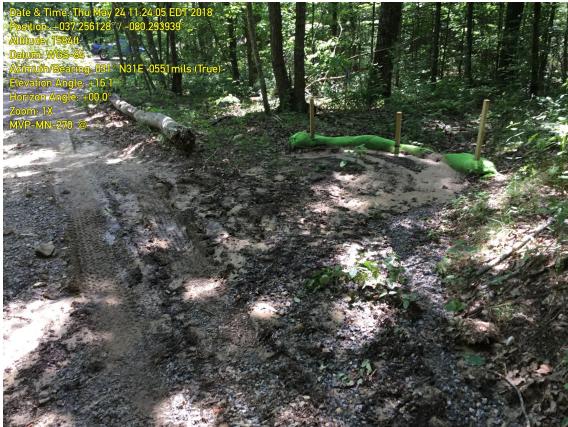
<p>Date &amp; Time: Thu May 24 11:24:05 EDT 2018 Position: +037.286128° / -080.293939° Altitude: 1634ft Datum: WGS-84 Azimuth/Bearing: 300° N31E 0853mils (True) Elevation Angle: +16.1° Horizon Angle: -00.0° Zoom: 1X MVP-MN-270 3</p>

GPS Location	37.2798843402474, -80.0296494288919	GPS Location	37.2800239736627, -80.0292423742981		
Description	Sediment going away from access road See photo for accurate coordinates	Description	Filter sock that needs to be maintained. See photo for accurate coordinates.		
<p>Date &amp; Time: Thu May 24 11:40:19 EDT 2018 Position: +037.256078° / -080.295014° Altitude: 1605ft Datum: WGS-84 Azimuth/Bearing: 315° N45W 5067mils (True) Elevation Angle: +23.5° Horizon Angle: -01.0° Zoom: 1X MVP-MN-270 rock muddy areas and maintain sediment sock</p>  		<p>Date &amp; Time: Thu May 24 11:40:19 EDT 2018 Position: +037.256078° / -080.297733° Altitude: 1510ft Datum: WGS-84 Azimuth/Bearing: 285° N75W 5067mils (True) Elevation Angle: +26.5° Horizon Angle: -01.1° Zoom: 1X MVP-MN-270.01 RCE East side of road is good</p>

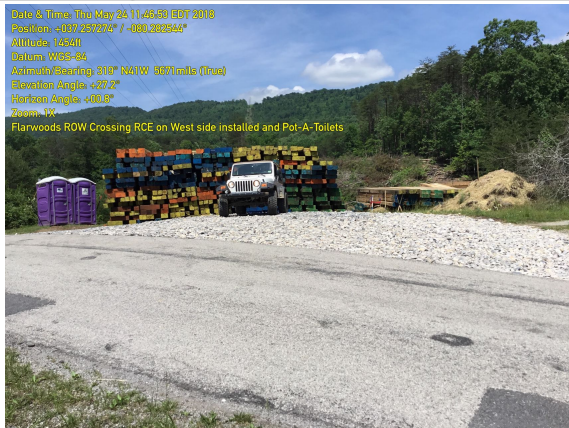
GPS Location	37.2798916930819, -80.0292154083228	GPS Location	37.2798736047966, -80.0292138566013		
Description	Access road holding water See photo for accurate coordinates.	Description	Top soil pile needs filter sock See photo for accurate coordinates		
<p>Date &amp; Time: Thu May 24 11:45:20 EDT 2018 Position: +037.257032° / -080.292544° Altitude: 1454ft Datum: WGS-84 Azimuth/Bearing: 310° N60W 9807mils (True) Elevation Angle: +27.2° Horizon Angle: -00.5° Zoom: 1X Flatwoods ROW Crossing RCE on West side installed and Pot-A-Toilets</p>

Description	West side of Flatwoods Rd. needs top soil filter sock. See photo for accurate coordinates	Description	East side of Flatwoods Rd needs top soil filter sock. See photo for accurate coordinates.

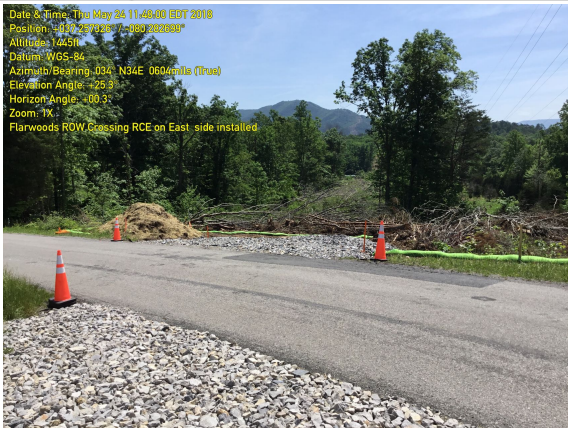
<p>Date &amp; Time: Thu May 24 11:45:40 EDT 2018 Position: +037.257032° / -080.292544° Altitude: 1455ft Datum: WGS-84 Azimuth/Bearing: 304° N34E 0604mils (True) Elevation Angle: +29.3° Horizon Angle: -00.3° Zoom: 1X Flatwoods ROW Crossing RCE on East side installed</p>
