# Visual Site Inspection Report

<b>Project Name</b>	H-600 Pipeline Spread H	<b>A/E</b>	124300138	<b>Spread</b>	H-600 Pipeline Spread H
<b>Contractor</b>	Precision			<b>Report #</b>	4861
<b>Inspector</b>	Dennis Evans			<b>Date/Time</b>	7/19/2018 6:45 PM
<b>Permit #</b>	TBD	<b>Inspection Type</b>	VA SWPP	<b>Station Begin</b>	12991+00
<b>State</b>	VA	<b>Inspection Area</b>	Partial	<b>Station End</b>	13024+06
<b>County</b>	Roanoke	<b>Ground</b>	Dry	<b>Temperature (°F)</b>	78.00
<b>Municipality</b>	N/A	<b>Weather</b>	Sunny	<b>Rain Gauge (in)</b>	0.00
<b>GPS Location</b>	37.2797456826671, -80.0294103906633			<b>Rain Accumulation Time (days)</b>	1.00

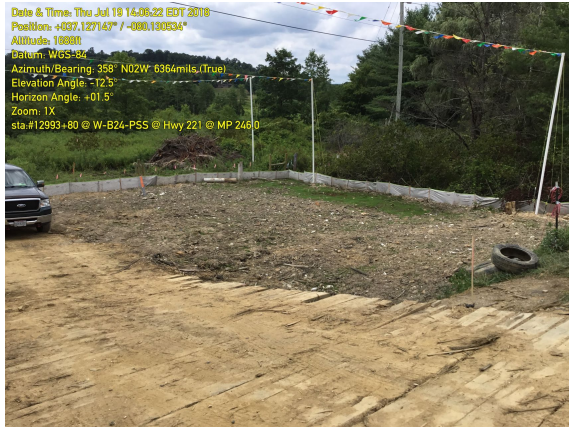
A/E	124300138	Date/Time	7/19/2018 6:45 PM	Report #	4861
Pictures					
<p>Date &amp; Time: Thu Jul 19 14:06:22 EDT 2018 Position: +037.127143° / -080.130534° Altitude: 1680ft Datum: WGS-84 Azimuth/Bearing: 358° N02W 6364mils (True) Elevation Angle: -12.5° Horizon Angle: +01.5° Zoom: 1X sta:#12993+80 @ W-B24-PSS @ Hwy 221 @ MP 246.0</p>

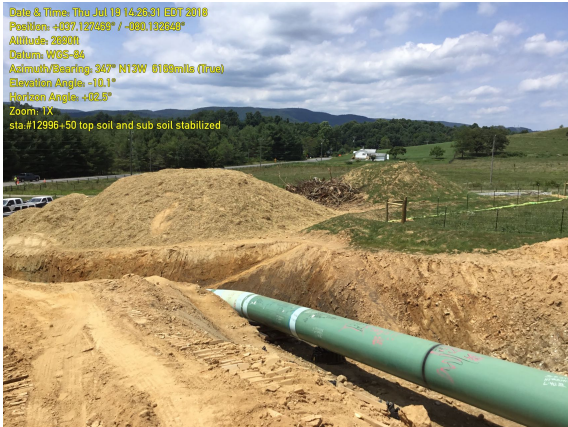
<p>Date &amp; Time: Thu Jul 19 14:36:31 EDT 2018 Position: +037.123600° / -080.130849° Altitude: 2600ft Datum: WGS-84 Azimuth/Bearing: 343° N13W 8180mils (True) Elevation Angle: -10.1° Horizon Angle: +02.5° Zoom: 1X sta:#12996+50 top soil and sub soil stabilized</p>

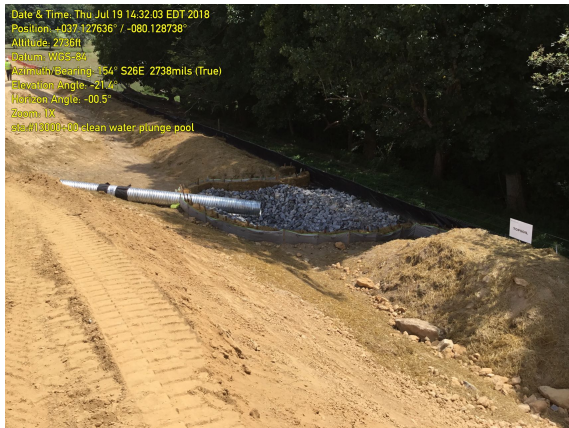
GPS Location	37.2800180125676, -80.0290505236765	GPS Location	37.2797468517173, -80.0294033537375		
Description	Sta:12993+80 W-B24 See photo for accurate coordinates	Description	Sta:#12996+50 top soil and sub soil stabilized See photo for accurate coordinates		
<p>Date &amp; Time: Thu Jul 19 14:32:03 EDT 2018 Position: +037.126736° / -080.128738° Altitude: 2700ft Datum: WGS-84 Azimuth/Bearing: 34° S26E 2738mils (True) Elevation Angle: -21.4° Horizon Angle: -00.5° Zoom: 1X sta:#13000+00 clean water plunge pool</p>

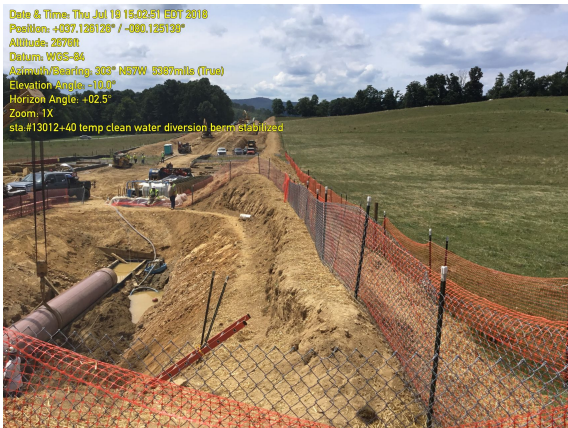
<p>Date &amp; Time: Thu Jul 19 14:42:01 EDT 2018 Position: +037.126120° / -080.126138° Altitude: 2670ft Datum: WGS-84 Azimuth/Bearing: 303° N57W 5367mils (True) Elevation Angle: -10.0° Horizon Angle: +02.5° Zoom: 1X sta:#13012+40 temp clean water diversion berm stabilized</p>

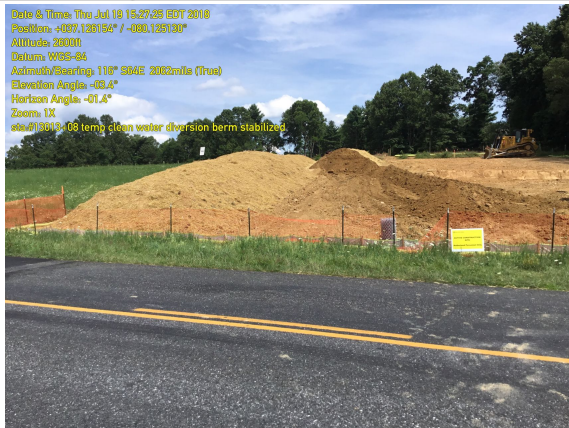
GPS Location	37.279744346343, -80.0294111502462	GPS Location	37.2797431219276, -80.0294118465473		
Description	Sta:#13000+00 clean water plunge pool See photo for accurate coordinates.	Description	Sta:#13012+40 temp clean water diversion berm stabilized. See photo for accurate coordinates,		
<p>Date &amp; Time: Thu Jul 19 15:37:59 EDT 2018 Position: +037.126154° / -080.135130° Altitude: 2600ft Datum: WGS-84 Azimuth/Bearing: 118° S04E 2062mils (True) Elevation Angle: -03.4° Horizon Angle: -01.4° Zoom: 1X sta:#13013+08 temp clean water diversion berm stabilized</p>

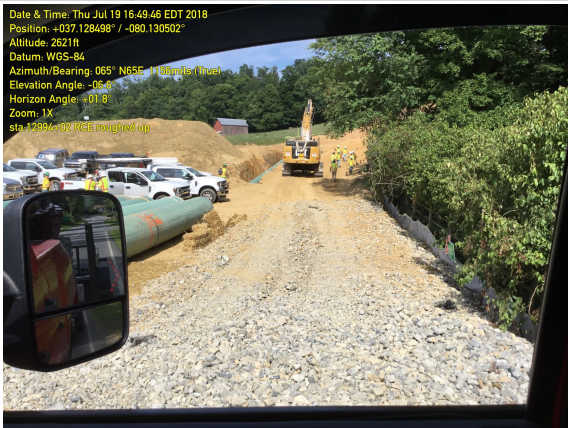
<p>Date &amp; Time: Thu Jul 19 16:49:46 EDT 2018 Position: +037.128498° / -080.130502° Altitude: 2621ft Datum: WGS-84 Azimuth/Bearing: 065° N65E 1110mils (True) Elevation Angle: -05.6° Horizon Angle: +01.8° Zoom: 1X sta:#12994+02 Hwy 221 RCE roughed up</p>

Description	Sta:#13013+08 temp clean water diversion berm stabilized. See photo for accurate coordinates.	Description	Sta:# 12994+02 Hwy 221 RCE See photo for accurate coordinates.
