Visual Site Inspection Report

Project Name	H-600 Pipeline Spread H	AFE	124300138	Spread	H-600 Pipeline Spread H
Contractor	Precision			Report #	4863
Inspector	Dennis Evans			Date/Time	7/19/2018 7:05 PM
Permit #	TBD	Inspection Type	VA SWPP	Station Begin	12991+00
State	VA	Inspection Area	Partial	Station End	13024+06
County	Roanoke	Ground	Dry	Temperature (°F)	78.00
Municipality	N/A	Weather	Sunny	Rain Gauge (in)	0.00
GPS Location	37.2797408691787, -80.0294131437521			Rain Accumulation Time (days)	1.00

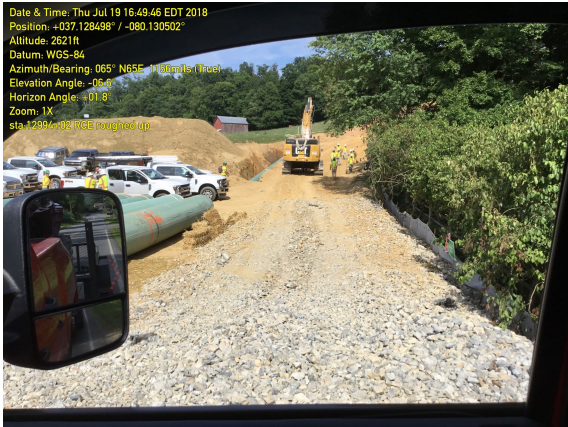
<p>Date & Time: Thu Jul 19 16:49:46 EDT 2018 Position: +037.128498° / -080.130502° Altitude: 2621ft Datum: WGS-84 Azimuth/Bearing: 065° N65E 1104mils (True) Elevation Angle: -06.4° Horizon Angle: +01.8° Zoom: 1X Sta:#2994+02 RCE Highway 221</p>

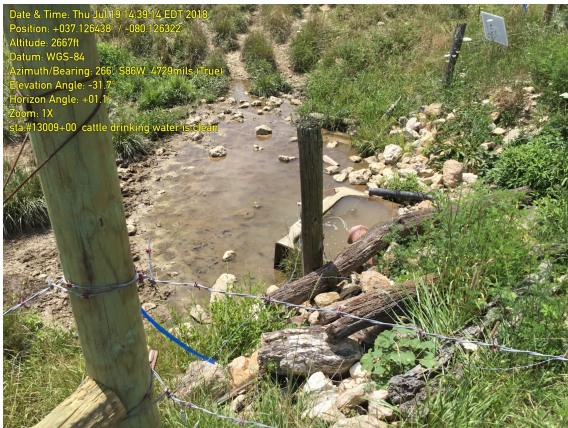
<p>Date & Time: Thu Jul 19 16:30:16 EDT 2018 Position: +037.126639° / -080.126322° Altitude: 2667ft Datum: WGS-84 Azimuth/Bearing: 266° S86W 4729mils (True) Elevation Angle: -31.7° Horizon Angle: +01.1° Zoom: 1X Sta:#13009+00 cattle drinking water is clean</p>

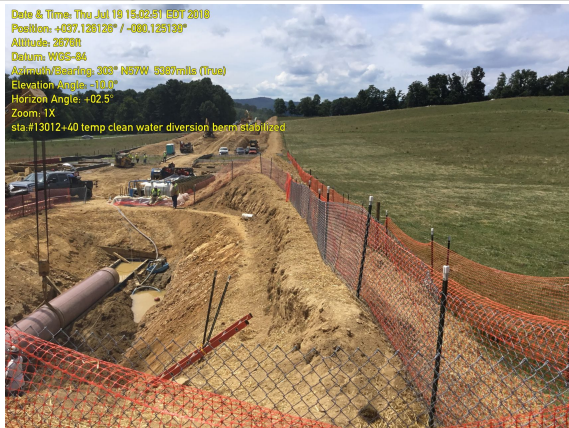
GPS Location	37.2797623091932, -80.029387341831	GPS Location	37.2800717927859, -80.0292346454371		
Description	Sta:#13000+00 plunge pool See photo for accurate coordinates	Description	Sta:#13009+00 cattle drinking water is clean. See photo for accurate coordinates		
<p>Date & Time: Thu Jul 19 15:02:51 EDT 2018 Position: +037.126128° / -080.125138° Altitude: 2576ft Datum: WGS-84 Azimuth/Bearing: 303° N67W 5347mils (True) Elevation Angle: -10.0° Horizon Angle: +02.5° Zoom: 1X Sta:#13012+40 temp clean water diversion berm stabilized</p>

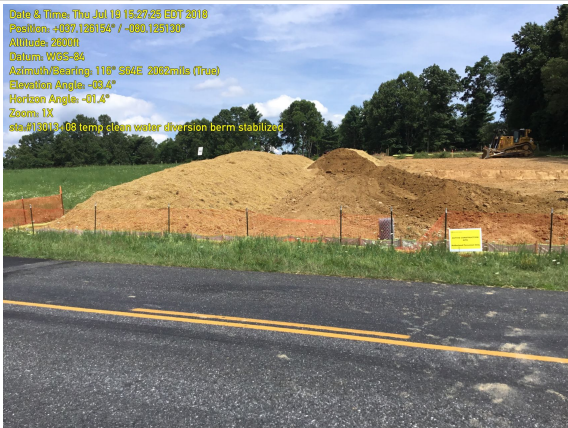
<p>Date & Time: Thu Jul 19 15:27:25 EDT 2018 Position: +037.126154° / -080.125130° Altitude: 2600ft Datum: WGS-84 Azimuth/Bearing: 110° S86E 2002mils (True) Elevation Angle: -03.4° Horizon Angle: -01.4° Zoom: 1X Sta:#13013+08 temp clean water diversion berm stabilized</p>
