# Visual Site Inspection Report

<b>Project Name</b>	H-600 Pipeline Spread H	<b>AFE</b>	124300138	<b>Spread</b>	H-600 Pipeline Spread H
<b>Contractor</b>	Precision			<b>Report #</b>	8125
<b>Inspector</b>	Dennis Evans			<b>Date/Time</b>	9/19/2018 6:50 PM
<b>Permit #</b>	TBD	<b>Inspection Type</b>	VA SWPP	<b>Station Begin</b>	12993+15
<b>State</b>	VA	<b>Inspection Area</b>	Partial	<b>Station End</b>	13024+06
<b>County</b>	Roanoke	<b>Ground</b>	Wet	<b>Temperature (°F)</b>	80.00
<b>Municipality</b>	N/A	<b>Weather</b>	Sunny	<b>Rain Gauge (in)</b>	0.00
<b>GPS Location</b>	37.2795665438721, -80.0290368602277			<b>Rain Accumulation Time (days)</b>	1.00

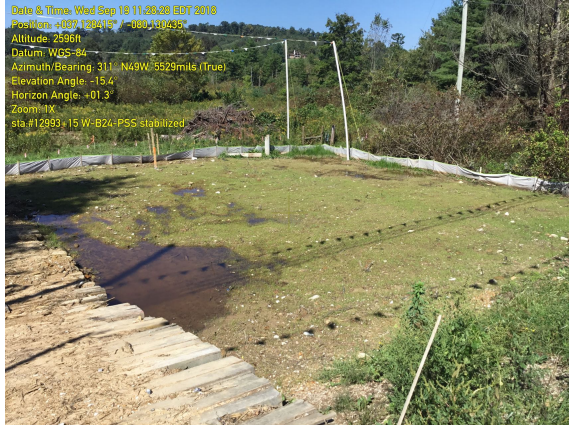
A/E	124300138	Date/Time	9/19/2018 6:50 PM	Report #	8125
Pictures					
<p>Date &amp; Time: Wed Sep 19 11:28:00 EDT 2018 Position: +037.128412° / -80.028648° Altitude: 2596ft Datum: WGS-84 Azimuth Bearing: 311° N49W 5529mils (true) Elevation Angle: -15.6° Horizon Angle: -01.3° Zoom: 1X Sta: #12993+15 W-B24 PSS stabilized</p>

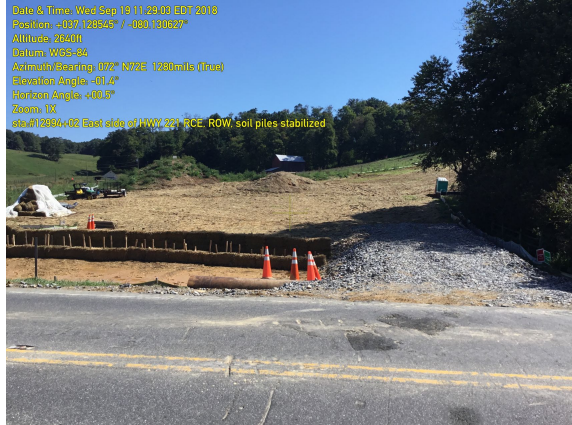
<p>Date &amp; Time: Wed Sep 19 11:28:00 EDT 2018 Position: +037.128525° / -80.028627° Altitude: 2630ft Datum: WGS-84 Azimuth Bearing: 088° N28E 1200mils (true) Elevation Angle: -01.4° Horizon Angle: -00.5° Zoom: 1X Sta: #12994+02 East side of HWY 221 RCE ROW soil piles stabilized</p>

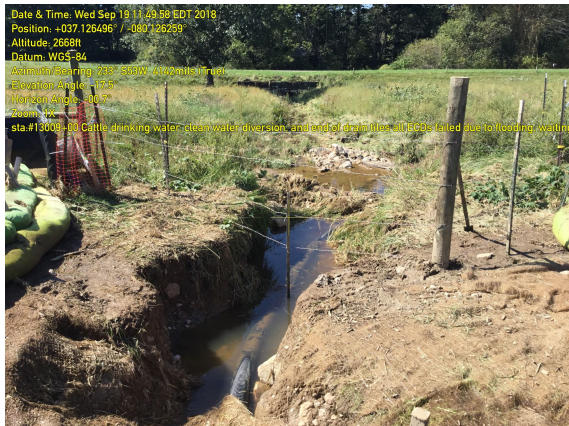
GPS Location	37.280166605003, -80.0286483951471		GPS Location	37.2801342001532, -80.0294438750297	
Description	Sta: #12993+15 W-B-24 stabilized. See photo for accurate coordinates.		Description	Sta: #12994+02 Hwy 221 RCE and ROW stabilized. See photo for accurate coordinates.	
<p>Date &amp; Time: Wed Sep 19 13:20:30 EDT 2018 Position: +037.125496° / -80.029426° Altitude: 2668ft Datum: WGS-84 Azimuth Bearing: 232° S23W 4300mils (true) Elevation Angle: -17.5° Horizon Angle: -00.5° Zoom: 1X Sta: #13009+00 Cattle drinking water, clean water diversion and area of bank line at RCEs Erod due to loading, waiting</p>

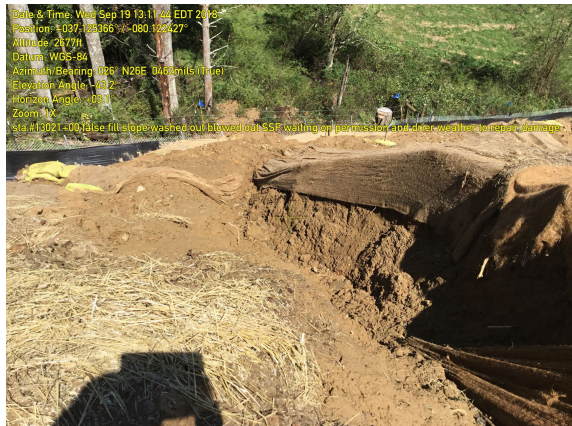
<p>Date &amp; Time: Wed Sep 19 13:11:00 EDT 2018 Position: +037.125568° / -80.029427° Altitude: 2770ft Datum: WGS-84 Azimuth Bearing: 088° N28E 0400mils (true) Elevation Angle: -01.2° Horizon Angle: -00.1° Zoom: 1X Sta: #13021+00 false fill side slope collapsed due to weather, no repair damage</p>

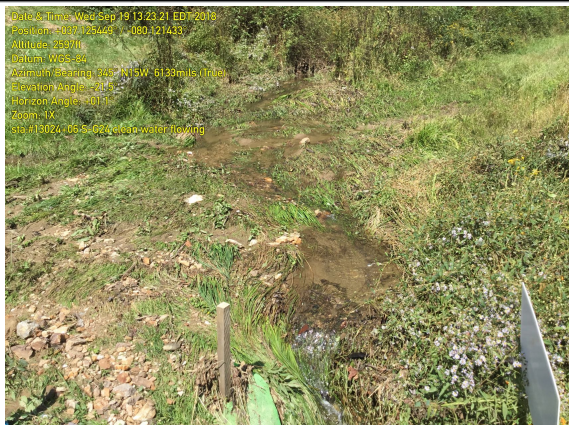
GPS Location	37.2800974035983, -80.029410263598		GPS Location	37.2801087191676, -80.0293908175826	
Description	Sta: #13009+00 Cattle drinking water pool and clean water diversion area eroded. See photo for accurate coordinates.		Description	Sta: #13021+00 false fill side slope collapsed. See photo for accurate coordinates.	
<p>Date &amp; Time: Wed Sep 19 13:23:21 EDT 2018 Position: +037.125425° / -80.029433° Altitude: 2597ft Datum: WGS-84 Azimuth Bearing: 144° N49W 5130mils (true) Elevation Angle: -17.5° Horizon Angle: -01.3° Zoom: 1X Sta: #13024+06 S-G24 up stream flowing clean and clear</p>

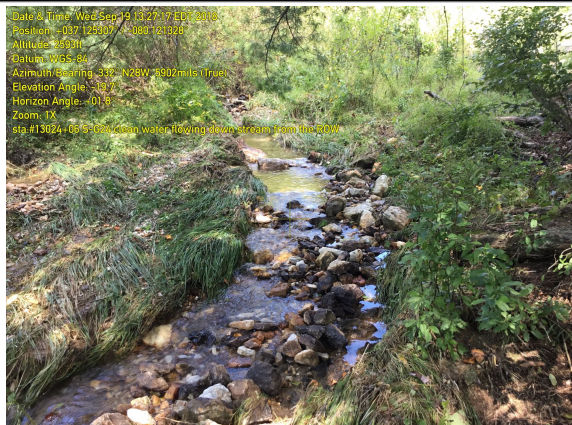
<p>Date &amp; Time: Wed Sep 19 13:23:19 EDT 2018 Position: +037.125307° / -80.029326° Altitude: 2590ft Datum: WGS-84 Azimuth Bearing: 335° N28W 3002mils (true) Elevation Angle: -17.5° Horizon Angle: -01.3° Zoom: 1X Sta: #13024+06 S-G24 down stream water flowing clean and clear from the ROW</p>
