Visual Site Inspection Report

Project Name	H-600 Pipeline Spread H	AFE	124300138	Spread	H-600 Pipeline Spread H
Contractor	Precision			Report #	8556
Inspector	Dennis Evans			Date/Time	9/28/2018 6:20 PM
Permit #	TBD	Inspection Type	VA SWPP	Station Begin	12993+15
State	VA	Inspection Area	Partial	Station End	13924+06
County	Roanoke	Ground	Wet	Temperature (°F)	71.00
Municipality	N/A	Weather	Sunny	Rain Gauge (in)	0.63
GPS Location	37.1915485477421, -80.1573235542329			Rain Accumulation Time (days)	1.00

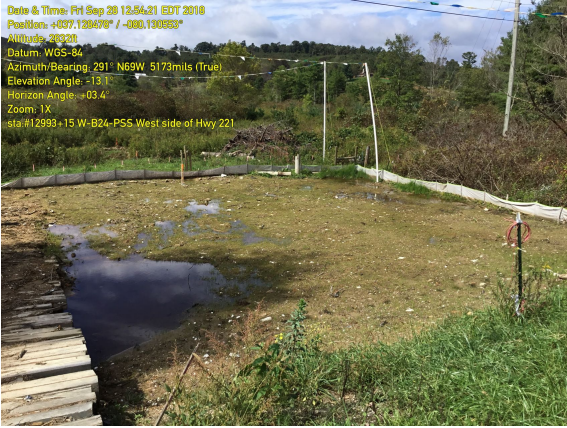
A/E	124300138	Date/Time	9/28/2018 6:20 PM	Report #	8556
Pictures					
<p>Date & Time: Fri Sep 28 12:54:21 EDT 2018 Position: +037.120478° / -080.130553° Altitude: 2032ft Datum: WGS-84 Azimuth/Bearing: 291° N69W 5173mils (True) Elevation Angle: -13.1° Horizon Angle: -03.4° Zoom: 1X Sta:#12993+15 W-B24-PSS West side of Hwy 221</p>

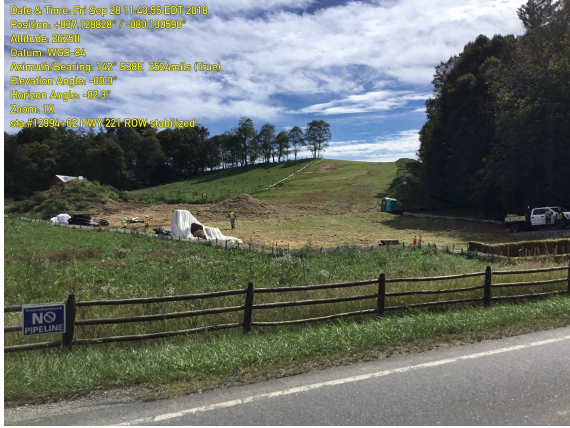
<p>Date & Time: Fri Sep 28 11:40:55 EDT 2018 Position: +037.130507° / -080.130500° Altitude: 2032ft Datum: WGS-84 Azimuth/Bearing: 143° S30E 2804mils (True) Elevation Angle: -03.0° Horizon Angle: -05.5° Zoom: 1X Sta:#12994+02 Hwy 221 ROW stabilized</p>

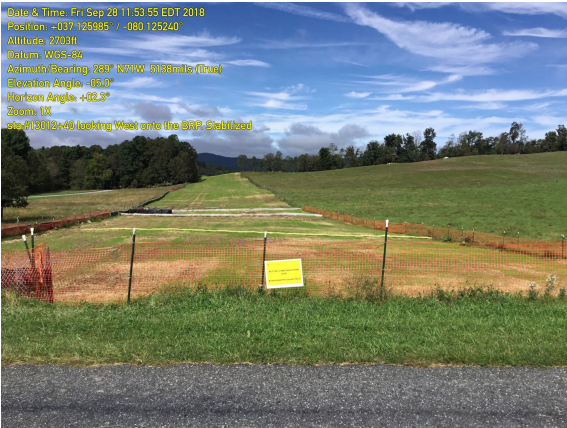
GPS Location	37.1310209809217, -80.1362918504329	GPS Location	37.1310252556923, -80.1362459176035		
Description	Sta:#12993+15 W-B24-PSS is stabilized See photo for accurate coordinates.	Description	Sta:#12994+02 Hwy 221 East side stabilized See photo for accurate coordinates.		
<p>Date & Time: Fri Sep 28 11:53:55 EDT 2018 Position: +037.130504° / -080.125340° Altitude: 2030ft Datum: WGS-84 Azimuth/Bearing: 358° N71W 1136mils (True) Elevation Angle: -05.0° Horizon Angle: -02.5° Zoom: 1X Sta:#13012+40 looking West onto the BRP Stabilized</p>

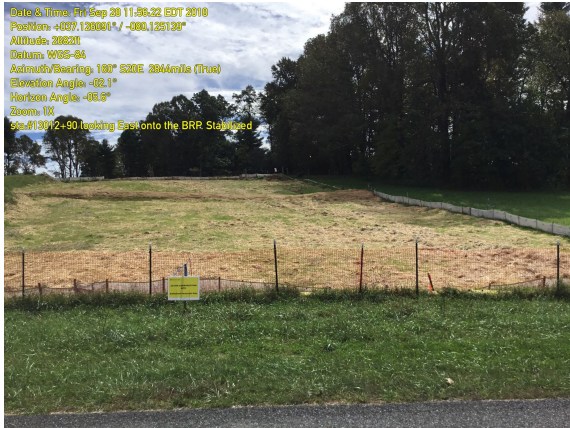
<p>Date & Time: Fri Sep 28 11:56:22 EDT 2018 Position: +037.130501° / -080.125138° Altitude: 2030ft Datum: WGS-84 Azimuth/Bearing: 100° S20E 2844mils (True) Elevation Angle: -02.1° Horizon Angle: -05.9° Zoom: 1X Sta:#13012+90 looking East onto the BRP Stabilized</p>

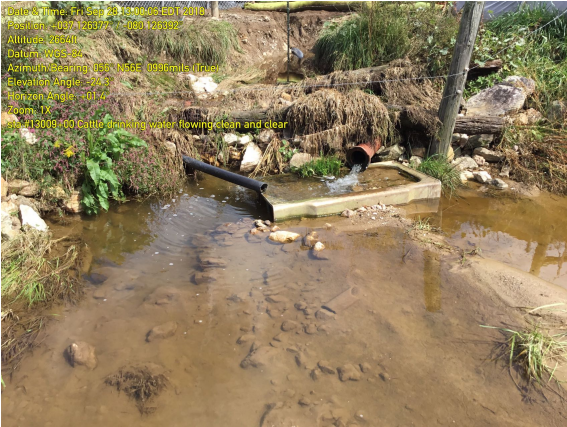
GPS Location	37.280329163221, -80.0294784084708	GPS Location	37.1309594996619, -80.1363753341885		
Description	Sta:#13012+40 Looking West onto the BRP See photo for accurate coordinates.	Description	Sta:#13012+90 Looking East onto the BRP See photo for accurate coordinates.		
<p>Date & Time: Fri Sep 28 11:54:54 EDT 2018 Position: +037.130504° / -080.124392° Altitude: 2030ft Datum: WGS-84 Azimuth/Bearing: 190° S60W 1239mils (True) Elevation Angle: -07.5° Horizon Angle: -06.5° Zoom: 1X Sta:#13009+00 cattle drinking water flowing clean and clear</p>

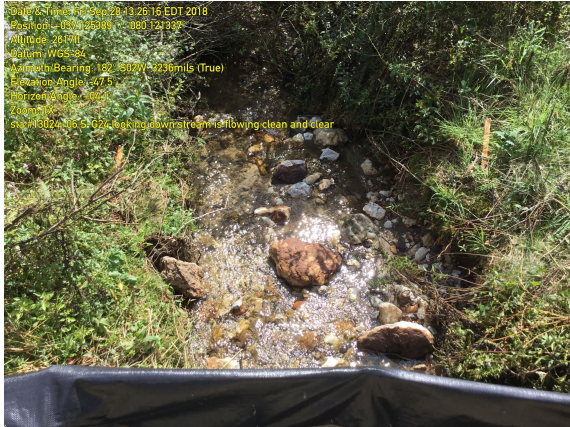
<p>Date & Time: Fri Sep 28 11:26:16 EDT 2018 Position: +037.130504° / -080.124392° Altitude: 2030ft Datum: WGS-84 Azimuth/Bearing: 190° S60W 1239mils (True) Elevation Angle: -07.5° Horizon Angle: -06.5° Zoom: 1X Sta:#13024+06 S-G24 looking down stream flowing clean and clear</p>
