Visual Site Inspection Report

Project Name	H-600 Pipeline Spread H	AFE	124300138	Spread	H-600 Pipeline Spread H
Contractor	Precision			Report #	8514
Inspector	Dustin Lyons			Date/Time	9/28/2018 7:39 AM
Permit #	TBD	Inspection Type	VA SWPP	Station Begin	12005+00
State	VA	Inspection Area	Partial	Station End	12072+00
County	Montgomery	Ground	Wet	Temperature (°F)	65.00
Municipality	N/A	Weather	Sunny	Rain Gauge (in)	1.50
GPS Location	37.2649984108631, -80.307128196657			Rain Accumulation Time (days)	1.00

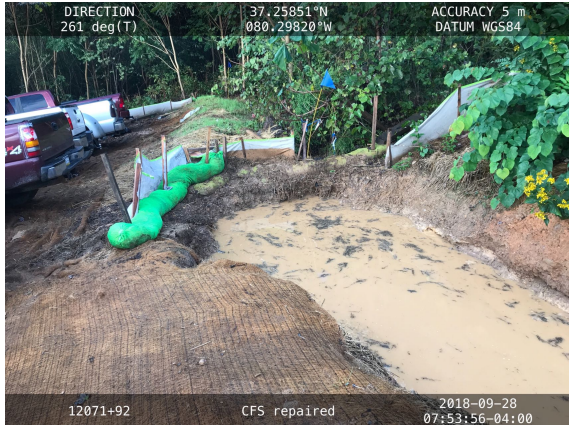
GPS Location	37.28872447, -80.2903331		GPS Location	37.28872447, -80.2903331	
Description	See photo for gps data. Photo shows the repaired CFS at 12072+92. (Punch list item 1276)		Description	See photo for gps data. Photo shows damaged P-1 at 12068+70.

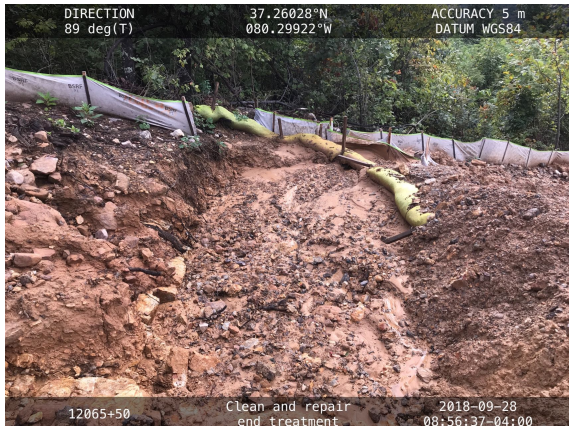
GPS Location	37.264905707014, -80.3072586190703		GPS Location	37.264905707014, -80.3072586190703	
Description	See photo for gps data. Photo shows full sump and damaged end treatment at 12065+50.		Description	See photo for gps data. Photo shows full sump pit at 13049+50.

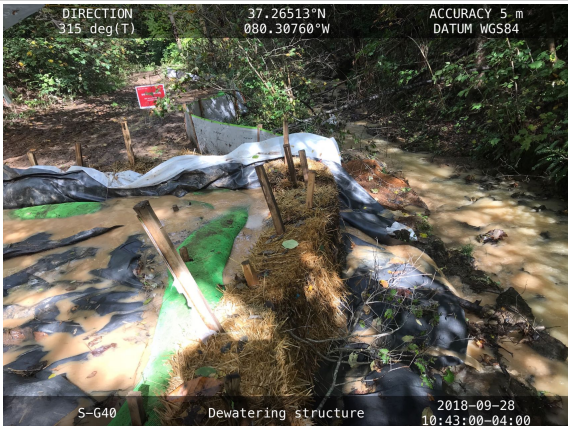
GPS Location	37.264905707014, -80.3072586190703		GPS Location	37.264905707014, -80.3072586190703	
Description	See photo for gps data. Photo shows bridge mats over S-G36.		Description	See photo for gps data. Photo shows water flowing through the dewatering structure at S-G40.
